re: ALDAN LODGE, WELLINGTON STREET, PICTON (BC: 011291)

ALDAN LODGE
 STORMWATER INVESTIGATION
 PICTON.

Building Consent No. 011291

Foundation inspection, two new motel units

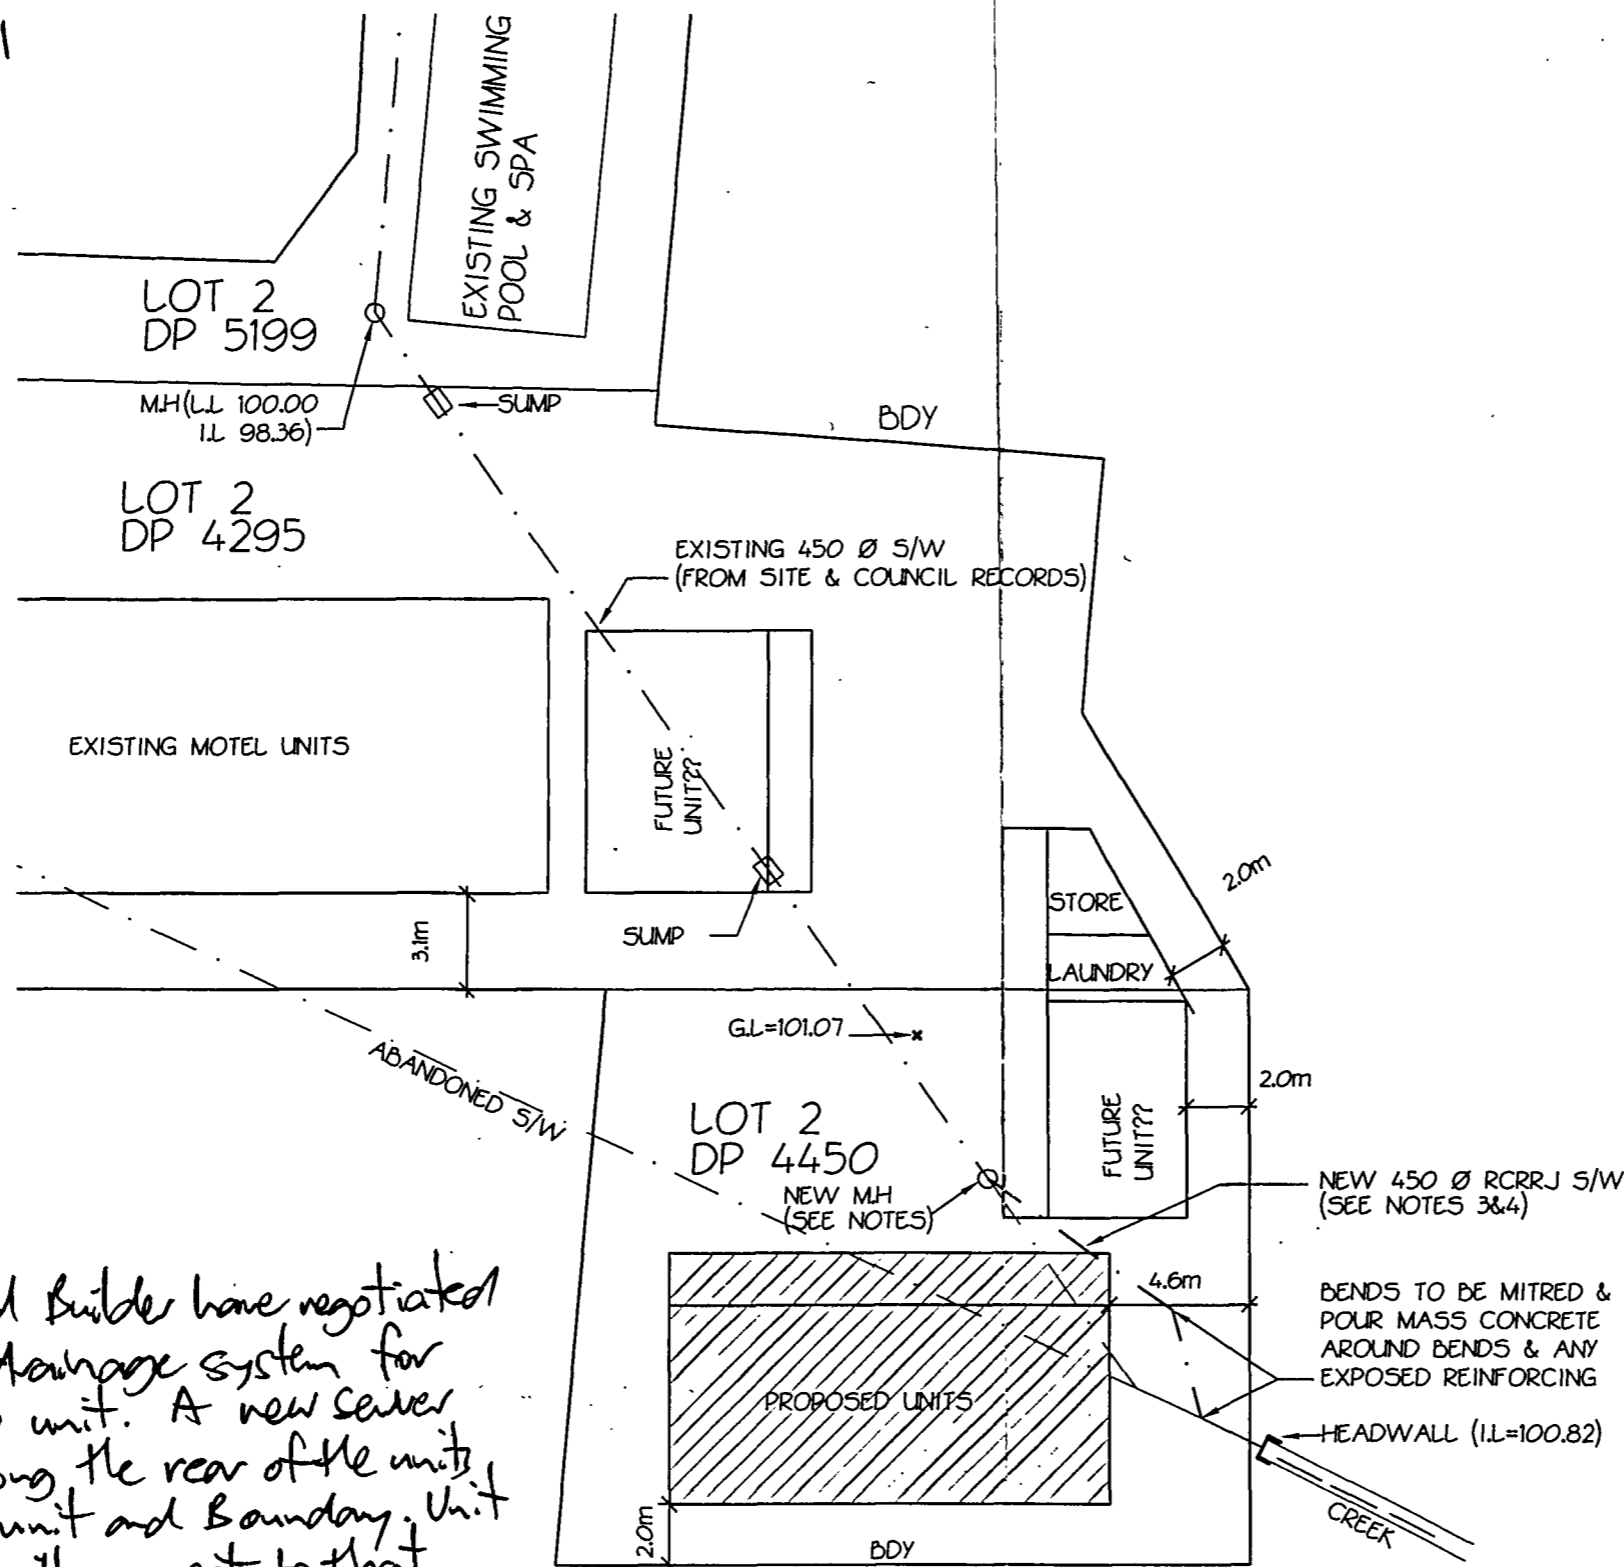
SITE PLAN
 1:250

Note
 Owner and Builder have negotiated revised drainage system for the new unit. A new sewer runs along the rear of the unit between unit and Boundary. Unit sewage will connect to that. S.W. is slightly different to this plan but is similar. Kerry Walsh has negotiated the change & WWA 1/11/01.

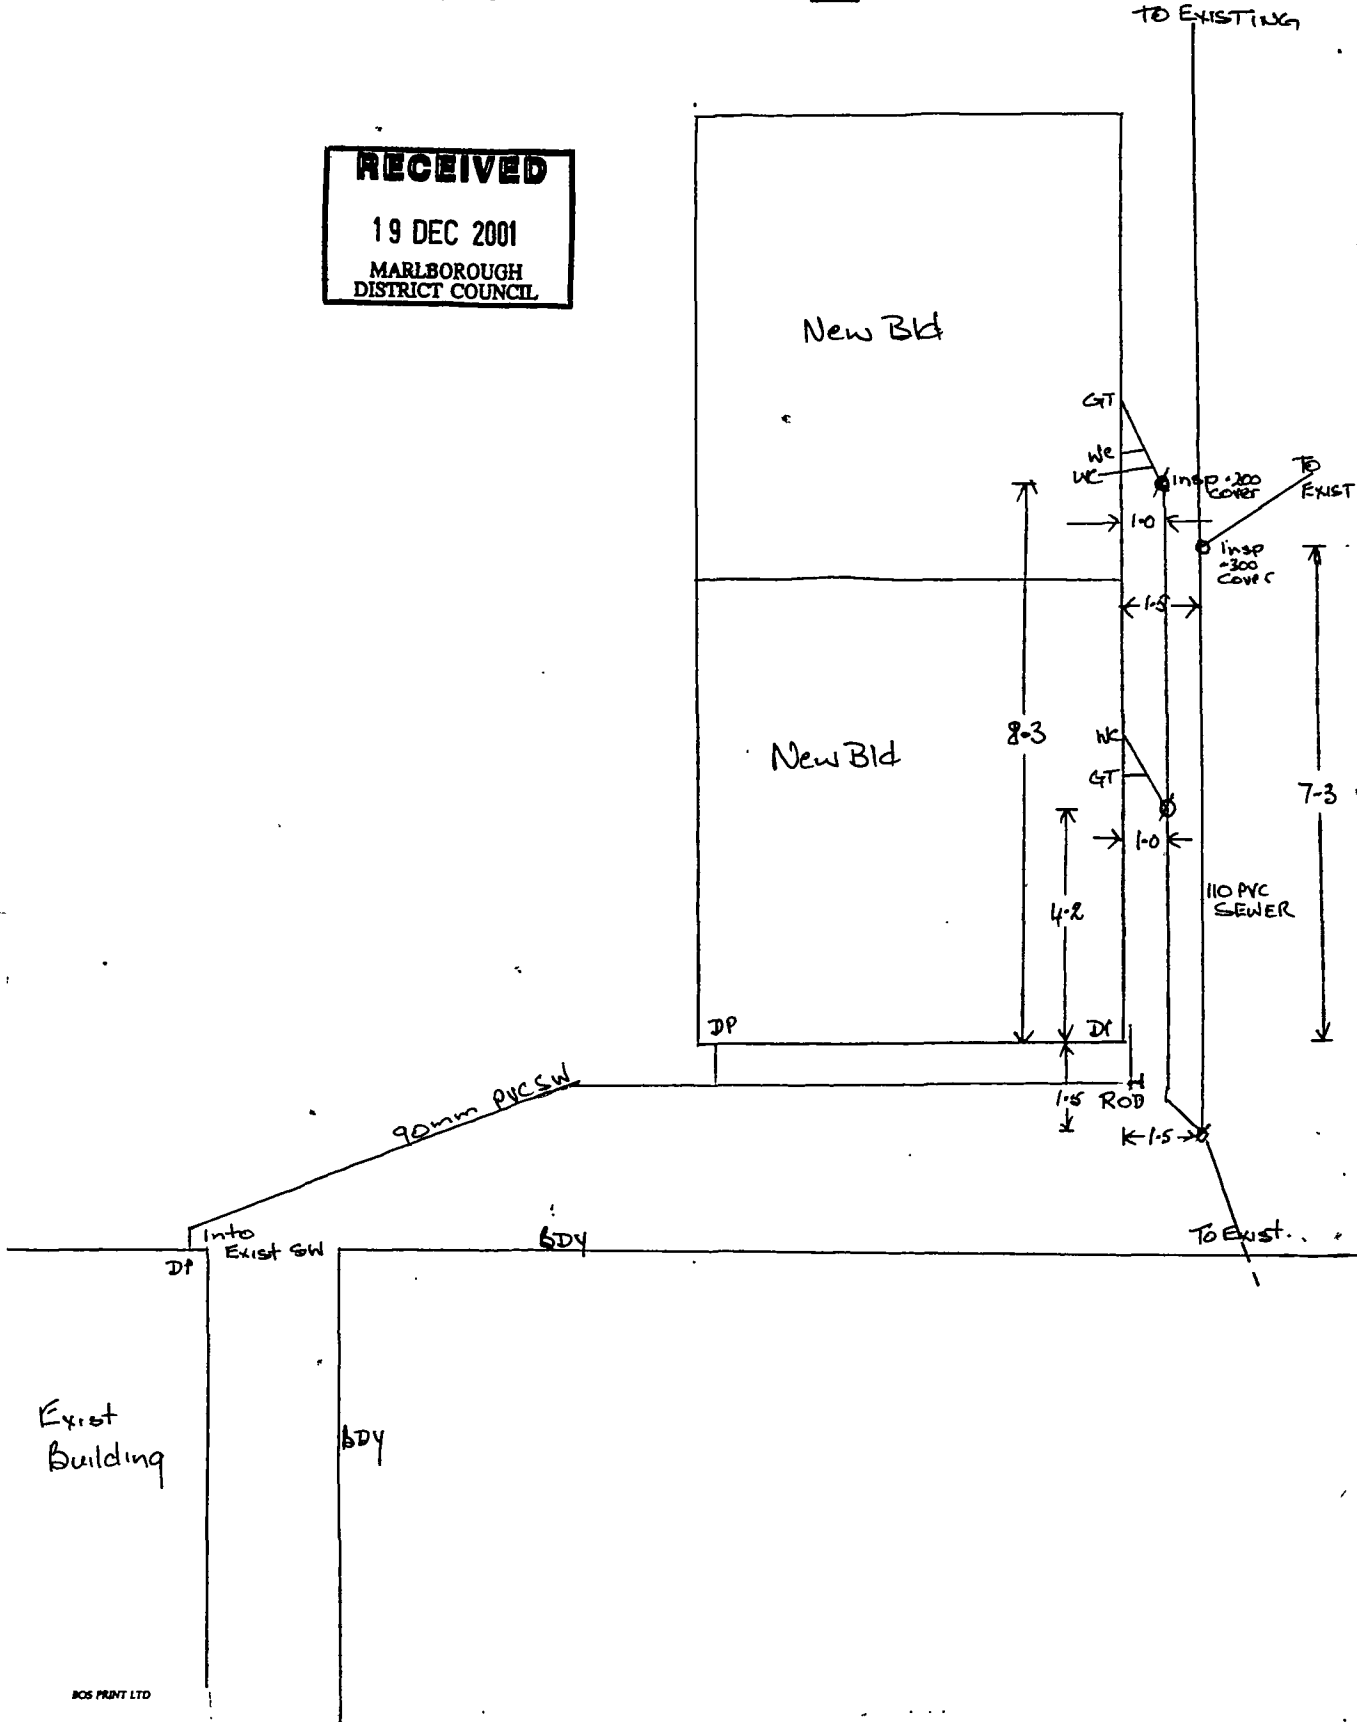
DRAINAGE PLAN

This was a drainage inspection to connect into an existing sewer line which Kerry Walsh has given permission to connect into. The drain was laid to a good grade in a chipped trench. The gullies were in place. A test was on and holding. Two toilet pans. There is a terminal vent on the outside. A drainage plan is still to be supplied. Also Andrew has put on an inspection for the stormwater on the top corner south west part of the building as asked for by Ken Curtin.
