# Body Corporate 46828, Windmill Centre

## Long-Term Maintenance Plan

Body Corporate Name: Windmill Centre  
Street Address: 181 Clarence Street  
Riccarton  
Christchurch  
Number of Units: 6

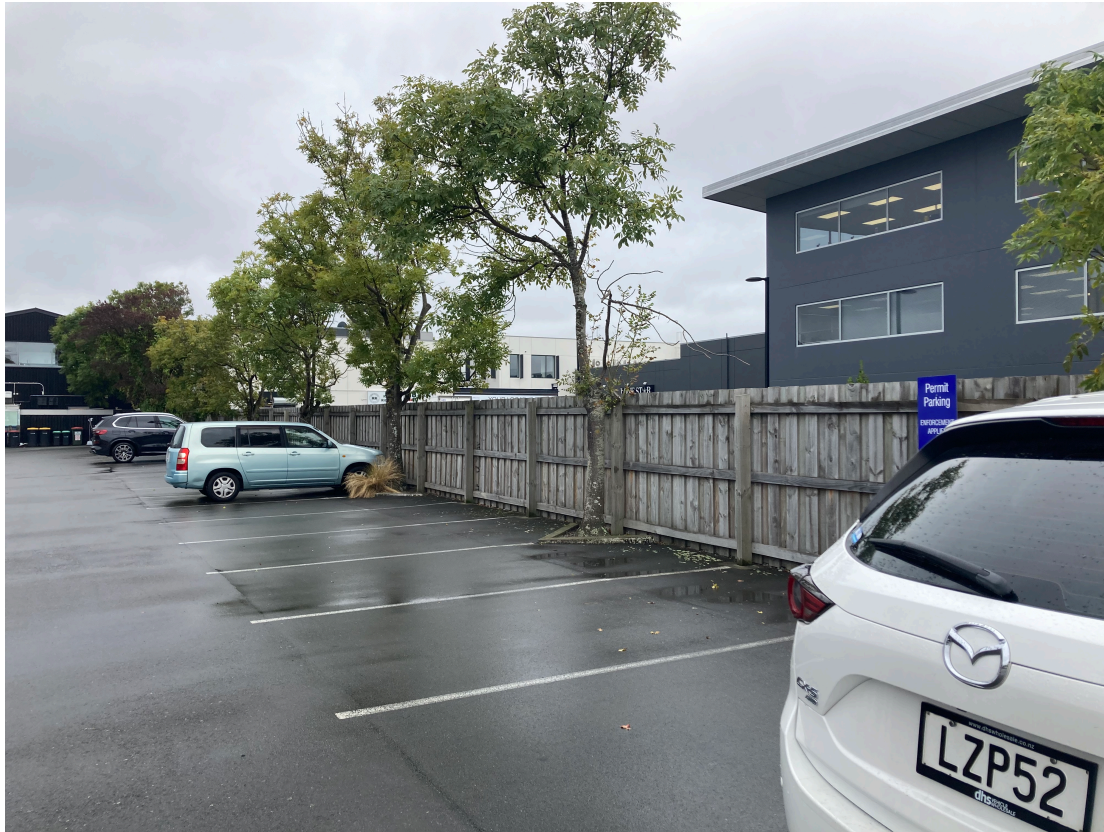
Above image number: 1 Name: Eastern carpark

The condition of the asphalt appears to be good.

The carpark markings appear to be in good condition

The sumps are able to be blocked with debris from the surrounding tall trees and requires regular cleaning.

The driveway is to be regularly swept or washed to remove leaves and debris falling from nearby trees and overhanging branches. This cost is funded from the operating budget.

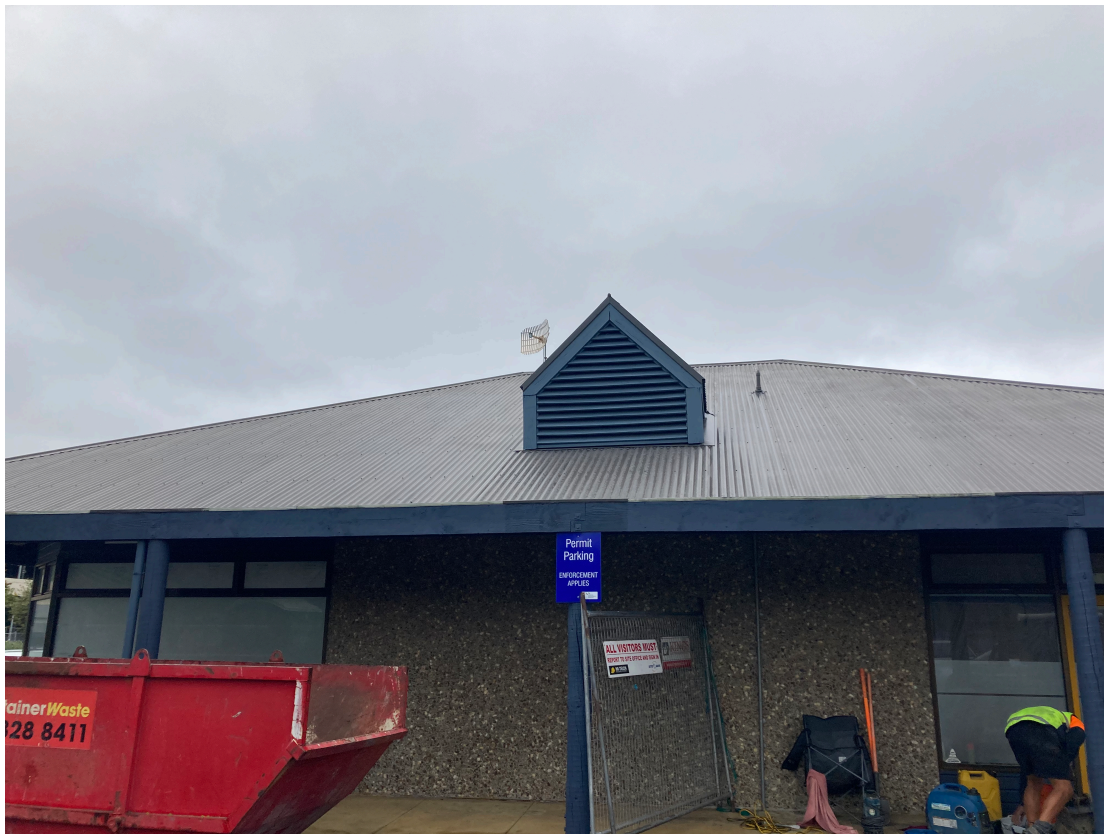
Above image number: 2 Name: Roof line

As of March 2024 the condition of the roof cladding that can be seen from ground level looks in good condition and a butynol repair was completed on the membrane in 2023, but the main roof will need painting in the term of this plan.

The gutters appear to be sound but it cannot be ascertained from ground level if cleaning is required. Some of the downpipes need to be painted and repaired due to damage.

A roof repaint will be required during the term of this plan, and a budget for it has been set up.
