Geotechnical site  
investigations,  
252-256 High Street,  
Lower Hutt

April 2019

For Superloans Hutt Limited

**Project Number 1272**

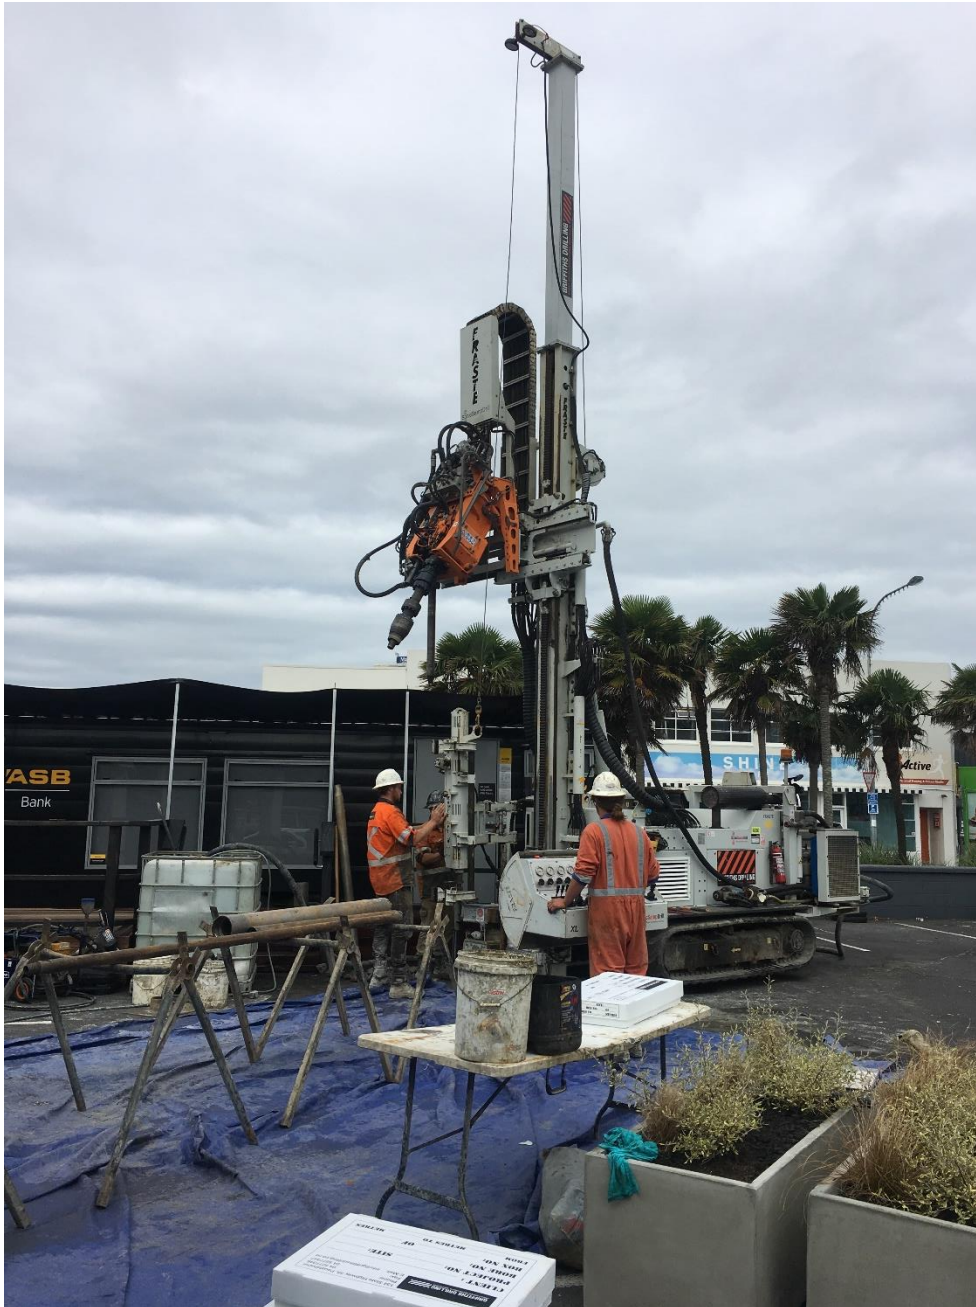
Image 1. Site investigations with sonic drilling rig

On 17th of March 2019, Griffiths Drilling (NZ) Ltd sonically drilled one cored borehole (WGDH368), with Standard Penetration Tests (SPT's) being performed at 1.5m intervals.

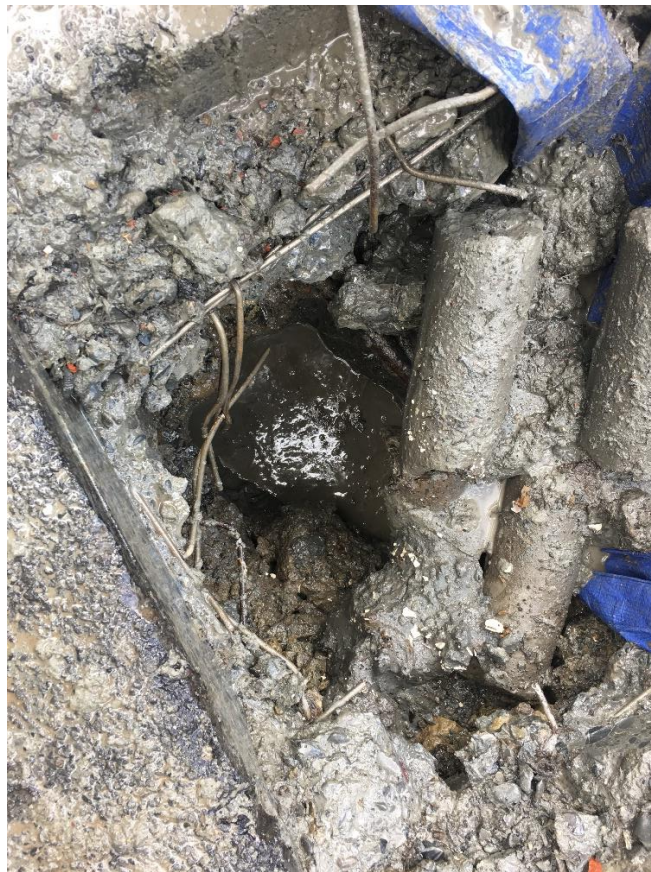
During the course of our investigations a mild petroliferous odour was detectable when the pavement cover over the site was penetrated. An oily sheen and foam were observed when excavating the upper 1.5m of BH1. These observations show that some level of hydrocarbon contamination is present beneath the surface of this site (Image 2). Silts and clays within the core of the borehole appear to be contaminated to a depth of ~3.5m (Figure 2).

*Image 2. Hydrocarbon contamination*

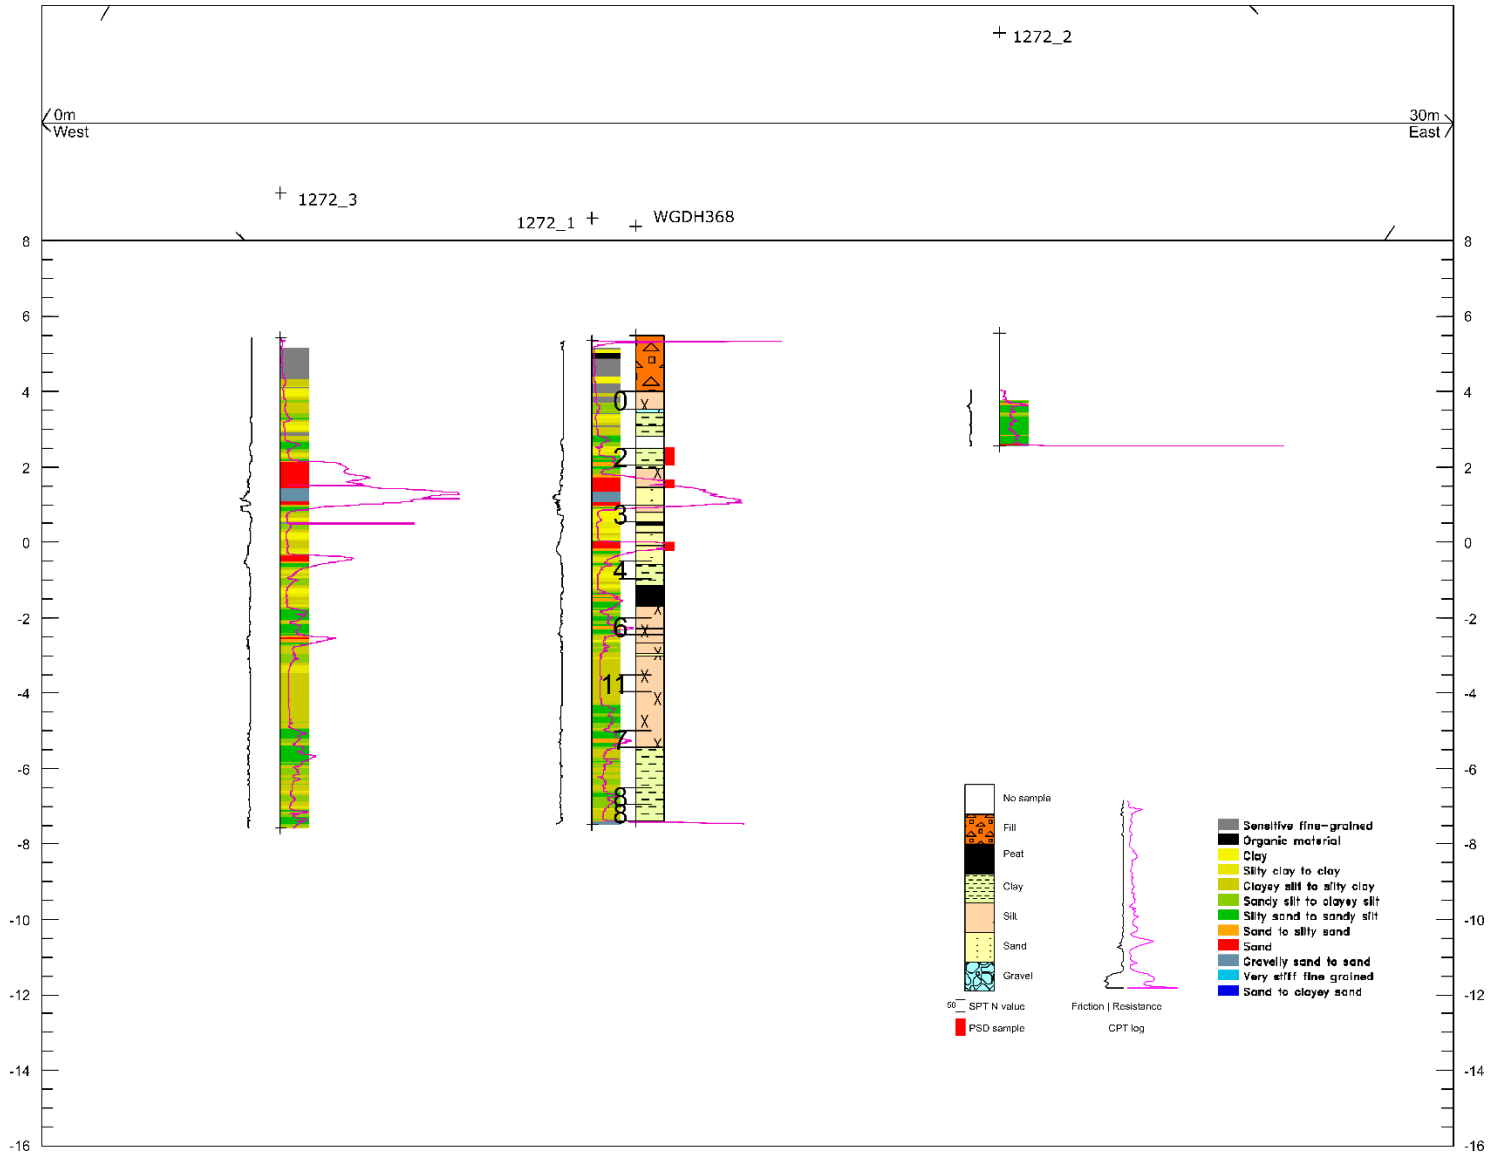
Figure 3. Cross section 1

Correlations between the drill hole and the CPT's show that the geology is consistent across the site, with some minor differences in bedding, attributable to the environment of deposition.

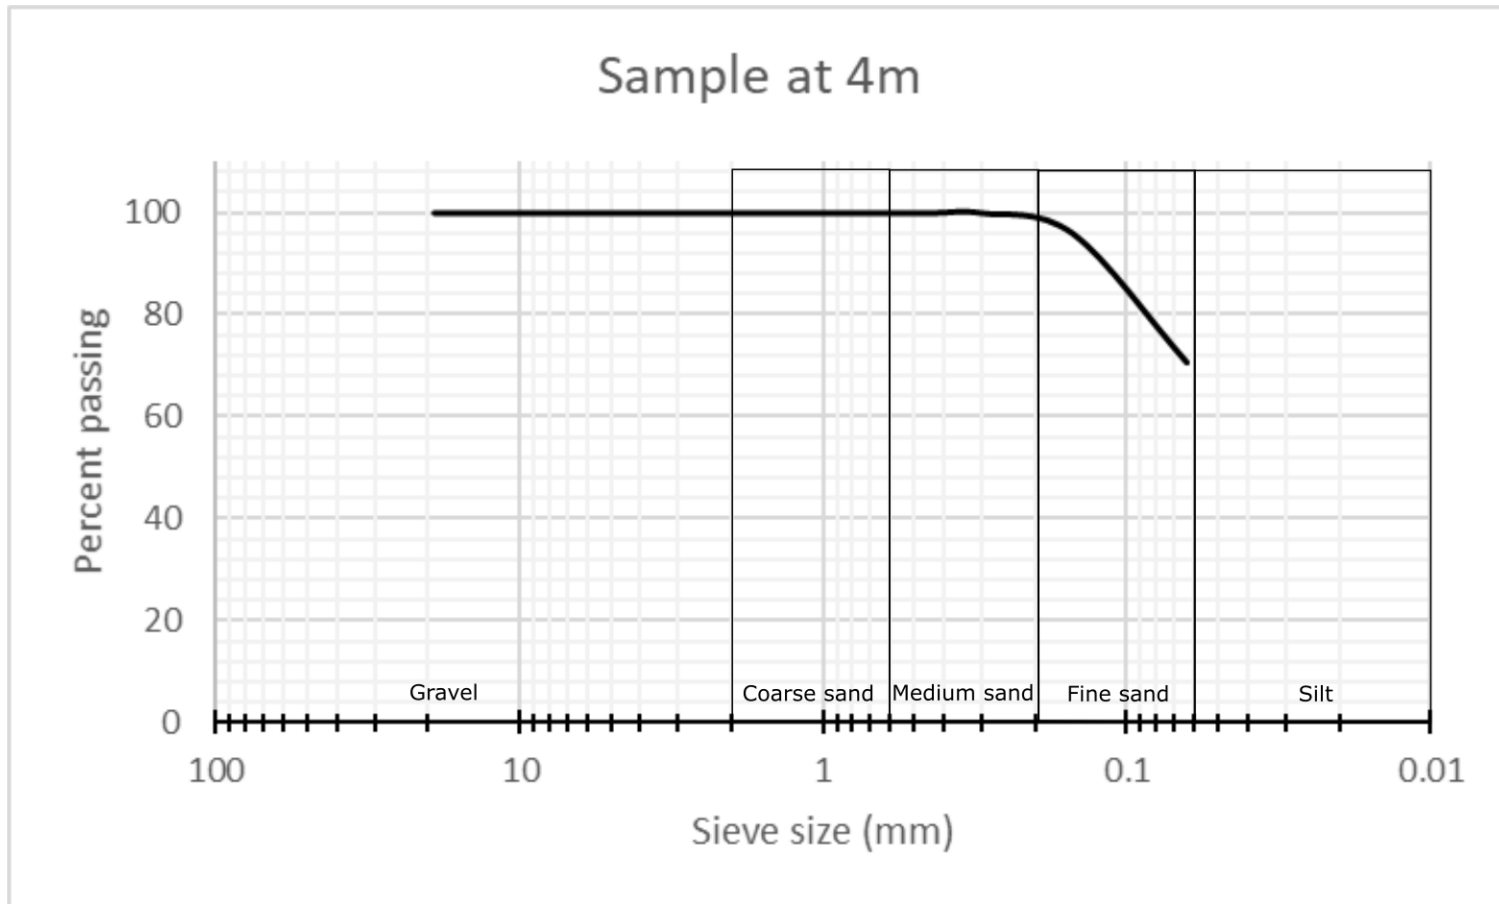
Figure 5. Sample 2, Soil size grading curve

Three soil samples were extracted from the core. These samples were collected from between; 3-4.5m (SPT), 3.9-4.1m and 4.9-5.1m. Particle size distribution analysis by wet sieving was undertaken by Materials Advisory and Testing Service Ltd (MATS), Figures 4-6.

Results from the particle size distribution testing for some of the layers identified as having a high probability of liquefaction show that the fines content (FC%) has been underestimated by CLiq. Soil layers with high fines content have increased resistance to liquefaction triggering, Leeves et al. (2015), which means that the probability of liquefaction for this site, as determined by CLiq calculations, is overestimated.

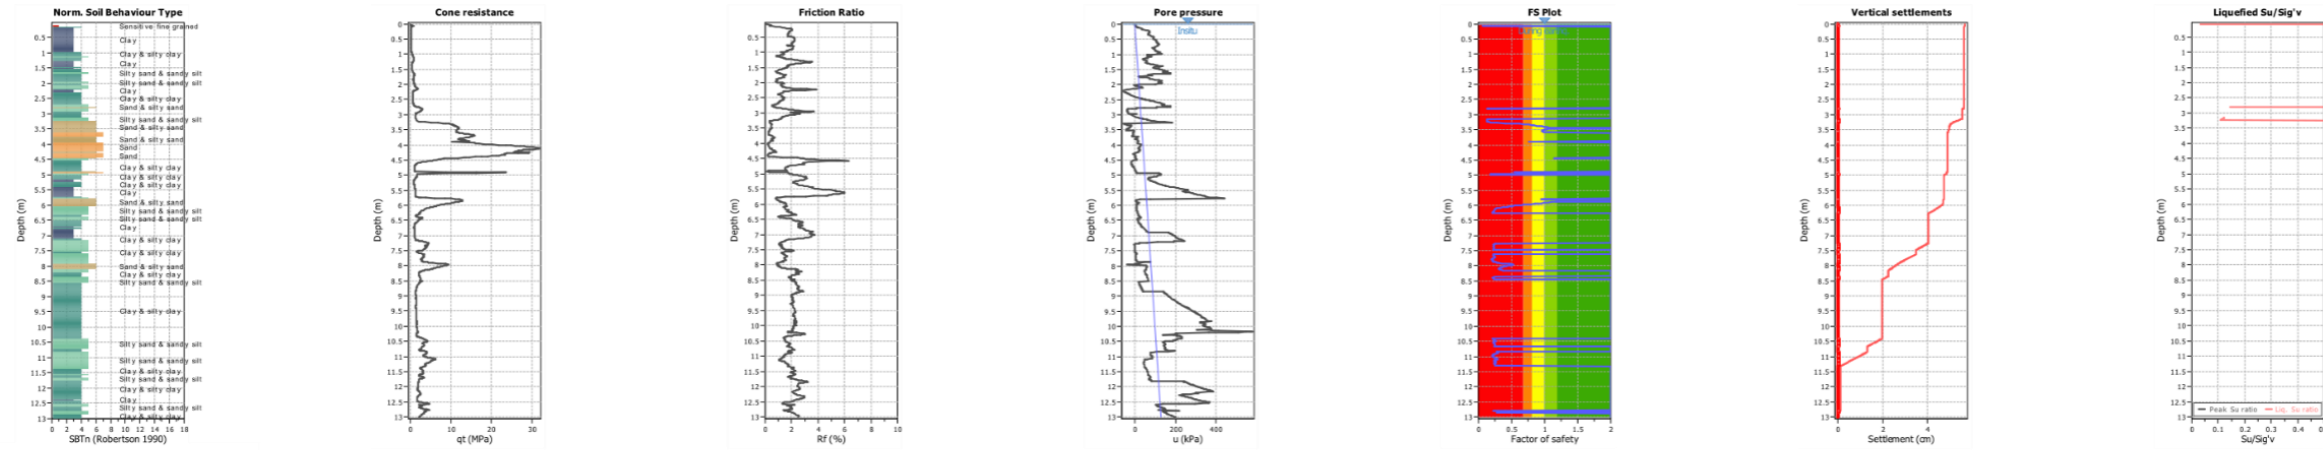
**CPT: 1272\_3 ULS**

Total depth: 13.00 m

Analysis method:	NCEER (1998)	G.W.T. (in-situ):	0.00 m	Use fill:	No	Clay like behavior	
Fines correction method:	NCEER (1998)	G.W.T. (earthq.):	0.00 m	Fill height:	N/A	applied:	Sands only
Points to test:	Based on Ic value	Average results interval:	3	Fill weight:	N/A	Limit depth applied:	No
Earthquake magnitude $M_w$ :	7.10	Ic cut-off value:	2.50	Trans. detect. applied:	Yes	Limit depth:	N/A
Peak ground acceleration:	0.52	Unit weight calculation:	Based on SBT	$K_v$ applied:	Yes	MSF method:	Method based

CLiq has predicted that under these ground shaking conditions, liquefaction may occur at this site (Appendix A). Any liquefaction however would be limited to thin, ~0.5m thick, mostly discrete, layers of sands-silty sands. Without continuity within the soil strata, damage from liquefaction is expected to be unlikely. The overall probability of liquefaction has been predicted by CLiq to be high for the investigated portion of this site.

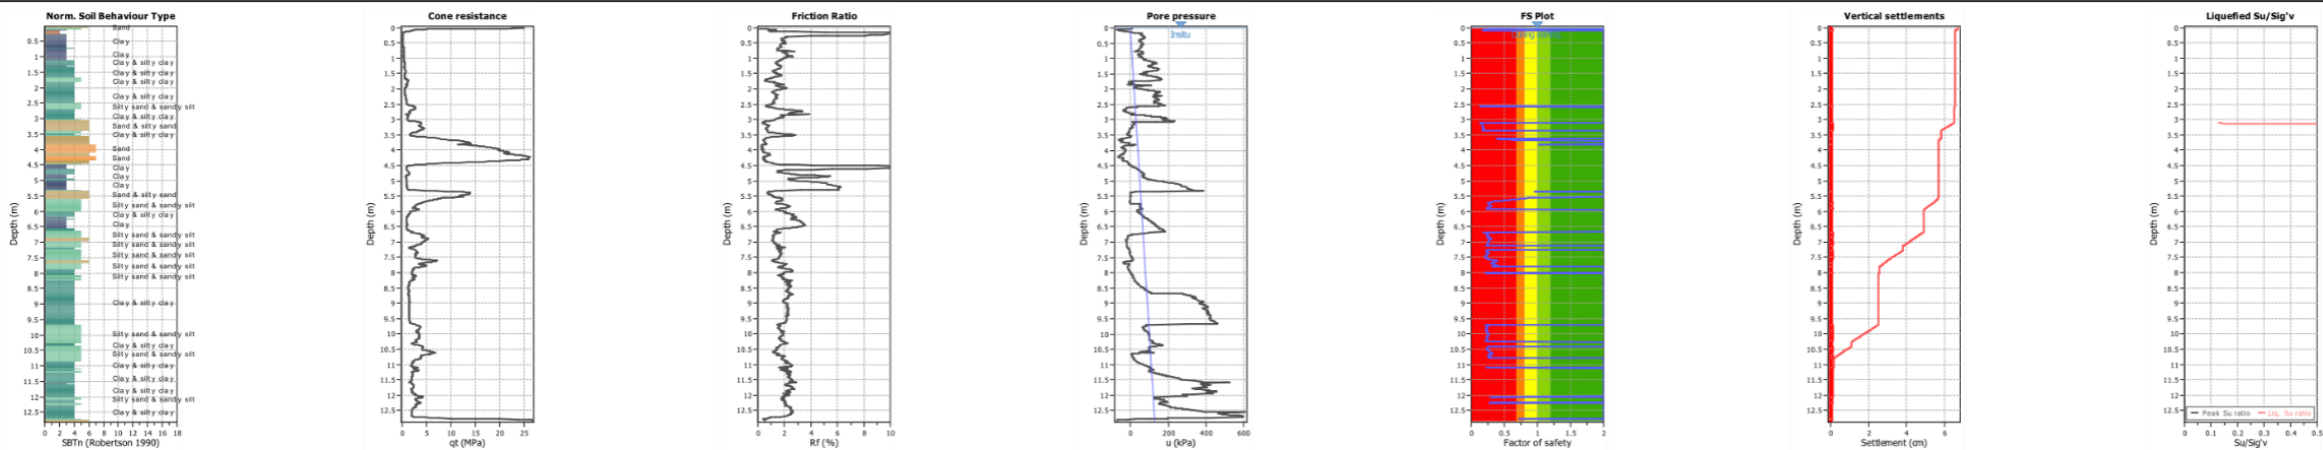
**CPT: 1272\_1 ULS**

Total depth: 12.83 m

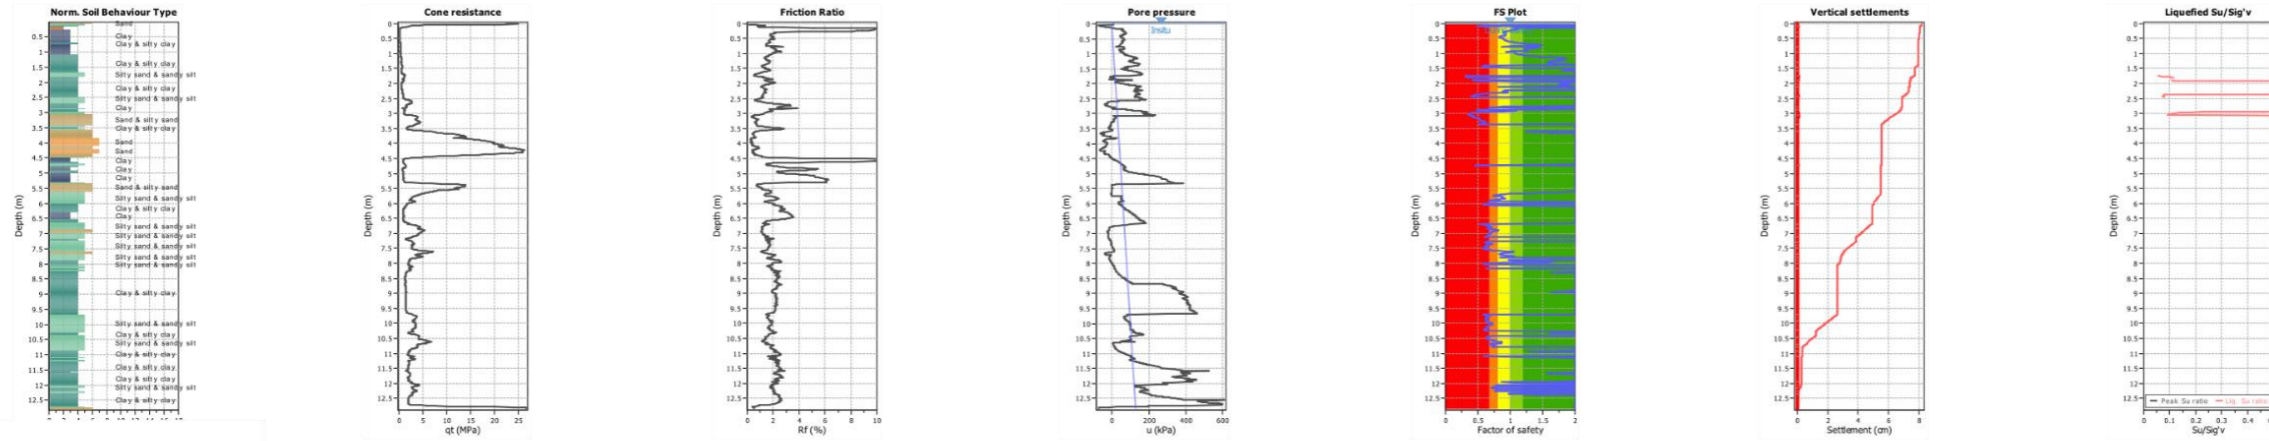
CPT: 1272\_1 Kaikoura  
Total depth: 12.83 m

Analysis method:	Robertson (2009)	G.W.T. (in-situ):	0.00 m	Use fill:	No	Clay like behavior	
Fines correction method:	Robertson (2009)	G.W.T. (earthq.):	0.00 m	Fill height:	N/A	applied:	All soils
Points to test:	Based on Ic value	Average results interval:	3	Fill weight:	N/A	Limit depth applied:	No
Earthquake magnitude $M_w$ :	7.82	Ic cut-off value:	2.60	Trans. detect. applied:	Yes	Limit depth:	N/A
Peak ground acceleration:	0.15	Unit weight calculation:	Based on SBT	$K_s$ applied:	No	MSF method:	Method based

It is unlikely that settlement occurred following the 2016 Kaikoura earthquake as no damage was reported in the area and no evidence of liquefaction is observable in the core. It would appear the program CLiq which is based on established relationships between point resistance and sleeve friction, is overestimating the potential for liquefaction at this site.

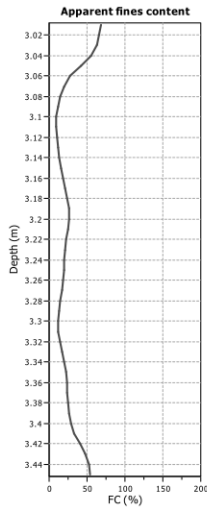
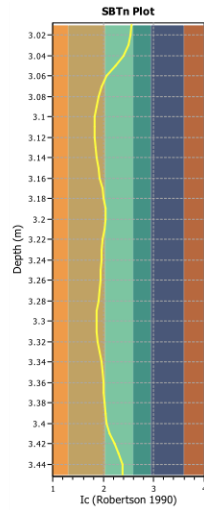
Measured FC: 94.1%

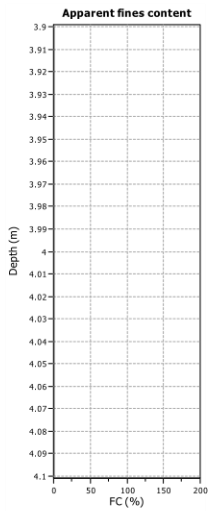
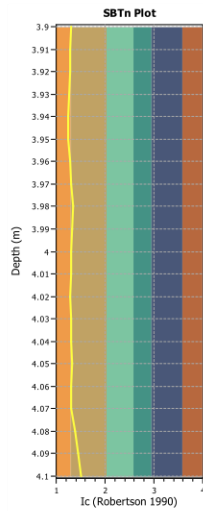
Measured FC: 7.2%

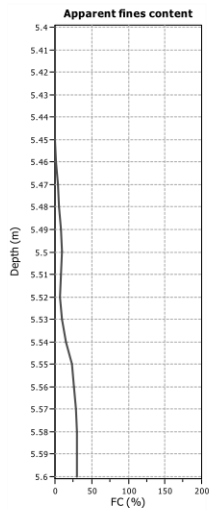
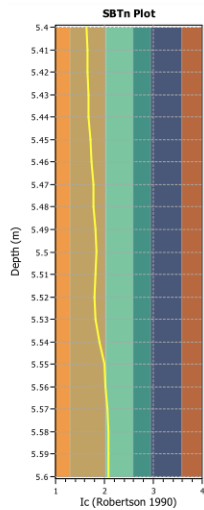
Measured FC: 70.6%
