# Land Information Memorandum

5/1 Stark Drive

**Property address** 5/1 Stark Drive, Hornby, Christchurch  
**Valuation roll number** 23436 00900 E  
**Valuation information** Capital Value: \$610,000  
Land Value: \$315,000  
Improvements Value: \$295,000  
*Please note: these values are intended for Rating purposes*  
**Legal description** Unit 5 DP 476863 on Lots 9  
10 DP 457595 having share in 1036  
**Existing owner** Wisdom Properties Investment Limited  
PO Box 8907  
Christchurch 8440

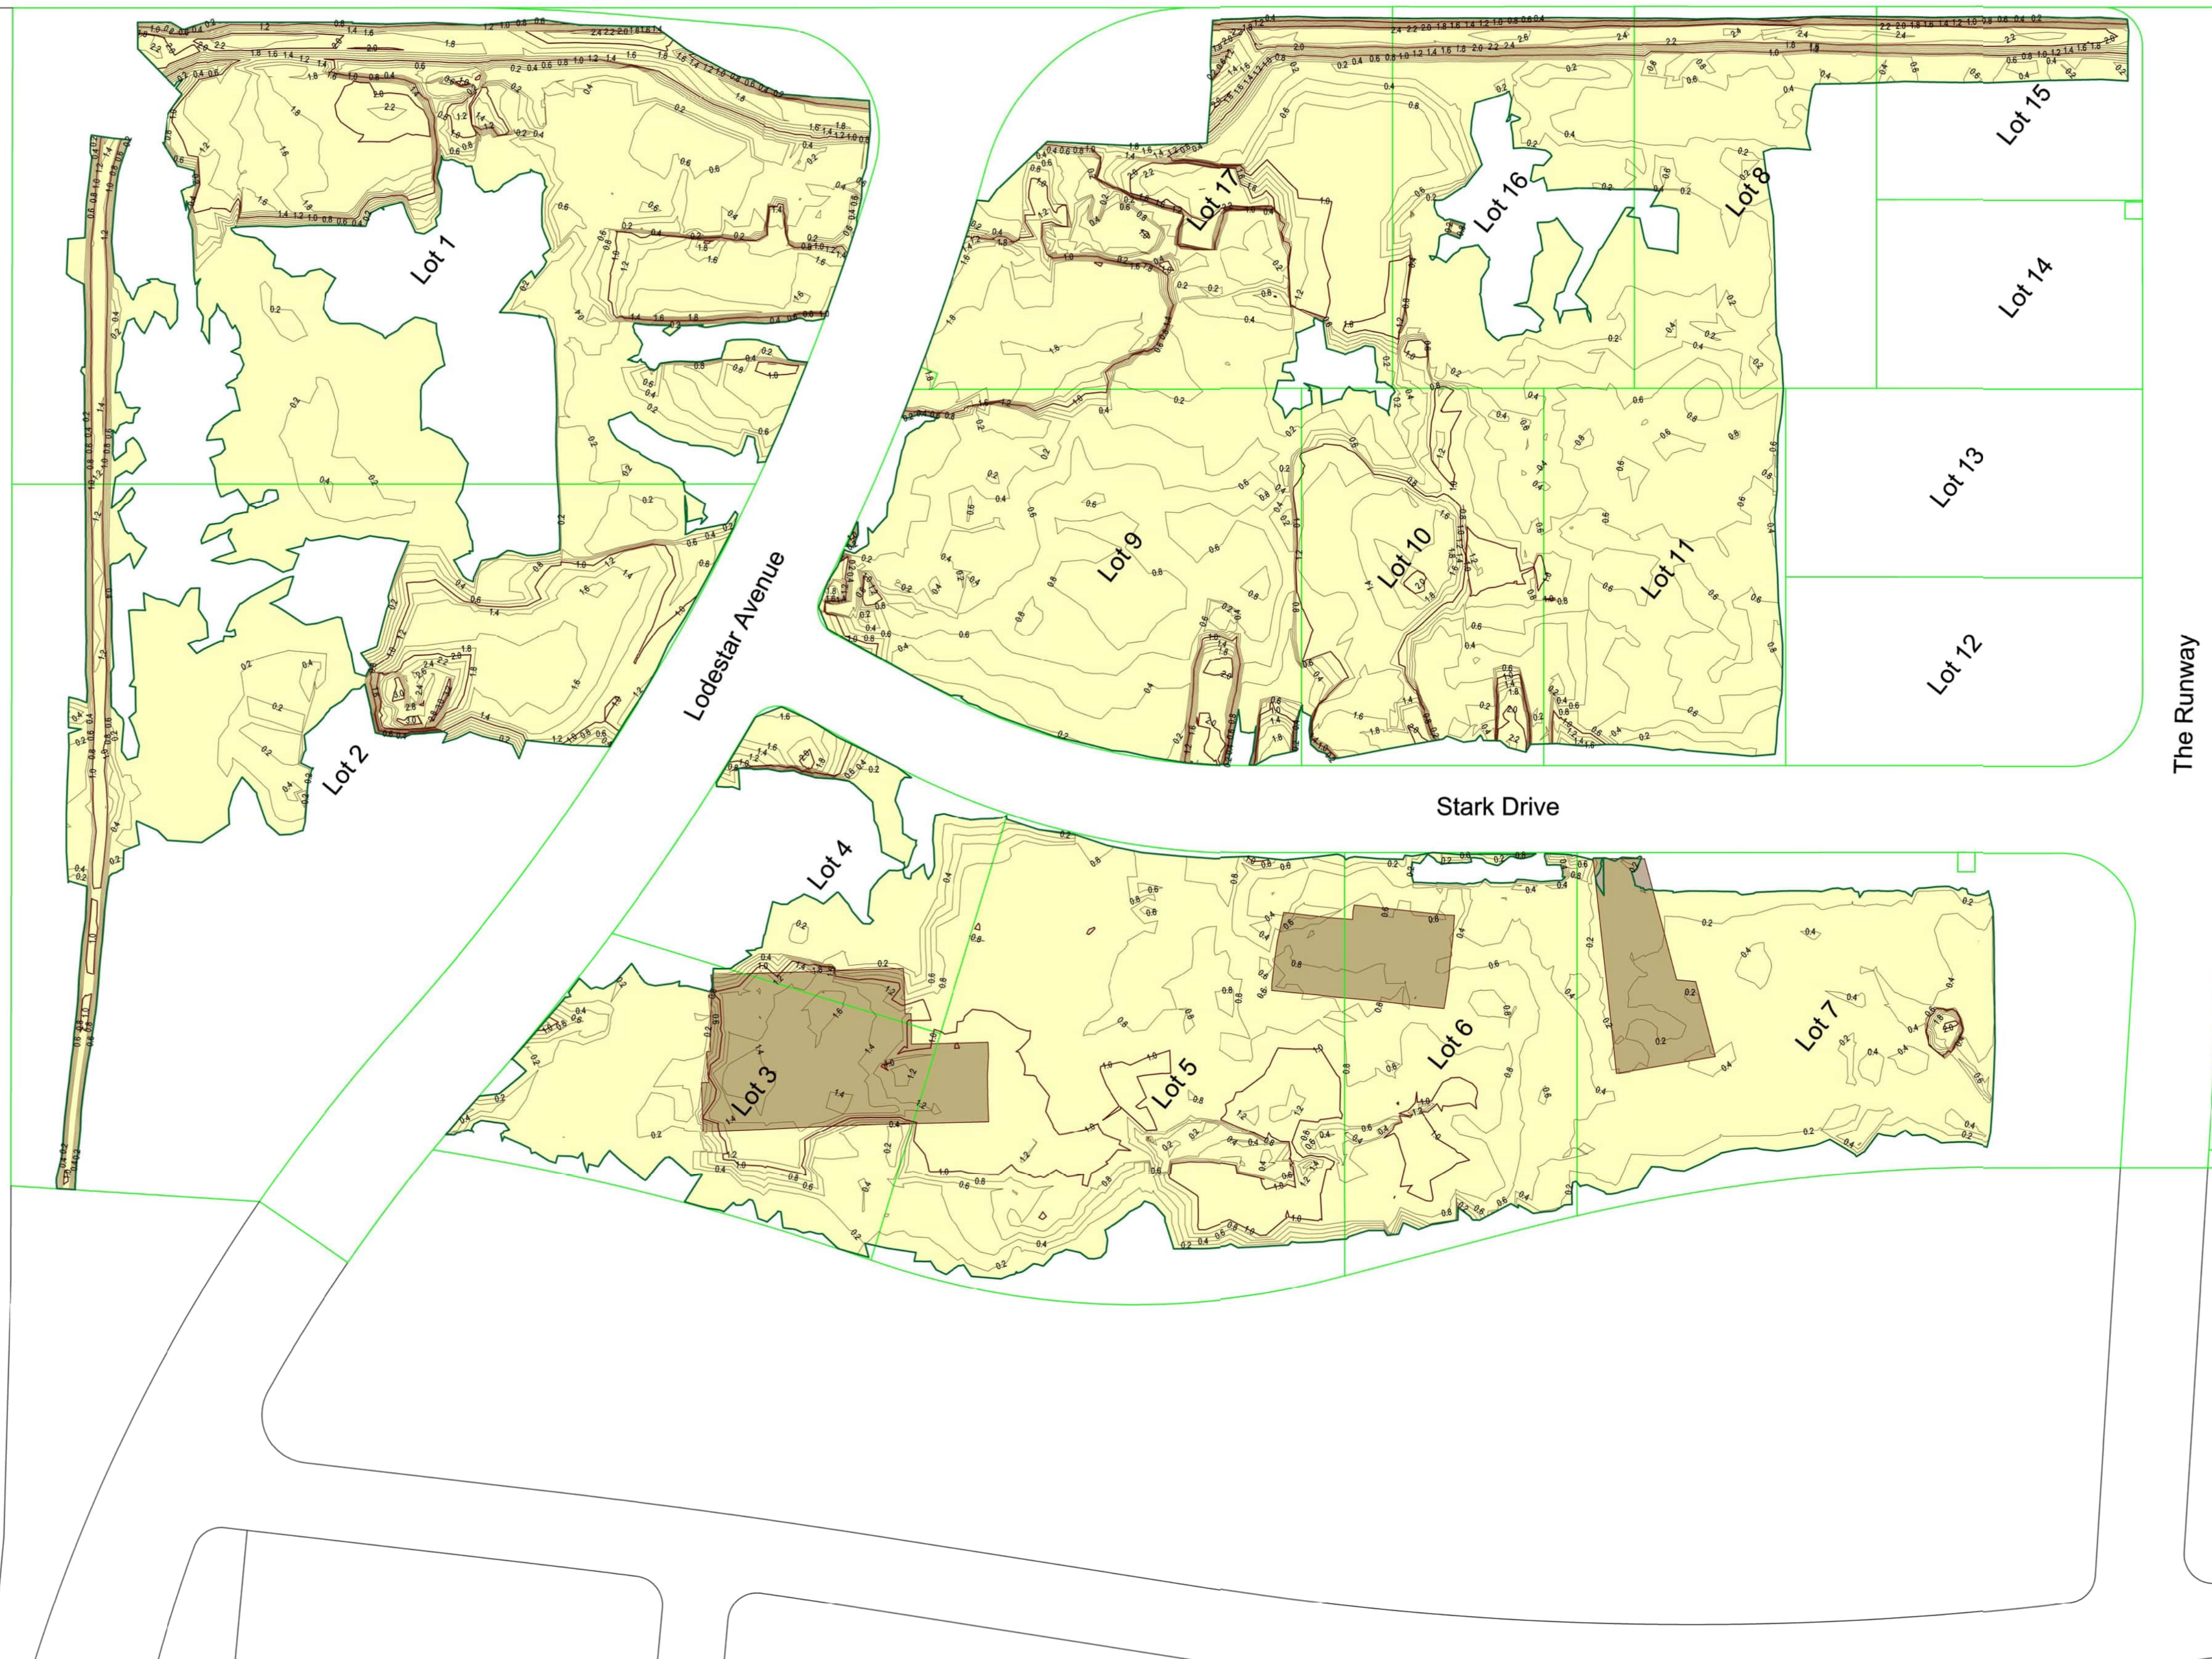
## Appendix A : PLAN OF CONTROLLED FILL AREAS

no.	amendment	initial	date	designed	surveyed	NZGD 2000 (Pest Quake)	Scale: 1:750 (A1) 1:1500 (A3)	Drawing Set	Sheet
A	Updated for completion of earthworks	WFP	28/4/13	manager	WFP	Mt Pleasant G22000	1:750 (A1) 1:1500 (A3)	347299 G5	1 of 2
B	Plan title amended	WFP	16/9/13	drawn	surv.date	origin of levels	Date: 28/04/2013	PLOT:05:13028:01	rev. B
				checked	to Apr 2013	Wigam Control Tower 71 Constar Drive RL -48.29m datum CDD (Jan 2012)
