## Westpac Branch Detailed Seismic Assessment Report - 2 Cobham Court, Porirua

We have now completed the more detailed seismic assessment of the Westpac branch located at 2 Cobham Court, Porirua and have summarised our methodology and the results within this report.

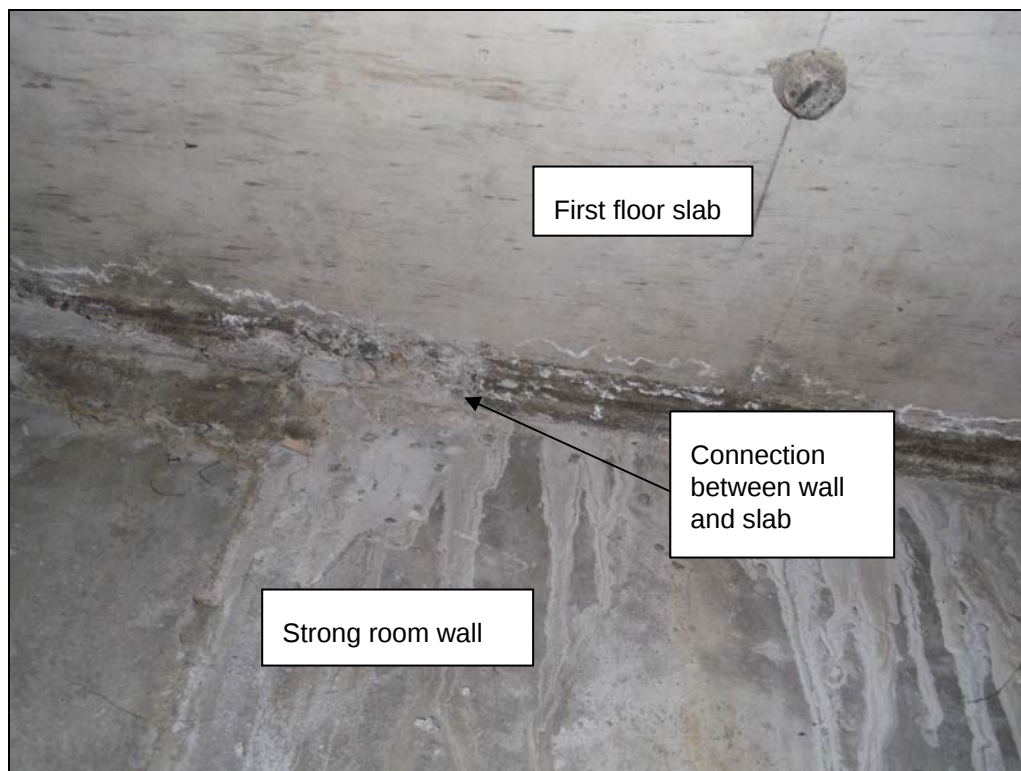
- The strong room was confirmed to be connected to the first floor diaphragm (Figure 4).
- The connection between the first floor column and beam in the first addition was confirmed (Figure 5).
- The reinforcing detailing of the first floor column in the first addition was confirmed (Figure 6).

**Figure 4 - Strong room to first floor slab connection**

Intrusive investigation confirmed that the strong room was connected to the first floor diaphragm and therefore able to transfer load as part of the structural system. When calculating the capacity of the strong room walls a conservative concrete strength was assumed and no reinforcing was accounted for. This achieved 70%NBS in the transverse direction. It was deemed inappropriate to investigate the wall further due to sensitive nature of the strong room and because the score achieved was above Westpac's minimum target building score of 67%NBS.

Beca understands it is Westpac's policy for their buildings to achieve greater >67%NBS, therefore Westpac may be satisfied that no further work be carried out on the Westpac Porirua Branch at this time.

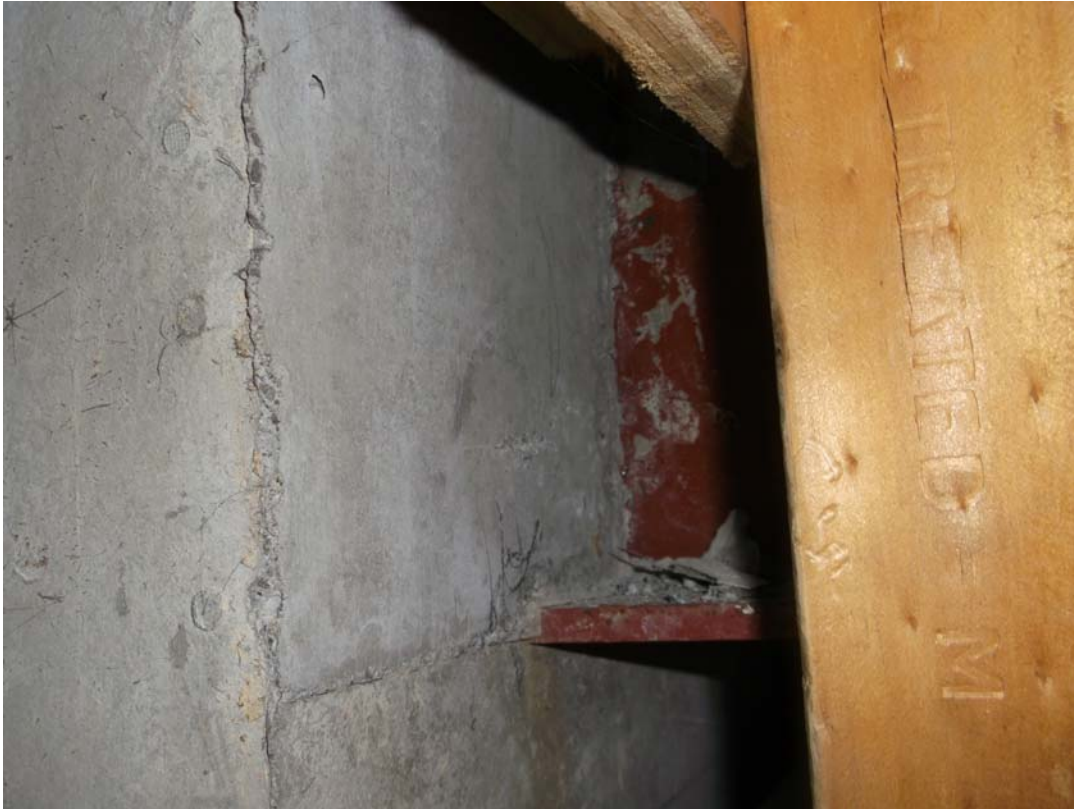
**Figure 5 - Roof beam to first floor column connection**
