# Land Information Memorandum

Property address:  
45 Princess Street

### DETAILED ENGINEERING EVALUATION

A Quantitative Detailed Engineering Evaluation (DEE) was carried out on the Whitebait and Hudson building located at 41 Princess Street, Christchurch. The building comprises of three independent structural areas denoted as Part 1, Part 2 and Part 3 in this report. An aerial photograph illustrating all three parts is shown below in Figure 1. Detailed descriptions outlining the buildings age and construction type are given in Section 3 of this report.

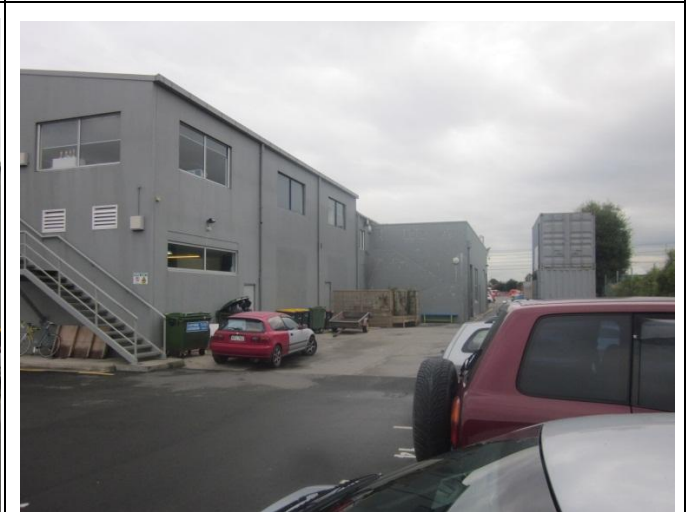
| <p>Photo 3 : Hudson Building (Part 2) – South Elevation</p> | <p>Photo 4: Hudson Building (part 2) – East Elevation<br/> (Note Existing Roller Doors Located in Panels 1 and 2)</p> |

- Installing additional hold-downs to Panels 1 and 2 located along the eastern wall.
- Installing collector beams and fixings to Panels 1, 2, 10, 12 and 13 at the first floor level.
- Installing additional roof bracing and upgrading the fixings between the roof braces and concrete panel walls.

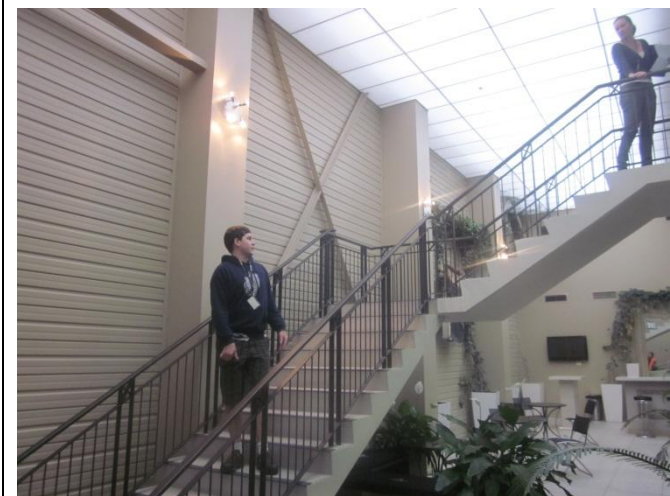
Photo 7: Existing Wall Bracing to Part 1 – East Wall

Strengthening works to Part 1 involve installing additional wall bracing along the western and eastern walls. Sketches detailing this proposed strengthening concept are shown below.

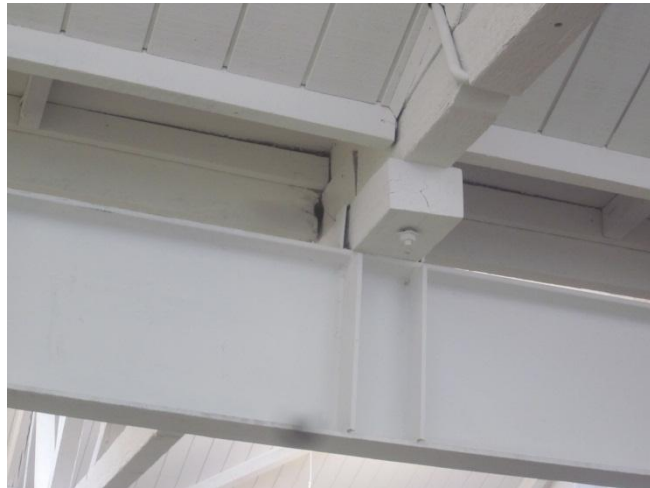
Photo 11: Part 3 – Roof Truss Connection to Spine Beam

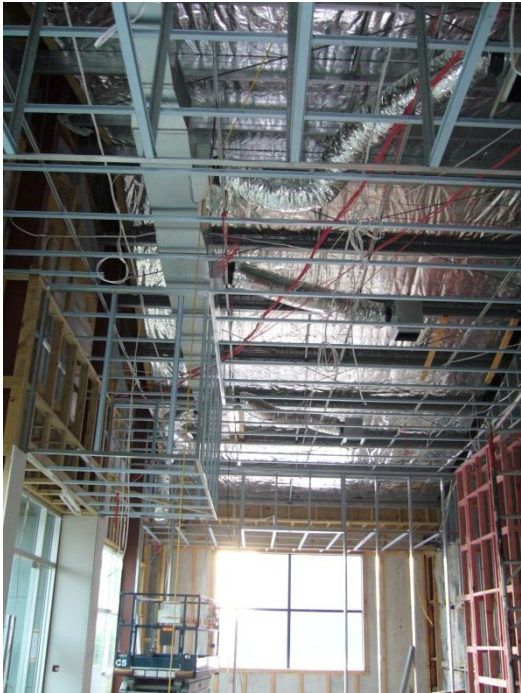
| Photo 17: Existing Construction Photos (Dated 2009) of Atrium between Part 1 and 3, Looking South | Photo 18: Existing Construction Photos (Dated 2009) of Part 2, Looking West. Show Roof Bracing Present |
