# INITIAL SEISMIC ASSESSMENT REPORT

9-11 Wakefield Street  
Alicetown  
Lower Hutt

P260449

**PROJECT:** Initial Seismic Assessment of the building located at 9-11 Wakefield Street, Alicetown, Lower Hutt.

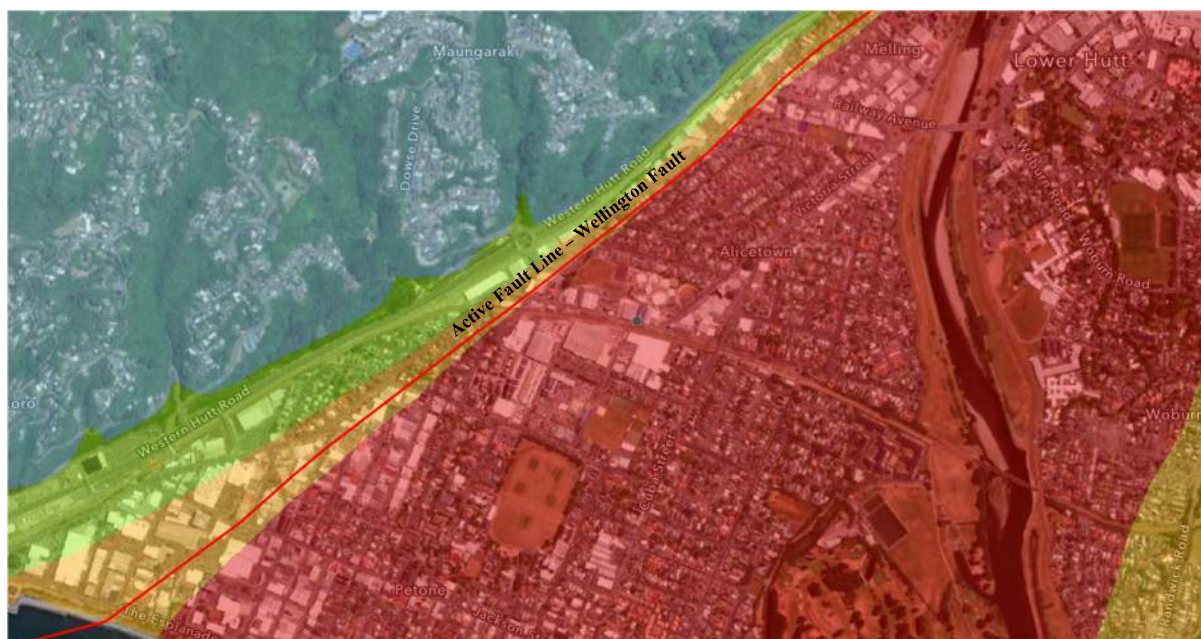
**Figure 3.** Ground shaking risk –High (GWRC webmap) and location of active fault (240m)

The building at 9-11 Wakefield Street, Alicetown, Lower Hutt is founded on a category **D** subsoil profile, as per numerous nearby borehole and CPT test logs available. The building of interest is located within 200 m towards South-East of the Wellington fault trace, with “**High**” severity of ground shaking (see Figure 3).

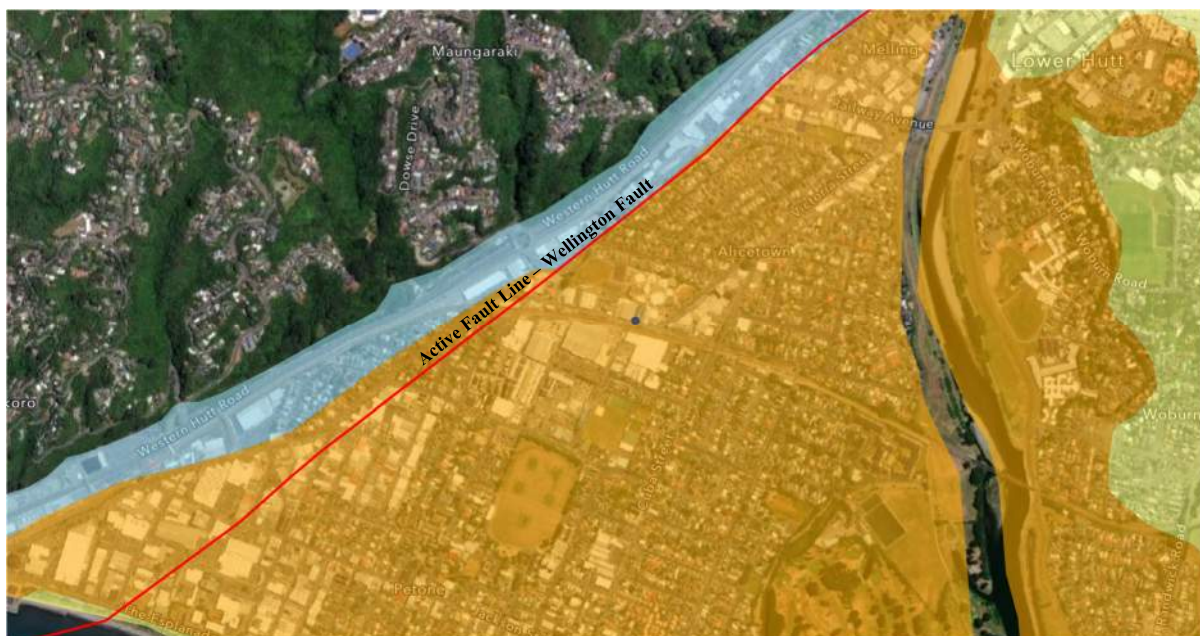
**Figure 4.** Liquefaction potential – High (GWRC Webmap) and location of active fault (240 m)

The building lies in a location that is deemed to have “High” liquefaction potential and “Low” risk of seismic slope failure (see Figure 4).

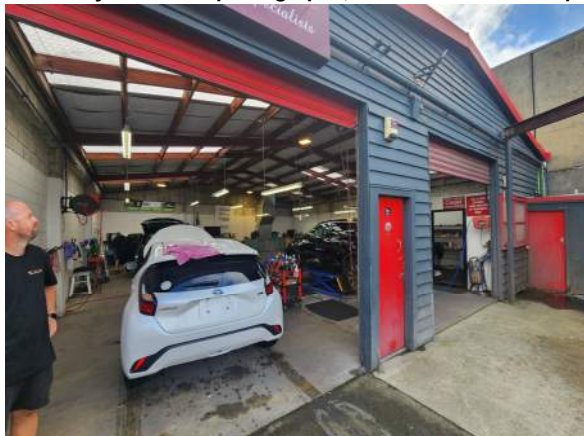
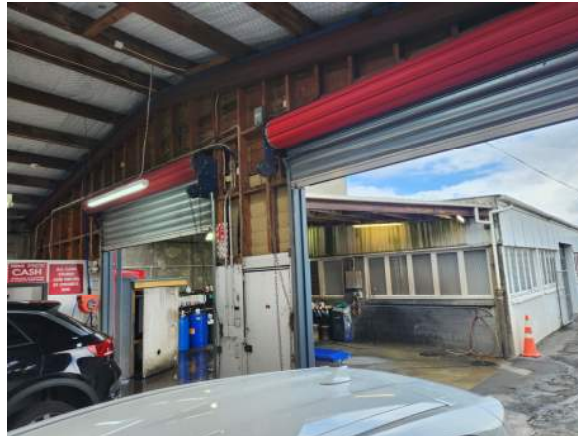
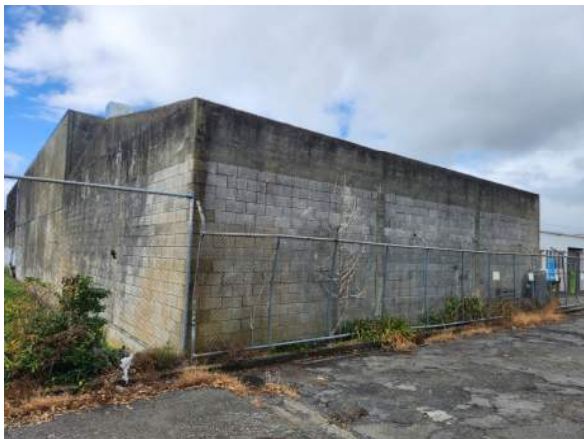
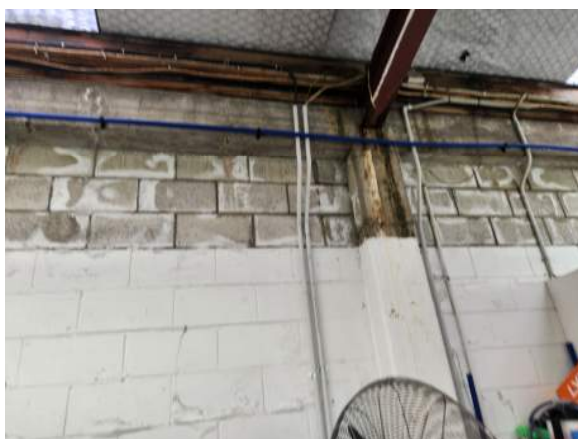
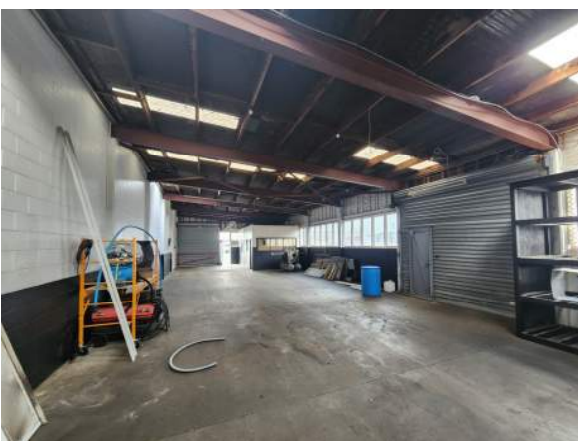
Table IEP-1a Additional Photos and Sketches

In transverse direction steel portals with concrete encased columns. At some locations the steel corrosion was substantial.

Although no signs of apparent damage was found to the structure, following points were noted.  
 As the IEP indicates the building as an EPB, a detailed seismic assessment is recommended to identify and address critical structural weaknesses of the building. The assessment shall also consider the effect of shared structural system with the adjacent title.  
 The building does not have a diaphragm to transfer lateral loads to LLRS and hence a truss diaphragm is advised to be added to ensure lateral loads are safely transferred to the LLRS.  
 It has been observed that part of the concrete beam in south elevation is likely discontinuous and it is advised to ensure LRS continuity.  
 Some openings were infilled as part of the alterations done and reinforcement in walls and block infills to be confirmed prior to strengthening.
