# DETAILED SITE INVESTIGATION (DSI)

362 MATAKANA VALLEY ROAD, MATAKANA, AUCKLAND

**REFERENCE NUMBER: REP-1165/DSI/APR18**

**PREPARED FOR: THREE BLOKES LTD**

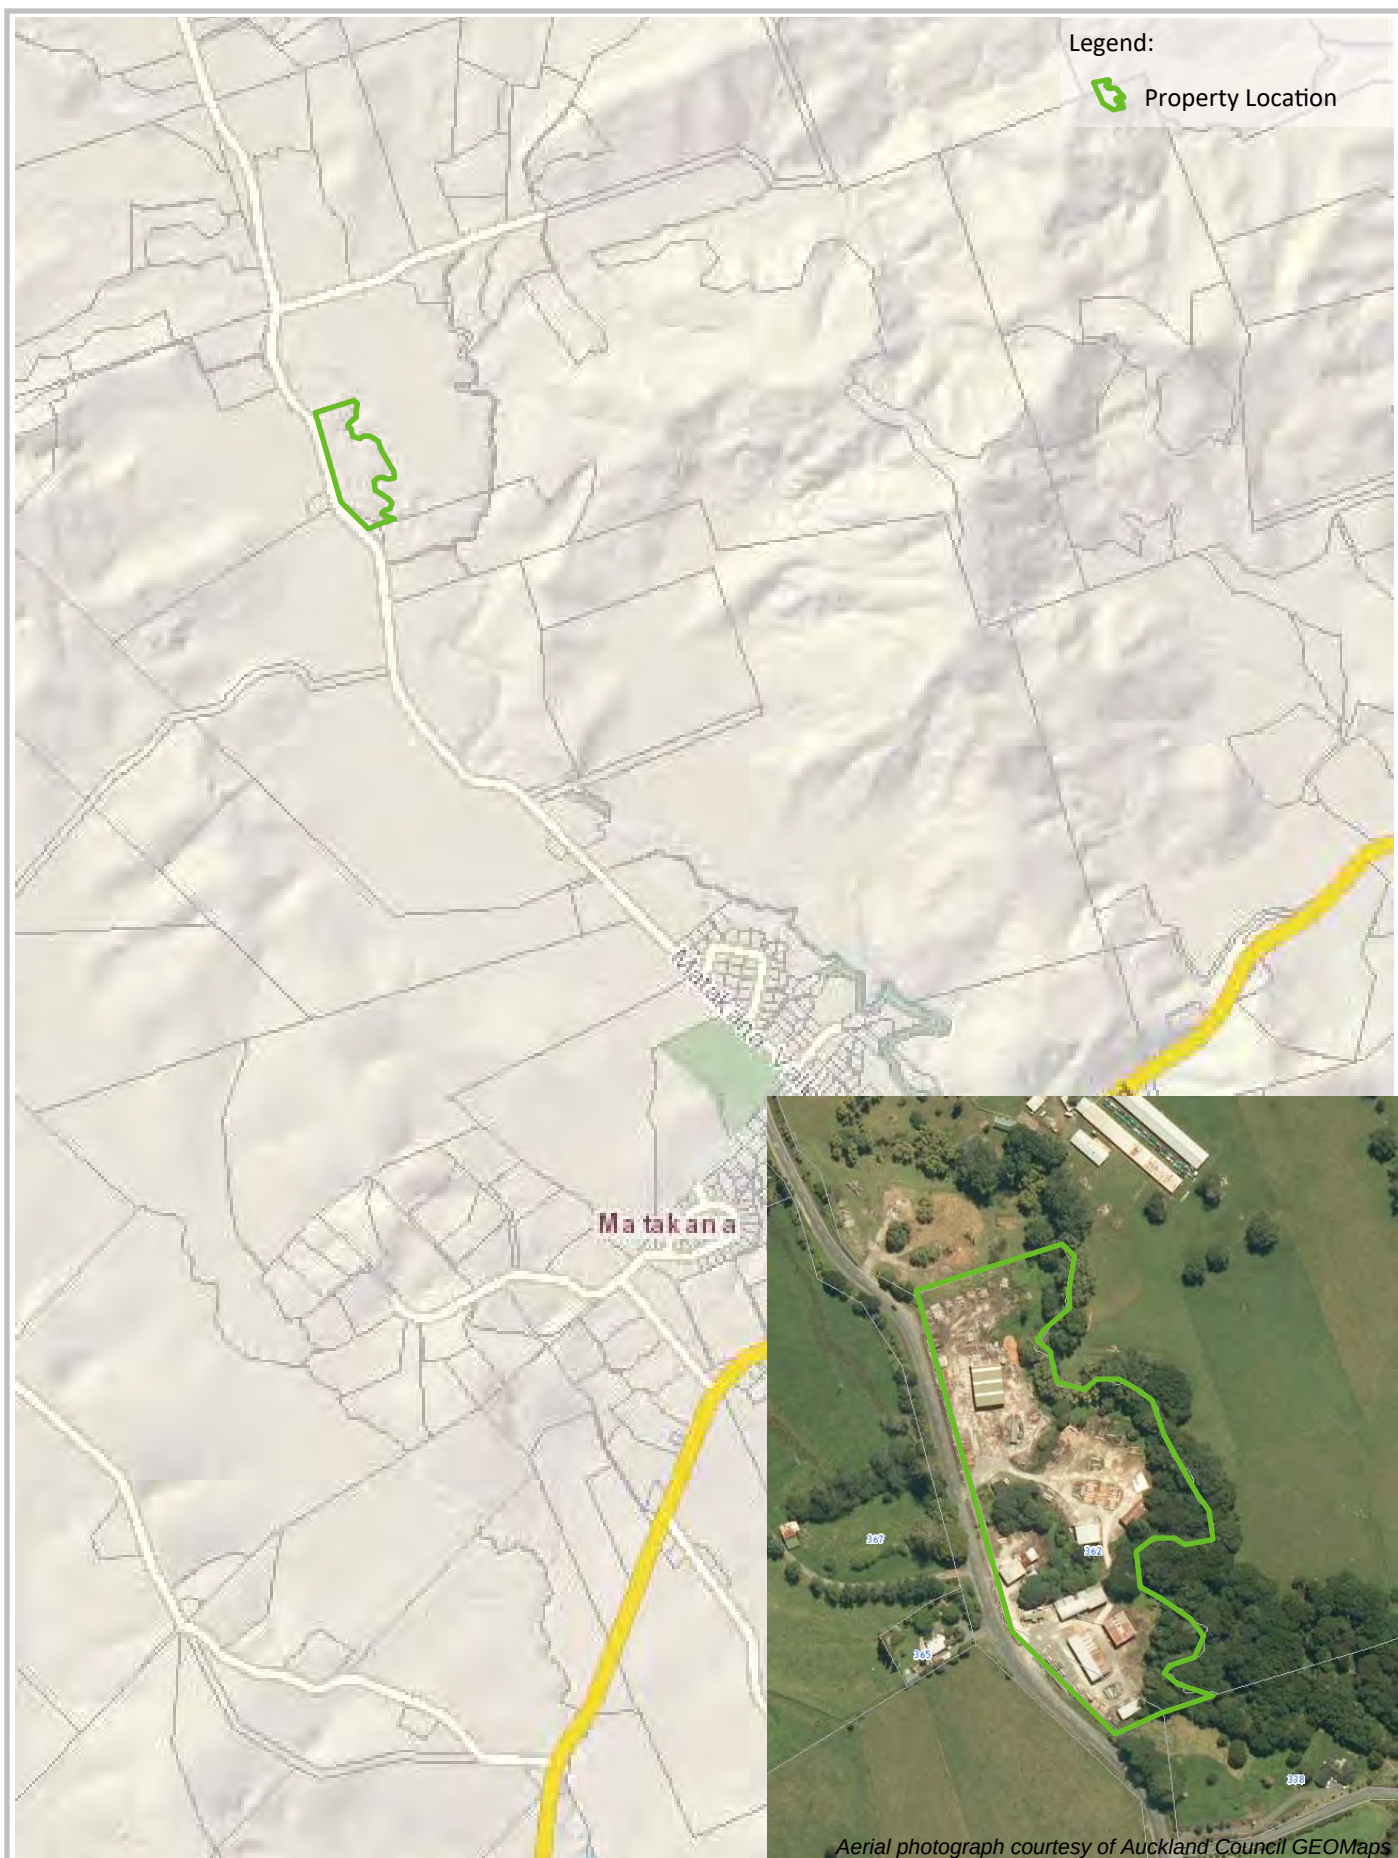
| <b>Title:</b> | <b>Figure 1 - Site Location</b> | <b>Reference:</b> J1163 |

The property at the above address is located within an area of rural land approximately 1.2km north-west of the Matakana township (Figure 1), and has been, and still is, the location of a timber mill. The property is situated on a flat to slight east facing slope adjacent to a tributary of the Matakana River. Consequently the Matakana River is the receiving environmental for any environmental discharged from the property.

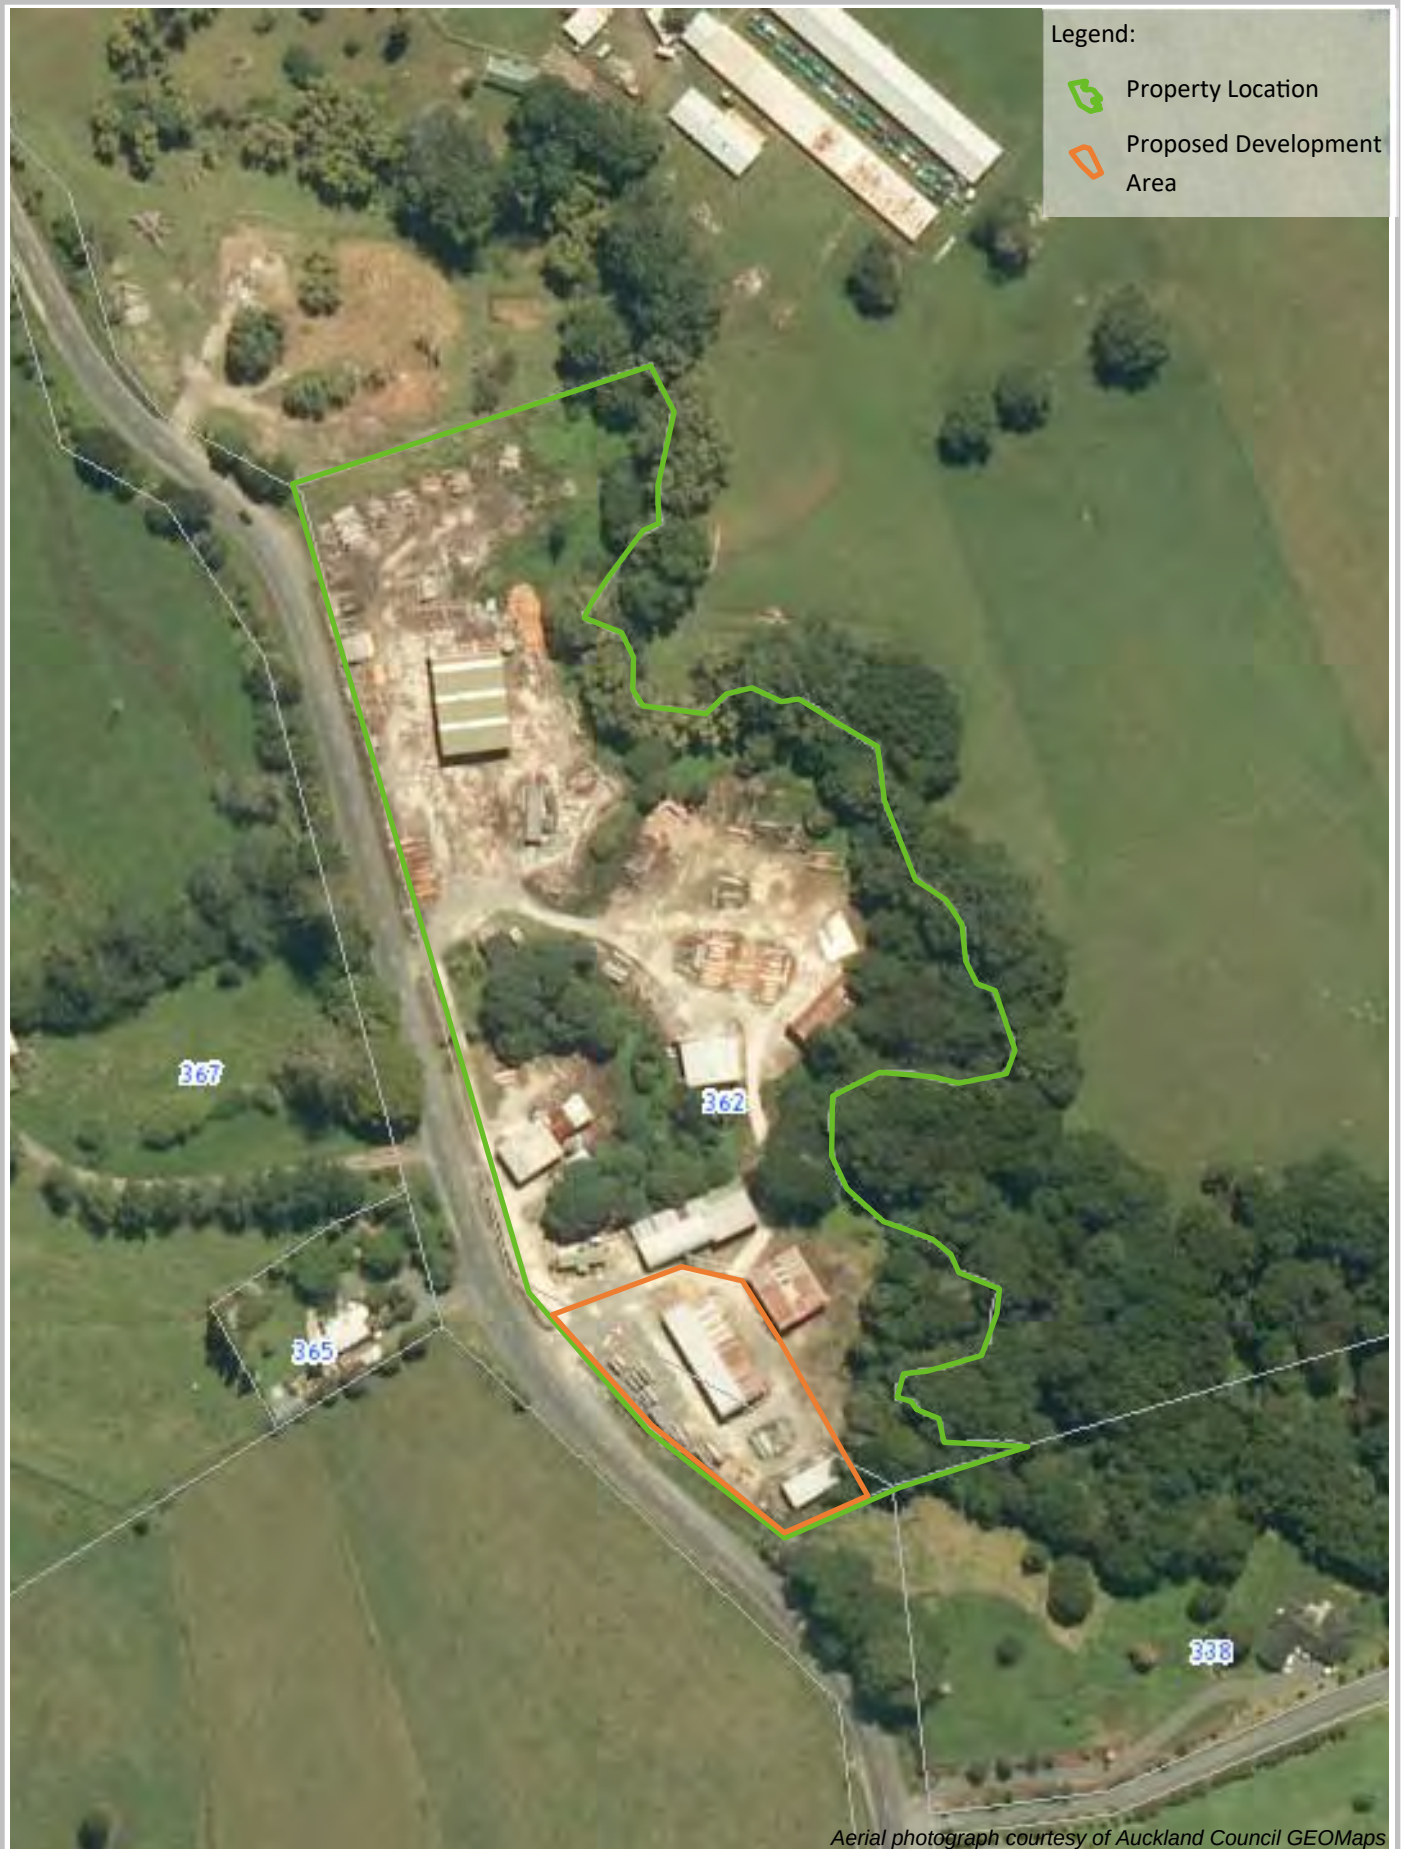
| <b>Title:</b> | <b>Figure 2 - Proposed Development Area</b> | <b>Reference:</b> J1163 |

It is proposed to develop an approximate 2,400m<sup>2</sup> portion adjacent to the south-western property boundary into boutique market. It is intended that market vendors will have the ability to produce goods onsite (i.e. pottery, timber products) alongside the sale of goods. The investigation undertaken focuses solely on the proposed area of development, and is hereafter referred to as 'the site' (Figure 2).

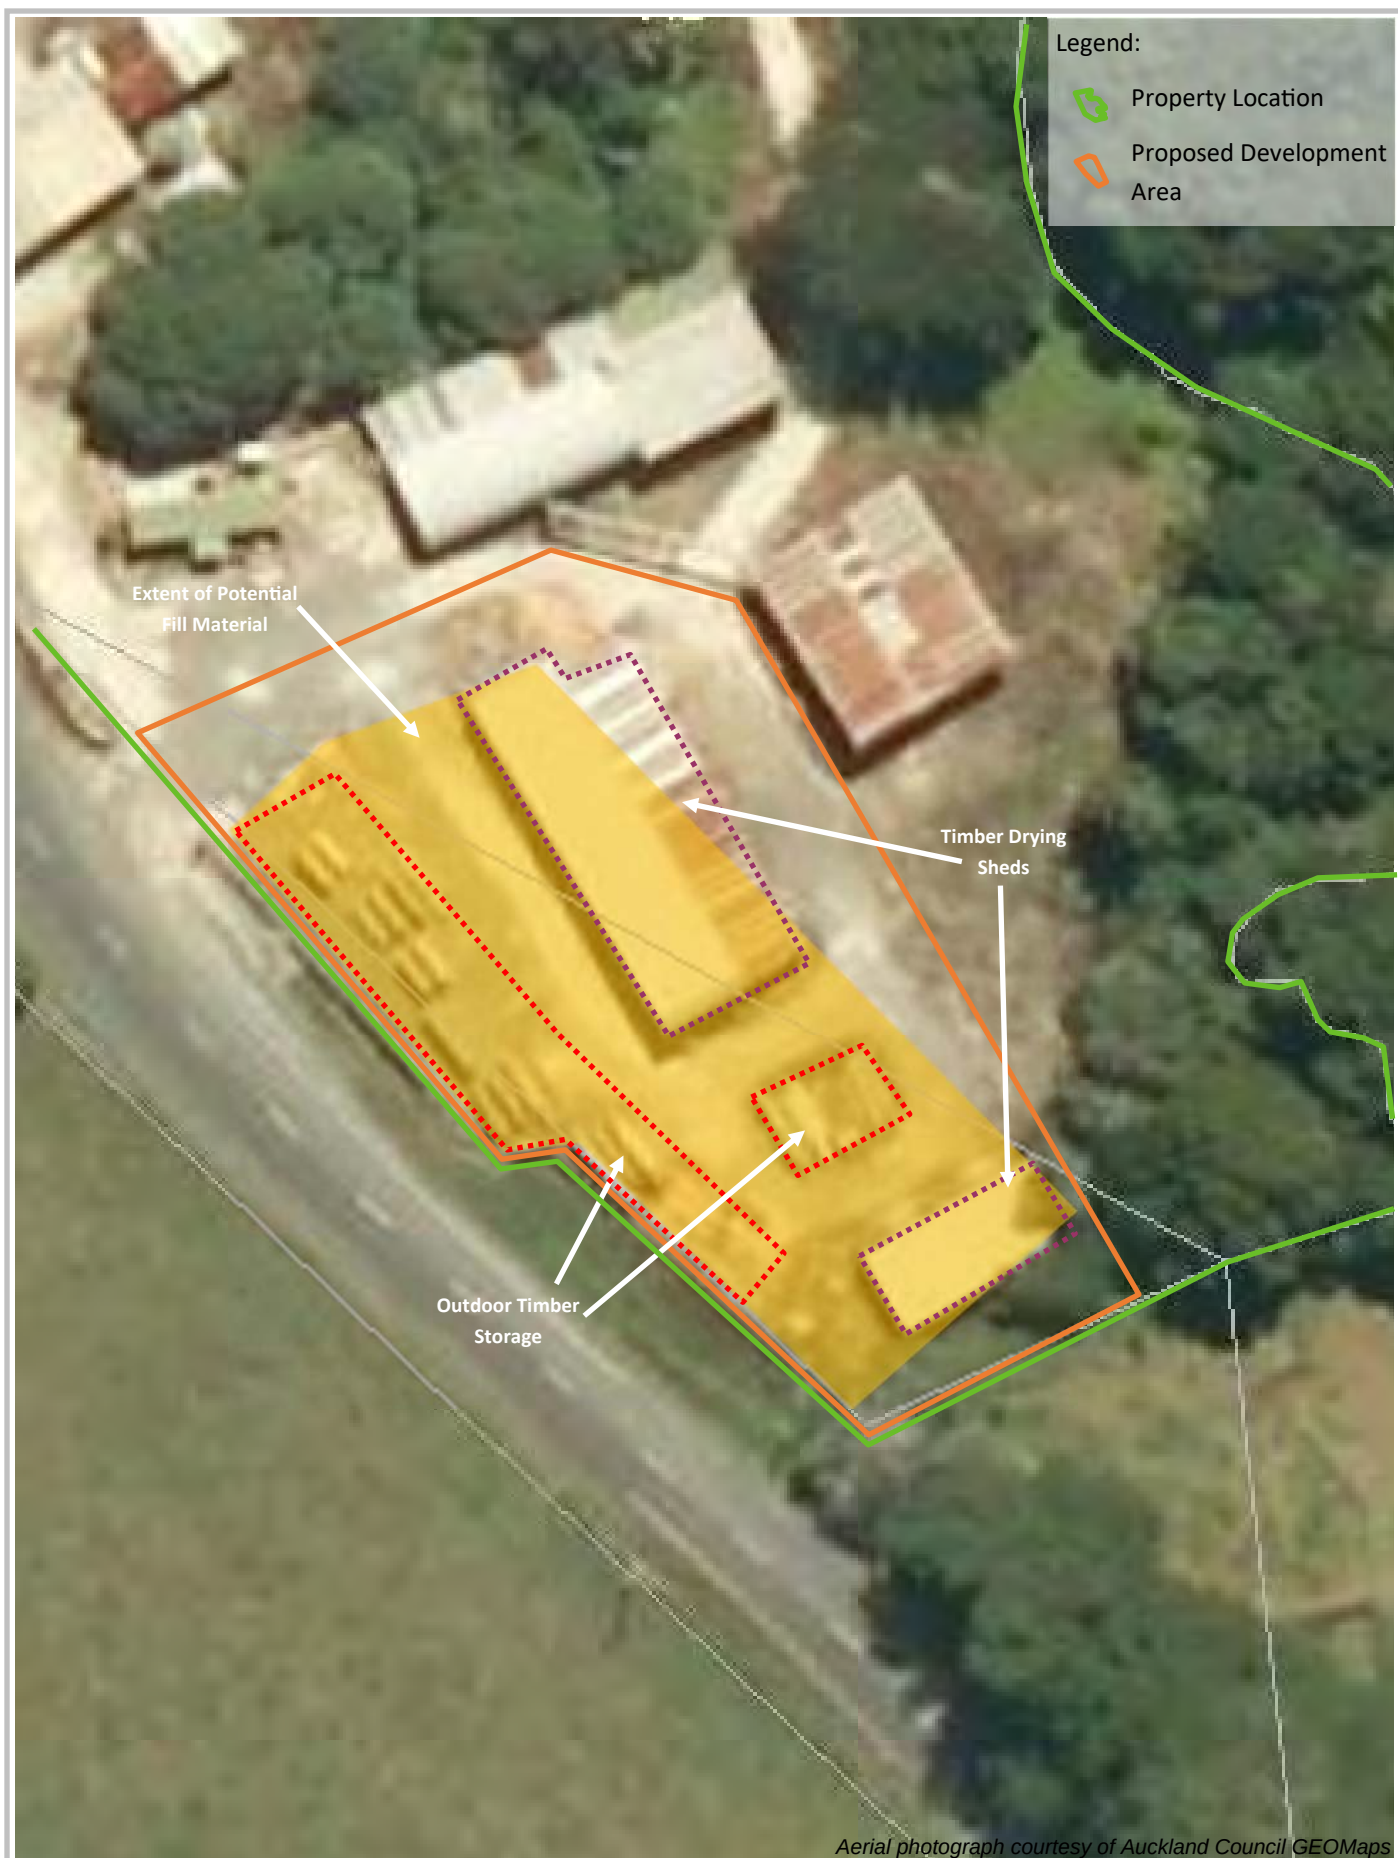
| <b>Title:</b> | <b>Figure 4 - HAIL Locations</b> | <b>Reference:</b> J1163 |

Previous investigations identified that the property at 362 Matakana Valley Road has been used to process and treat timber historically (HAIL Item A.18), while this investigation has found the site may have been used for the bulk storage of treated timber during its history.

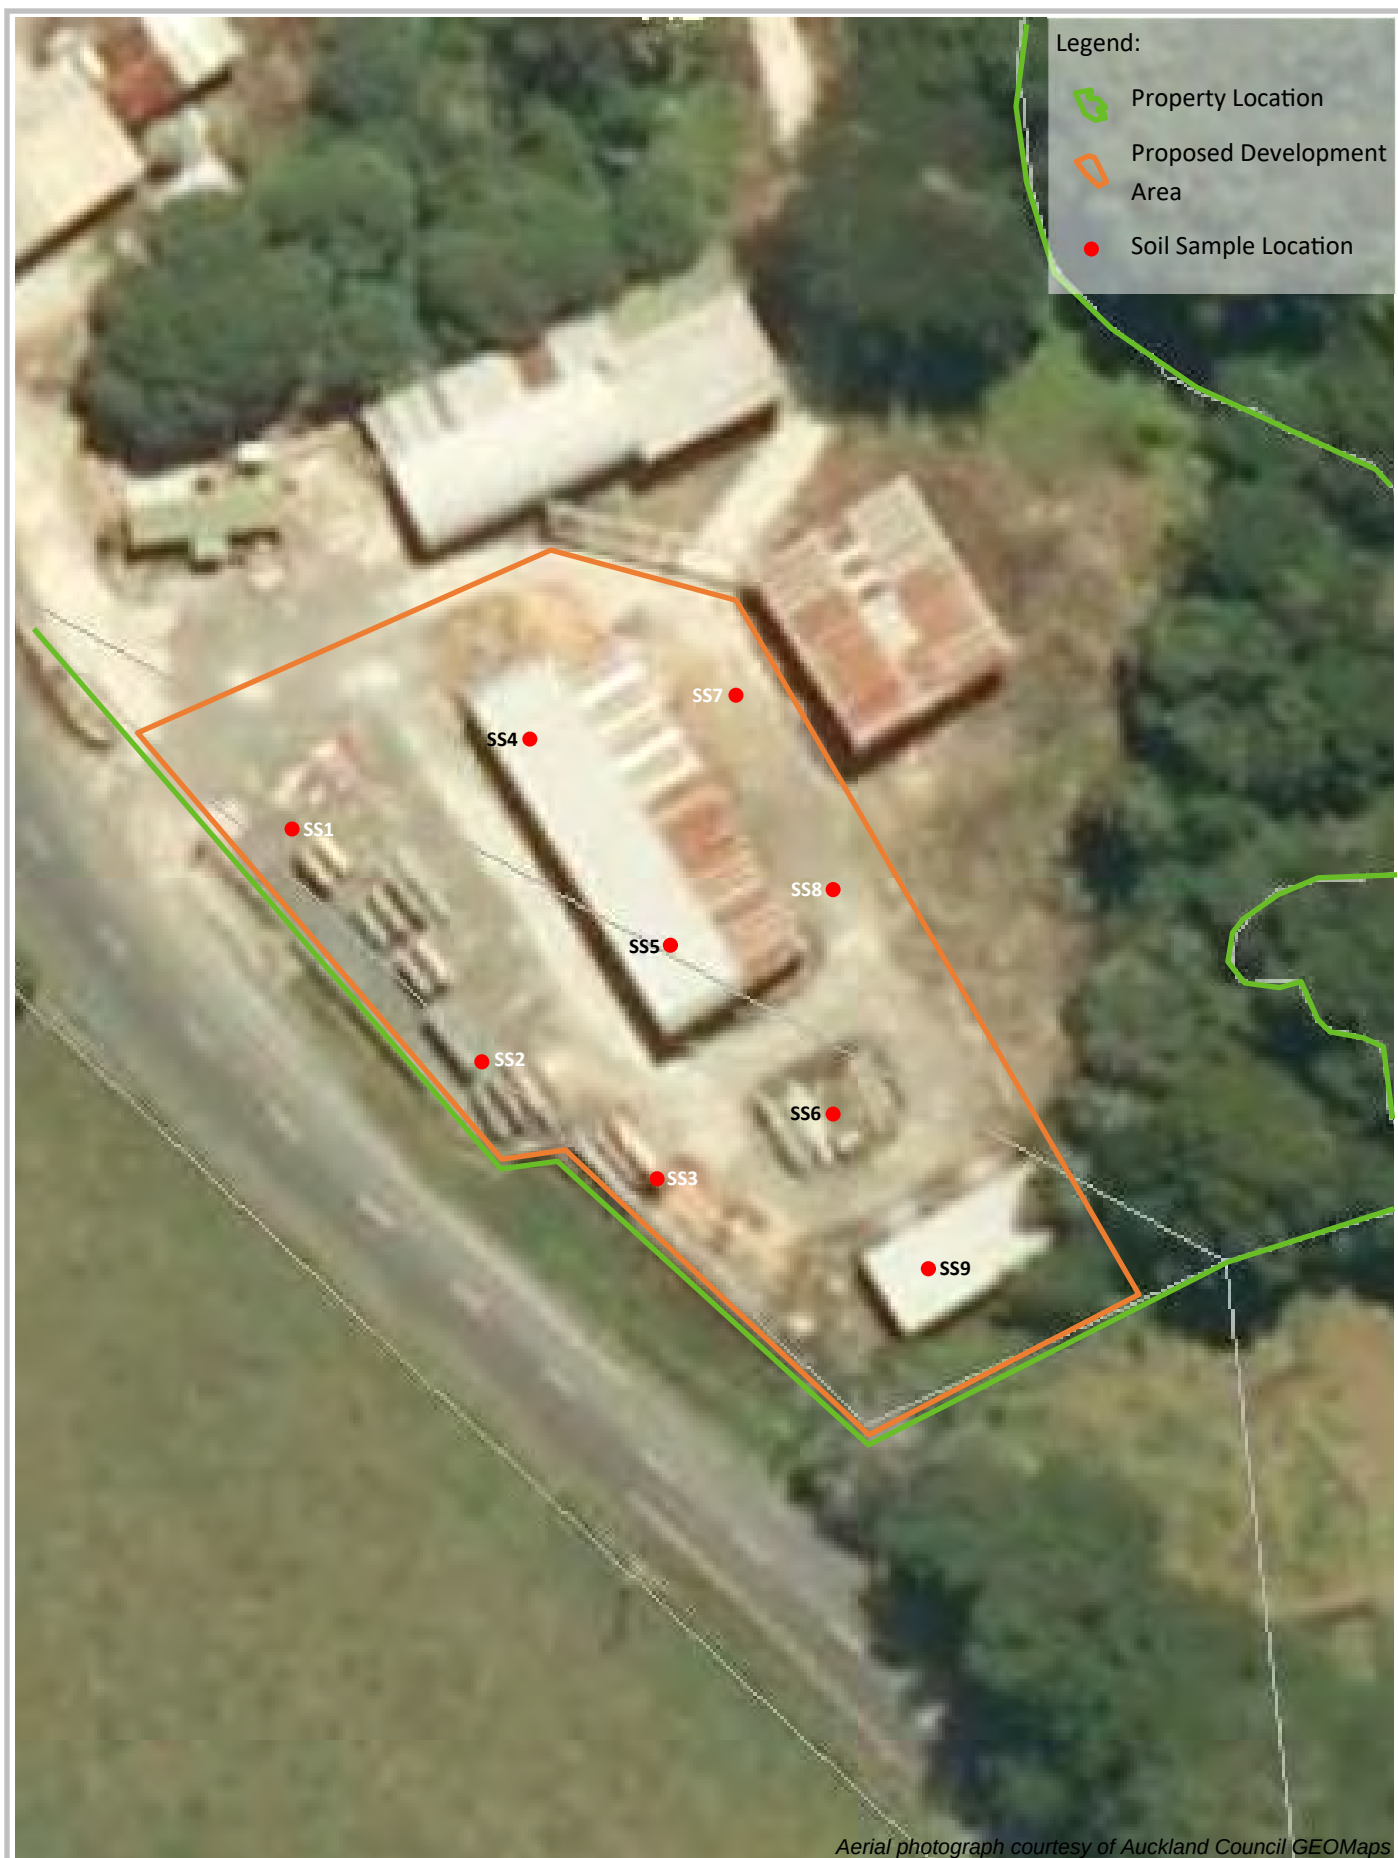
| <b>Title:</b> | <b>Figure 5 - Soil Sample Locations</b> | <b>Reference:</b> J1163 |

Under the requirements of CLMG No.5, a site of this size requires a minimum of nine soil sample locations where seeking a circular hotspot of 21.5 m diameter. Based on the above conceptual model, GSL considers that any impacts within the site footprint would be localised to the stacks of potentially treated timber stored therein, with onsite observations suggesting that the packets of stored timber covered between 10 m<sup>2</sup> and 20 m<sup>2</sup> depending on the lengths of timber milled. Packets were stored close together which would cause distinct overlaps with any discharges from the storage bays. Based on those observations alongside the conceptual site model, GSL considered that a judgemental soil sampling methodology, targeting the portions of the site which represented the highest potential risk for soil contamination was an appropriate mechanism for assessing risk and nine discrete locations would provide sufficient certainty in light of the conceptual model presented. Soil sampling targeted the locations of timber storage and the fill material noted by geotechnical borehole logs reviewed prior to the site visit. Soil sample locations are shown in Figure 5.

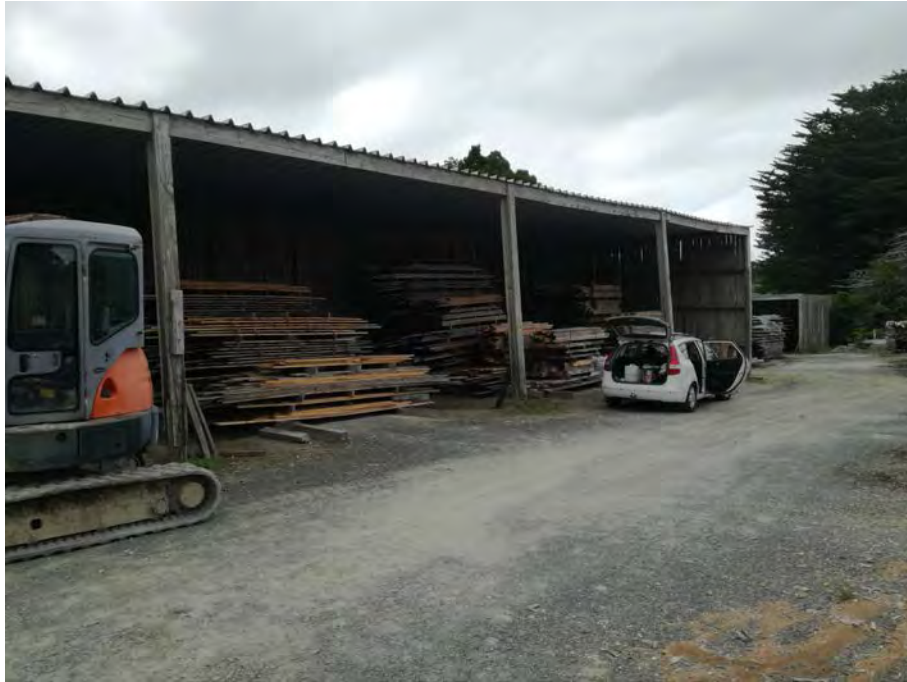
**PLATE 1:** Large Timber Drying Shed in Centre of Proposed Development Area

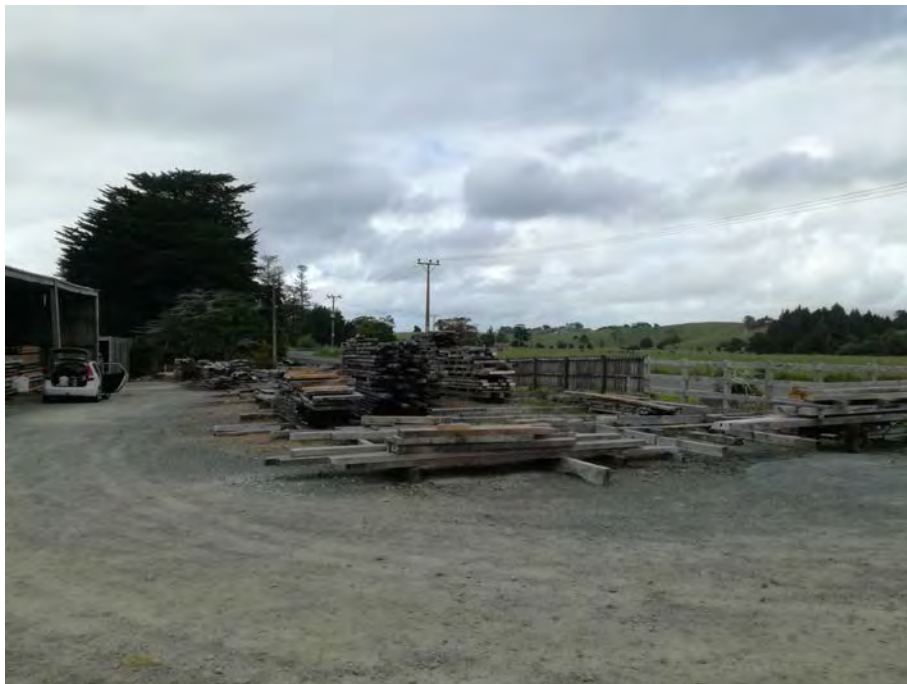
The outdoor area of the site was entirely under gravel hardstand, on which milled timber had been stacked. No staining of the gravel surface which would indicate incidental fuel spills from the use of machinery onsite was observed, nor was any evidence of chemicals associated with the storage of treated timber (i.e. distinct green staining from CCA processes).

**PLATE 2:** Outdoor Timber Storage adjacent to Matakana Valley Road

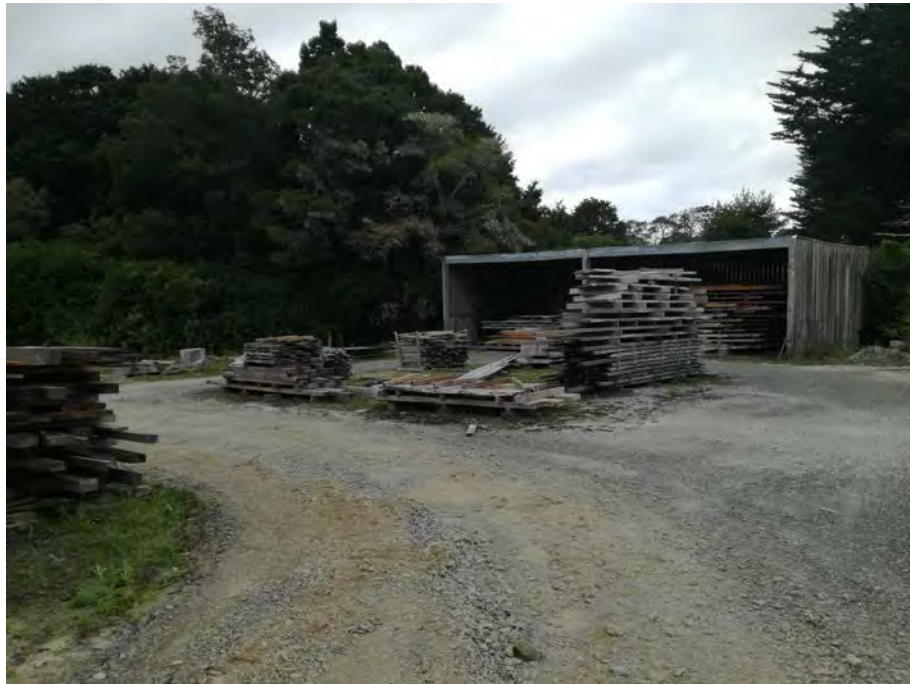
**PLATE 3:** Outdoor Timber Storage and Small Timber Drying Shed

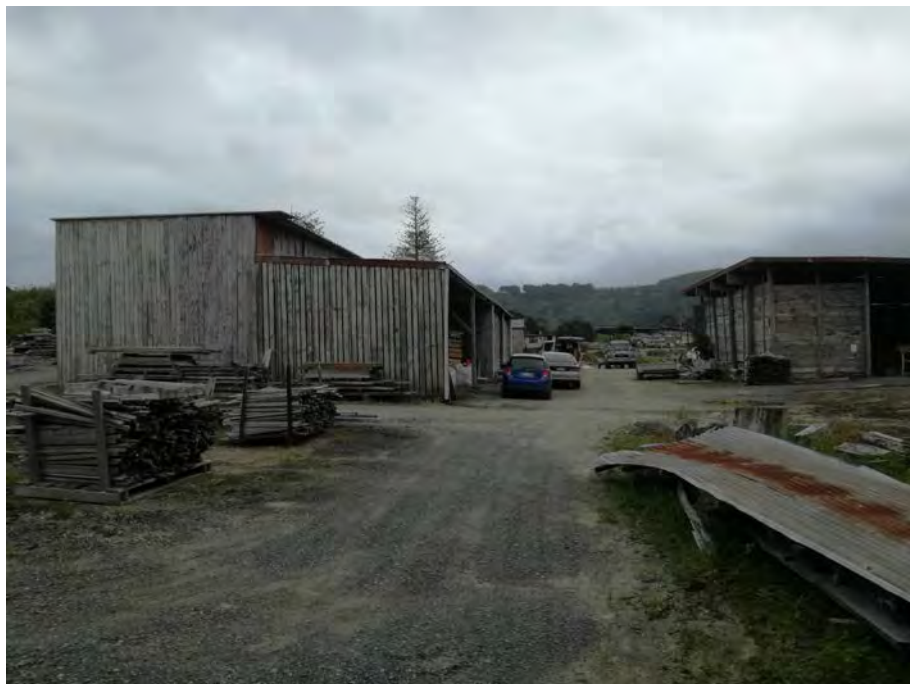
**PLATE 4:** Proposed Development Area Looking North
