Geotechnical Investigation Report
Proposed New Shed
Koutu Loop Road, Opononi
Lot 2, Deposited Plan 519375
For
Tony Rouse

Haigh Workman reference 20 038

March 2020

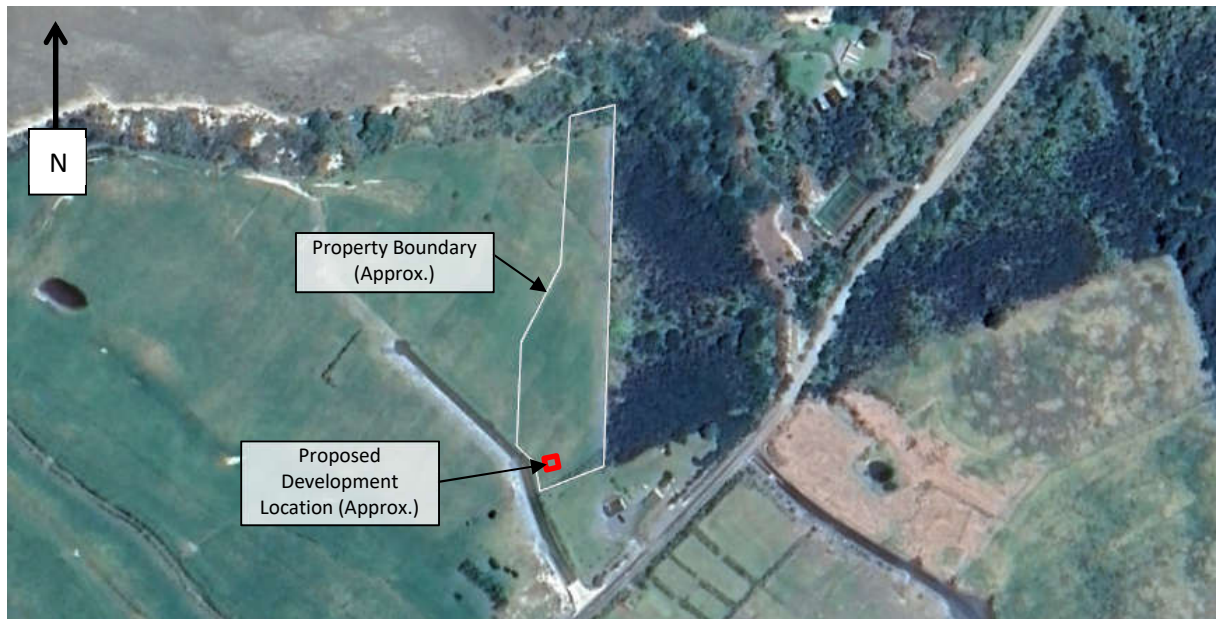
This geotechnical investigation and report consider the geotechnical aspects of the proposed development and the suitability of the ground for a light weight, single story structure with particular reference to the proposed shed location (refer to Figure 1 - Site Location and appended drawings).

The proposed development was set out on site with spray marks on the ground, the approximate property borders and proposed site location is shown in Figure 1.

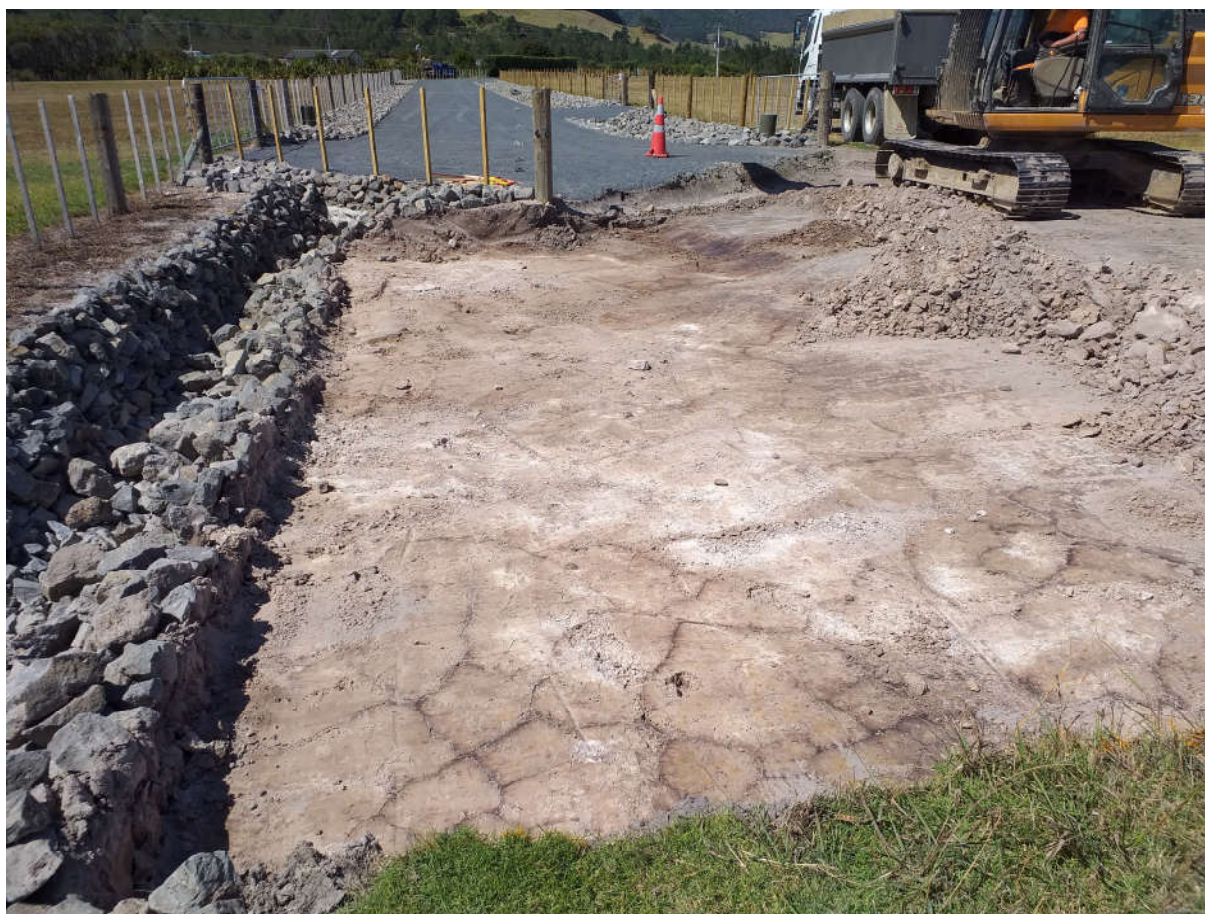
Figure 3 – Evidence of soil desiccation below ground surface and hard pan layer

Excavation work being carried out for the construction of a cul-de-sac at the end of the right of way was also observed which clearly shows the effects of seasonal shrinkage on the soil condition, refer Figure 3. Cracking of the soils is often observed across northland during the summer months and foundations must be designed to accommodate the seasonal effects.

A 'hard pan' layer was encountered across the site to approximately 0.6 m and was difficult to penetrate due to the layer being slightly cemented, which is likely as a result of the soils being podzolized. Podzol soils are strongly acidic soils and can be identified by a bleached horizon immediately below the topsoil. An organic rich layer was encountered within BH01, underlying the hard pan layer.

Evidence of surface cracks in the soils above the hard pan layer was recorded during the site investigation. On this basis and based on experience of similar soils elsewhere, the near surface fine grained cohesive soils of the Karioitahi Group are considered as moderately susceptible to swelling and shrinking under seasonal variations of water content. For the purposes of design, the site may be designated as moderately reactive (Class M) in accordance with AS2870:2011.

We recommend 'Footing Type B' as shown on the Versatile plans.

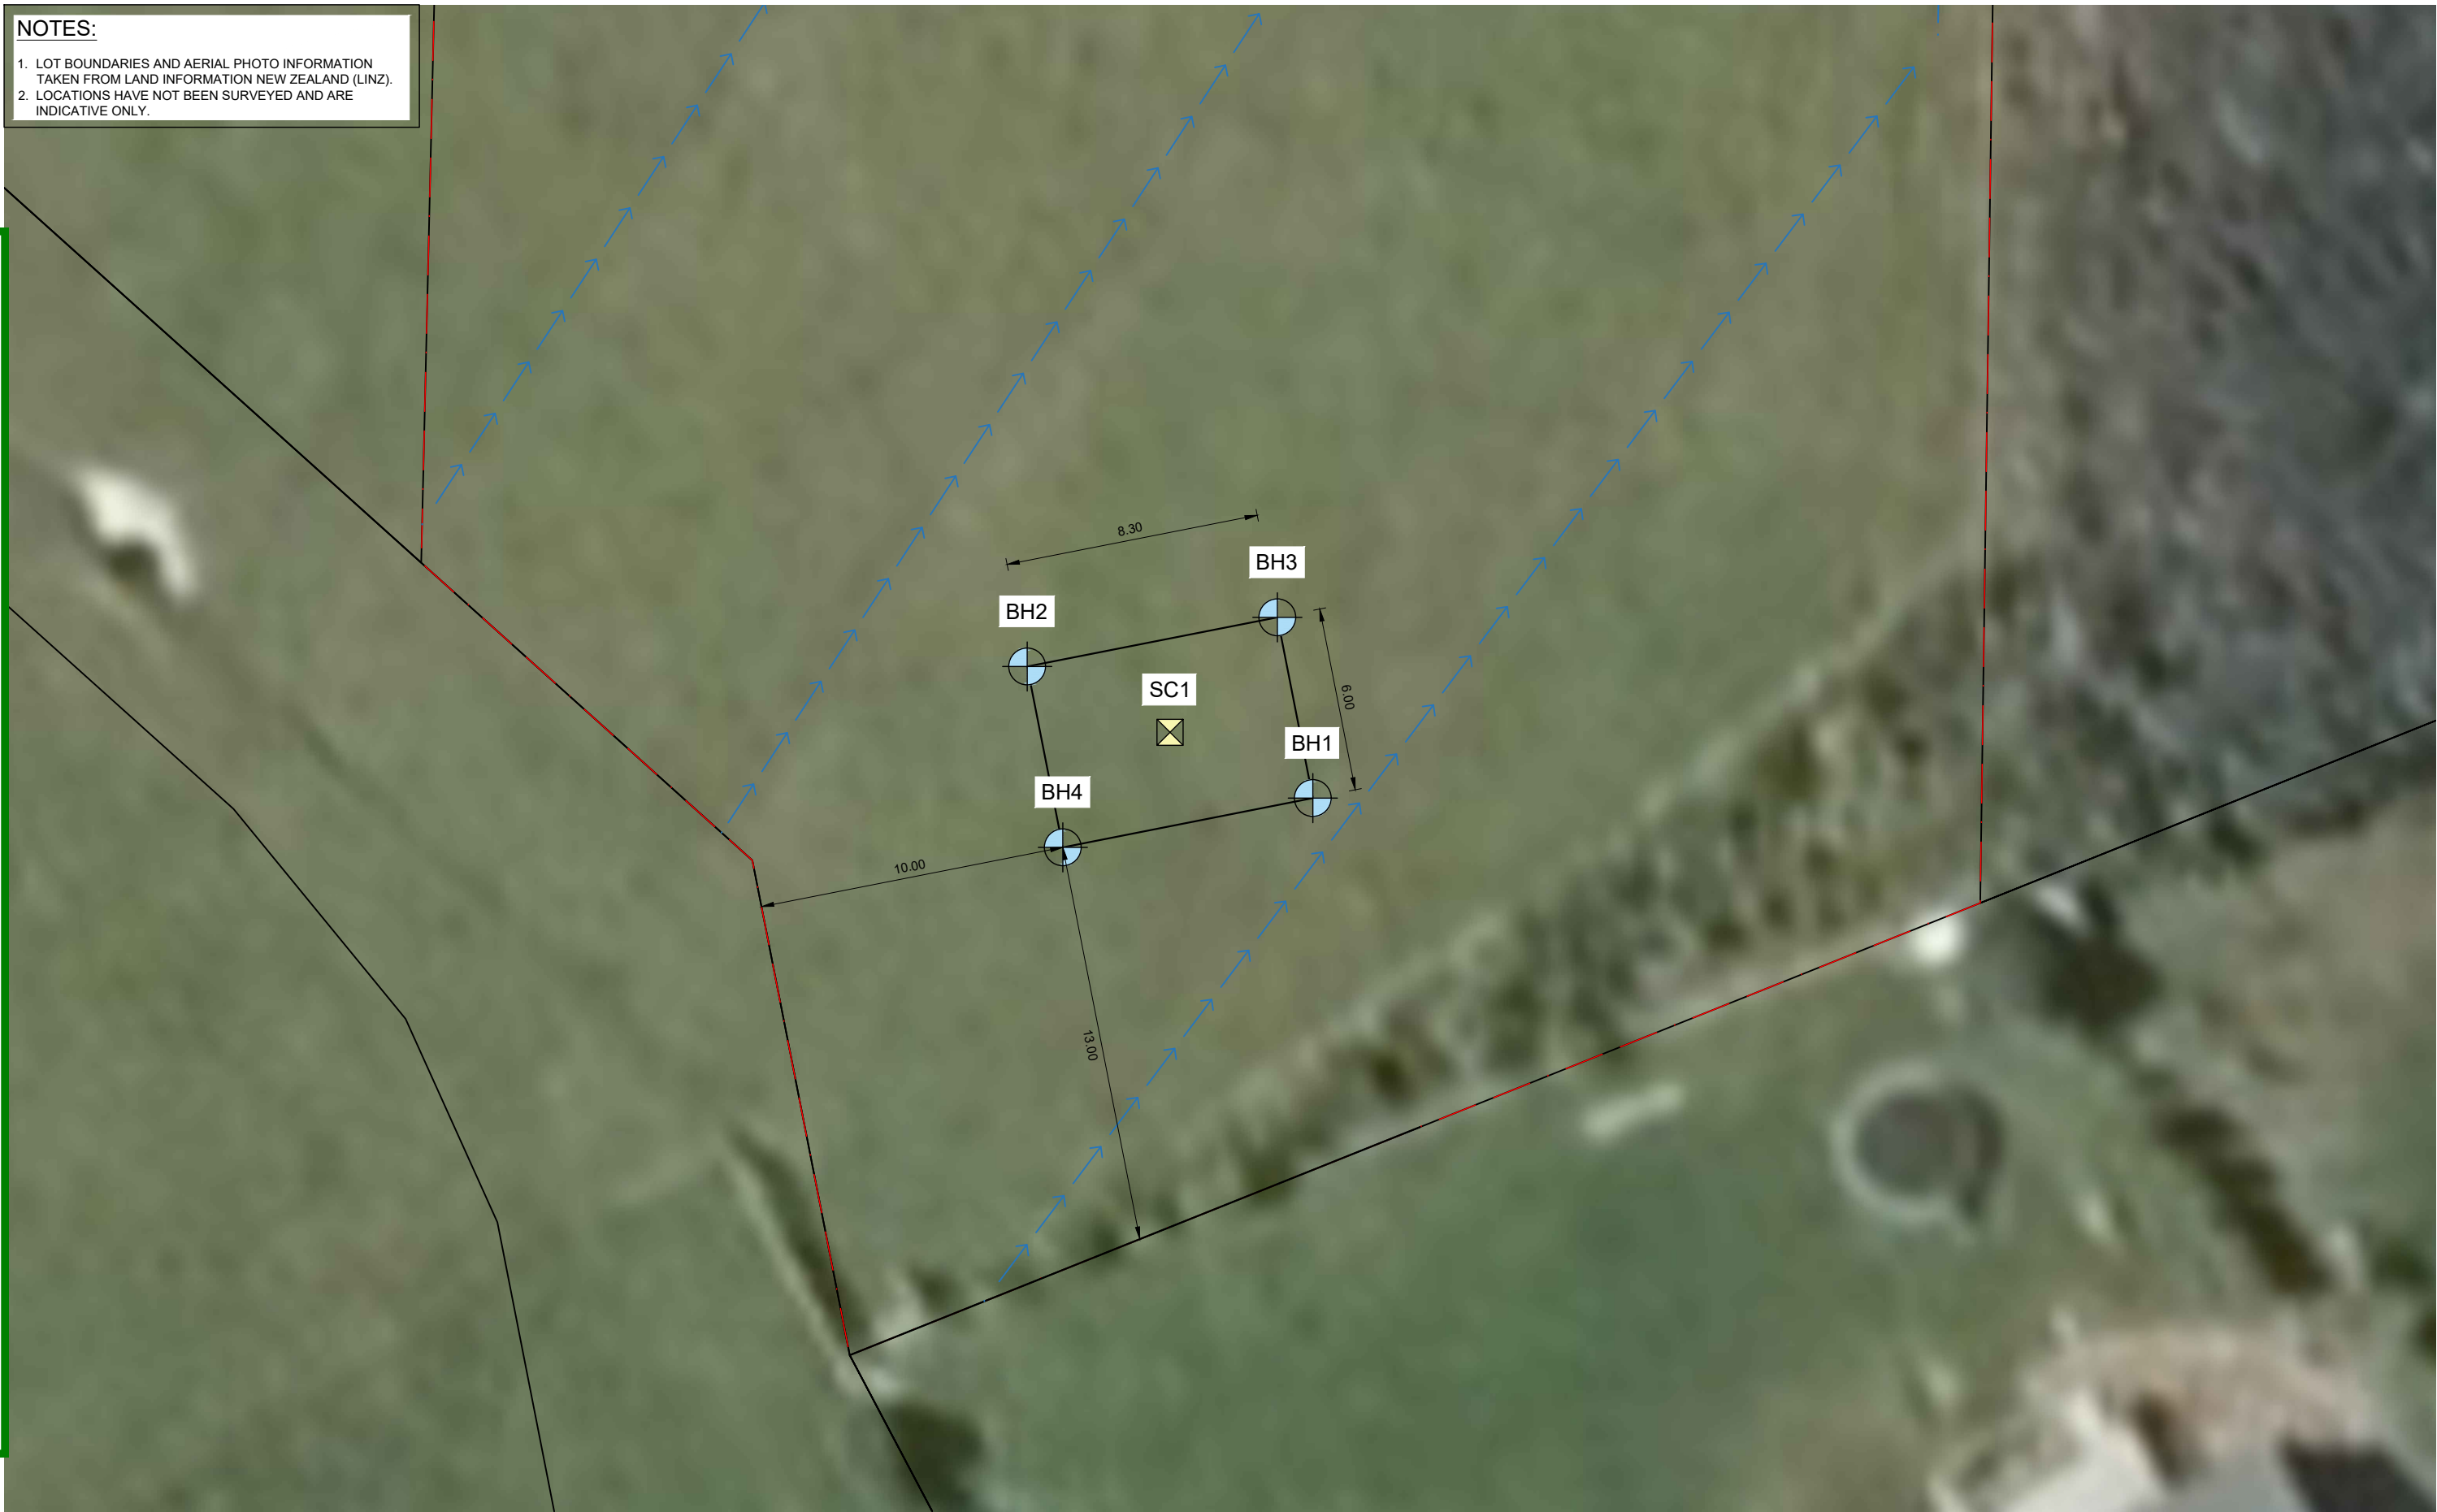
DWG No.	02
Sheet No.	2 of 2

NOTES:
1. LOT BOUNDARIES AND AERIAL PHOTO INFORMATION
TAKEN FROM LAND INFORMATION NEW ZEALAND (LINZ).
2. LOCATIONS HAVE NOT BEEN SURVEYED AND ARE
INDICATIVE ONLY.

DWG Site Features, Borehole and Geological Cross Section Locations			
Scale	1: 1000 @A3	Date	10/03/20
Drawn	OT	Checked	WT
Approved	JP		
File	X:\20 JOBS\20 038 TONY ROUSE\ENGINEERING\DRAWINGS\20 038_GEODRAWINGS.DWG

Considering the swale drains observed during our site walkover, as shown on the appended drawings; we recommend subsoil drains are installed to convey water away from the building platform. This could be achieved with a network of deep trench drains across the site.
