# ASBESTOS SAMPLING REPORT

1473 Main North Road Waikuku

24 Apr 2026

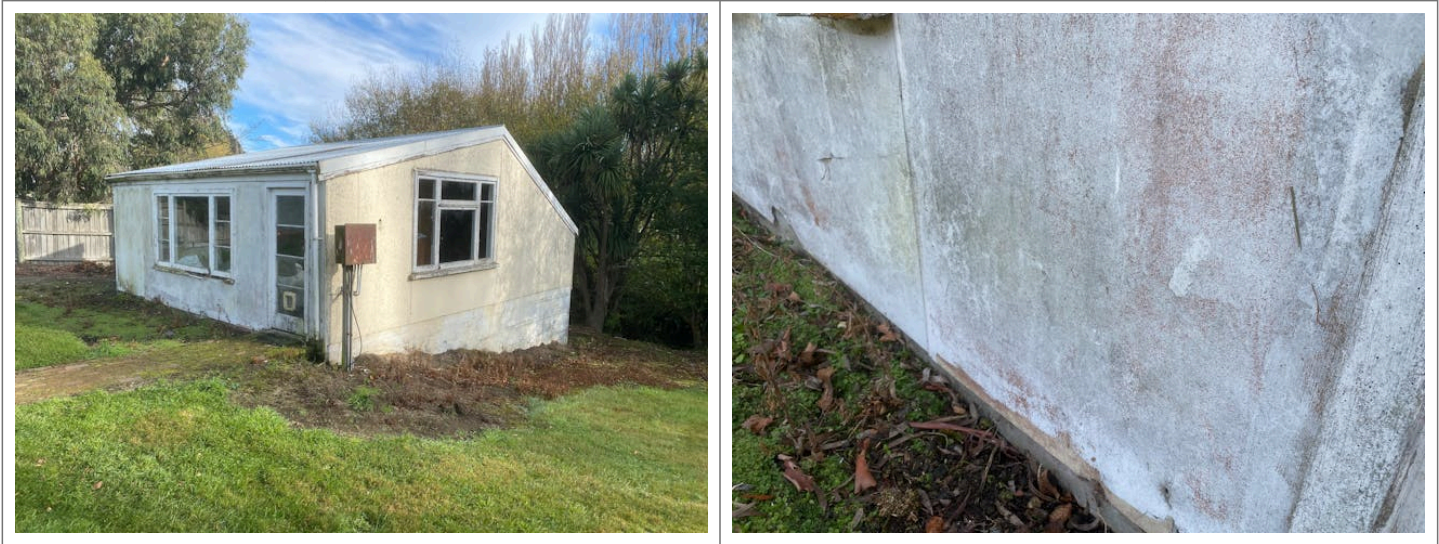
| Sample ID | AS260584-1 | Lab ID | N/A |

| Location | External | Item | Cladding |
| Material | Cement board | Extent | -- |
| Result | No Asbestos Detected | | |

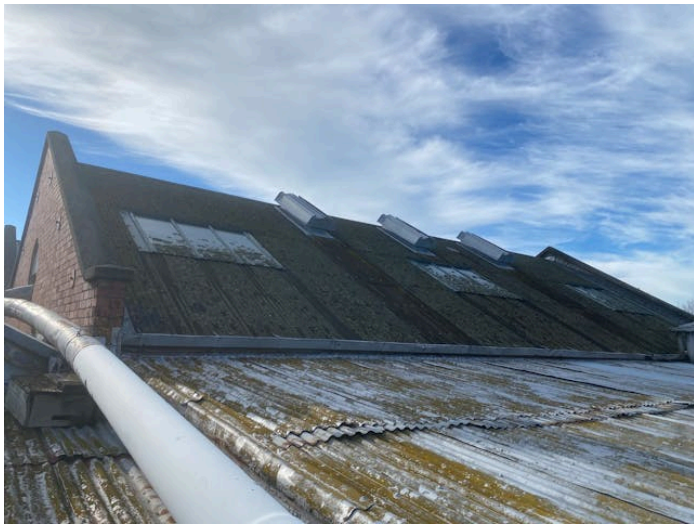
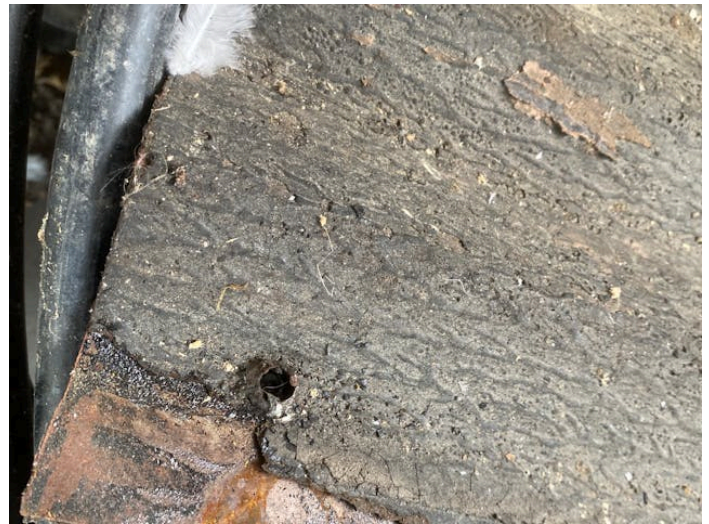
| Sample ID | AS260584-2 | Lab ID | N/A |

| Location | External | Item | Roofing |
| Material | Galbestos (Iron with Bitumen) | Extent | -- |
| Result | Chrysotile | | |

| Recommendation | Label and Manage | | |

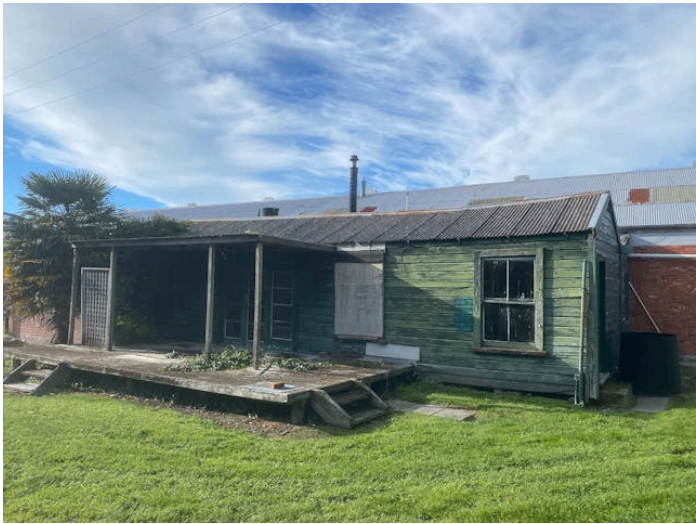
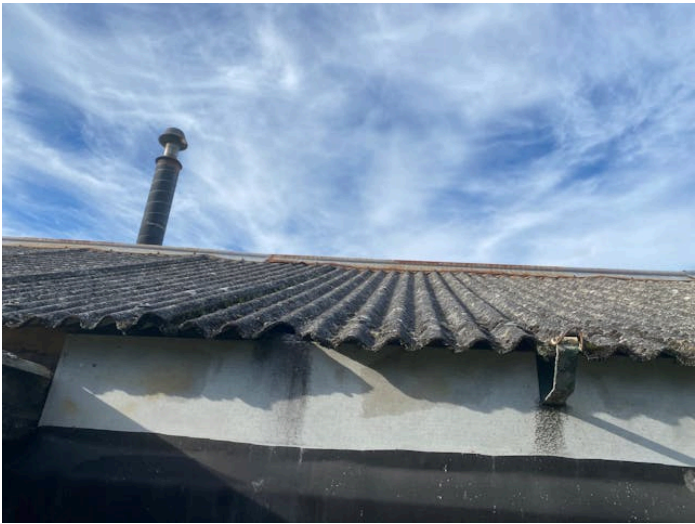
| Sample ID | Strongly Presume | Lab ID | N/A |

| Location | External | Item | Roofing |
| Material | Corrugated cement | Extent | -- |
| Result | Chrysotile | | |

| Recommendation | Label and Manage | | |
