## GoGet Inspection Outcome Report

Consent No: **20172013**  
 Applicant: **Spaghetti Junction Limited**  
 Site Address: **80 Byron Street Sydenham**  
 Legal Description: **Lot 1 DP 449853**  
 Work Type: **Addition to Factory - New Offices, Meeting and Store Room**  
 Workgroup: **Area 4 - Residential**

Inspection Type: **217 - Pre Roof**  
 Inspection Outcome: **Pass**  
 Inspected By: **Scott Copplestone**  
 Inspection Date: **13 September 2019 9:35 a.m.**  
 Duration: **45 minutes**

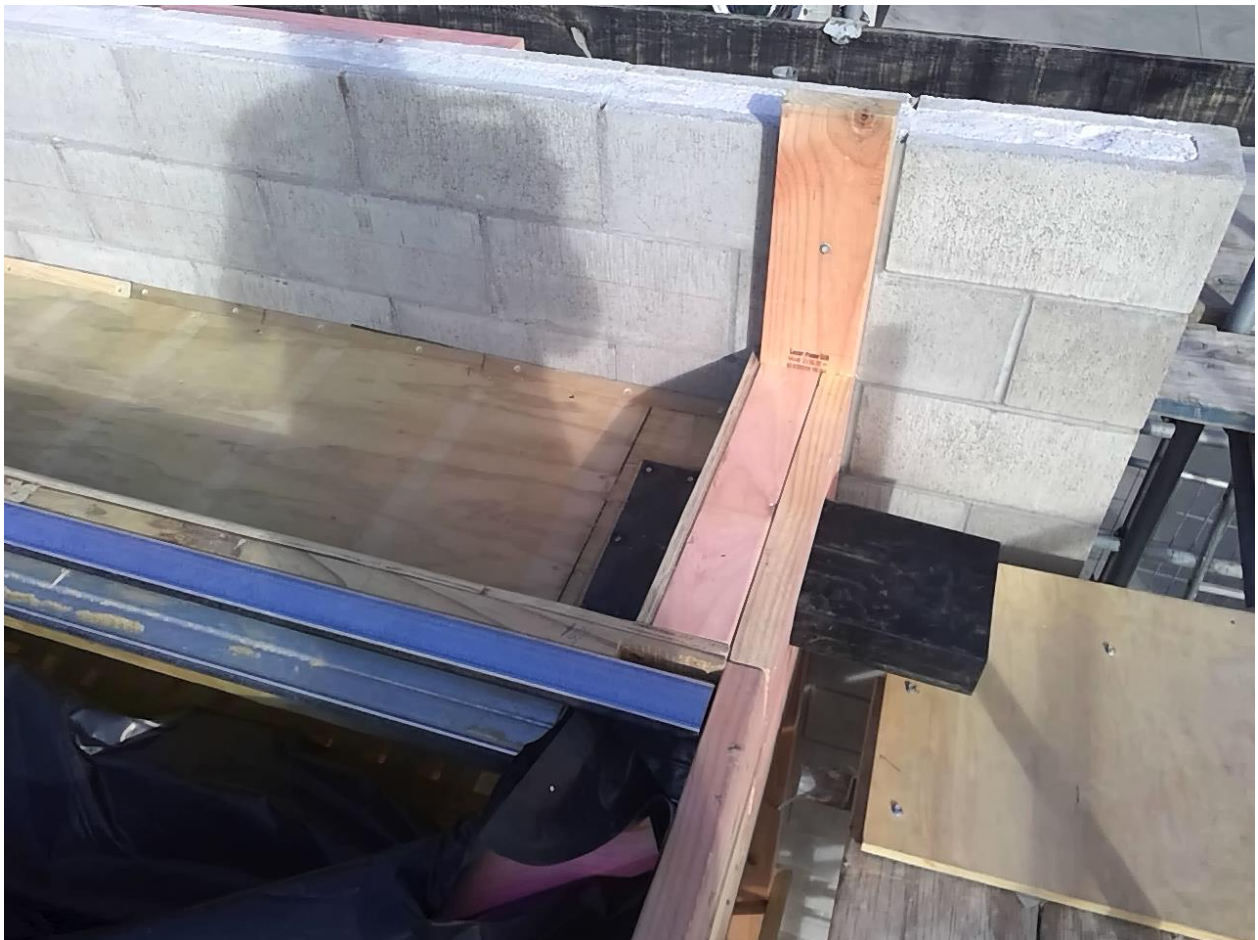
Taken at 9:14 AM on Friday 13/09/2019

| Membrane roof & internal gutter construction:<br><b>Timber treatment: H3.2</b><br><b>Corner fillets installed.</b><br><b>Stainless steel fixings installed.</b> | Pass |

**internal gutter**

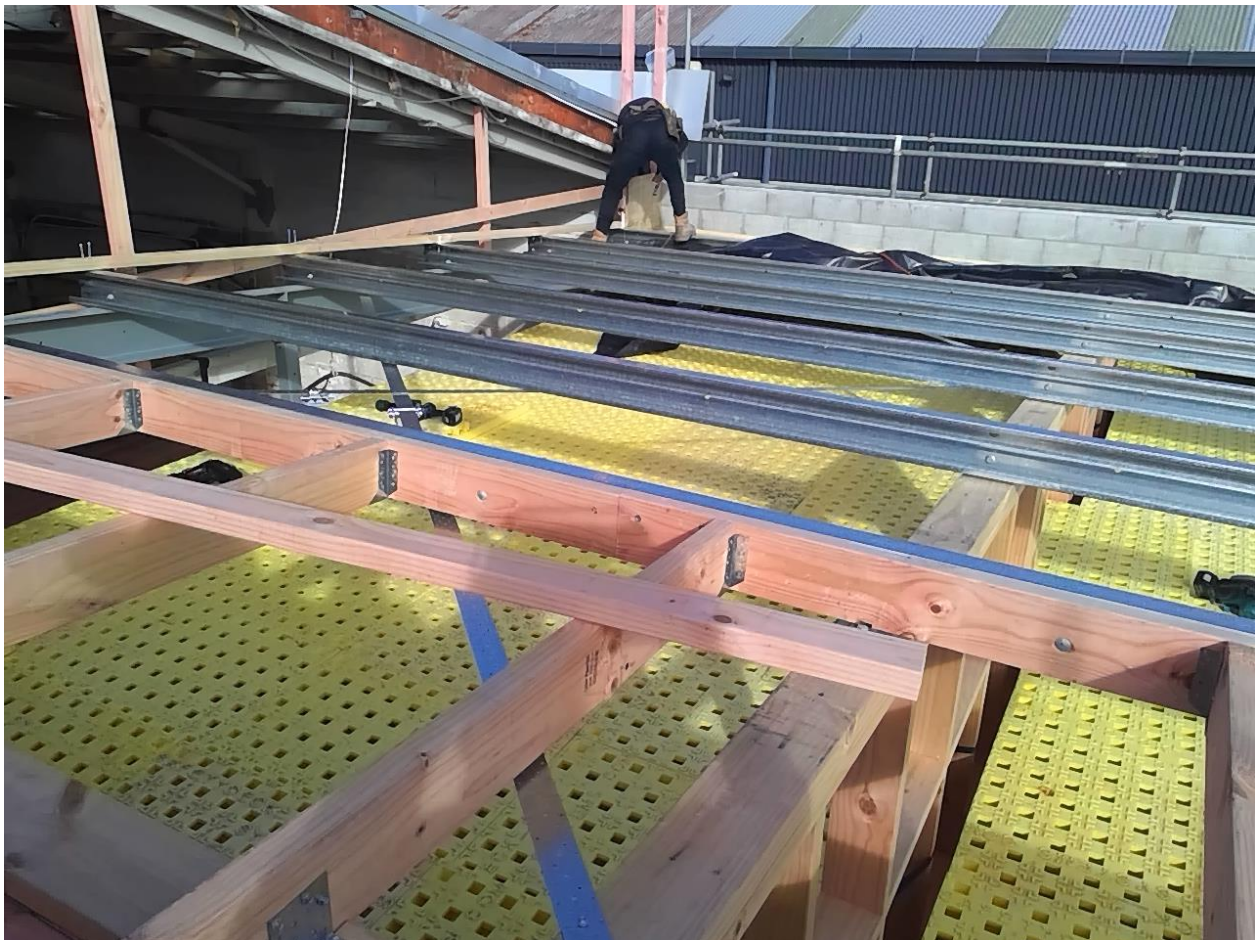
Taken at 9:16 AM on Friday 13/09/2019

| Roof framing & connections:<br><b>SED design</b><br><b>Framed roof/rafters</b><br><b>Purlin connections: sed</b><br><b>Roof plane bracing</b> | Pass |

**roof plane brace**
