# Your Building Inspection Report

CONFIDENTIAL REPORT FOR  
Wallcork Upland Ltd  
ID 165984  
Monday, April 13, 2026

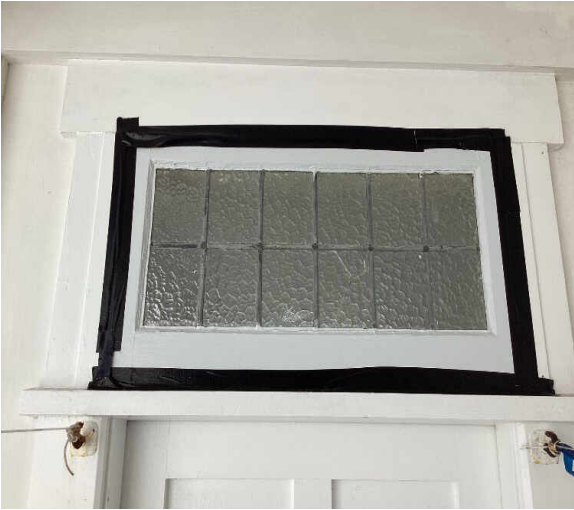
A sash is taped, is this draft proofing?

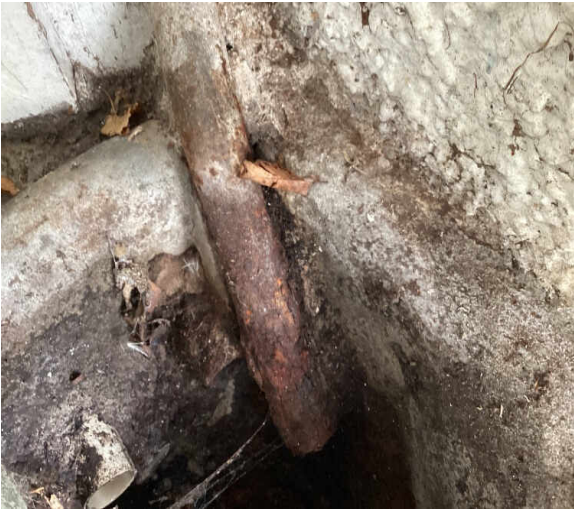
The waste pipes are made of galvanised steel. Galvanised steel pipes are prone to corroding from the inside (which is unable to be inspected). We recommend that the plumbing is visually inspected annually to check for leaks.

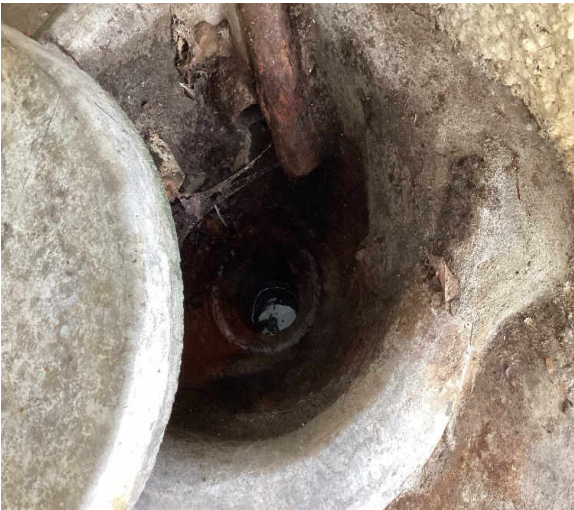
The waste pipes are made of cast iron. Cast iron pipes are susceptible to cracking. (which is unable to be inspected).

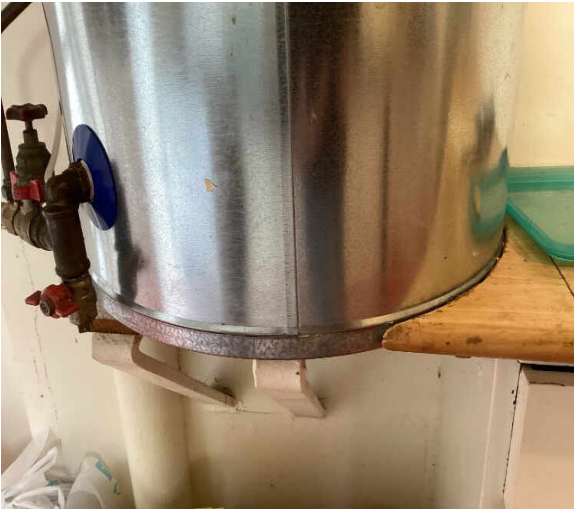
There is no overflow tray installed. We recommend to install a drained overflow tray.

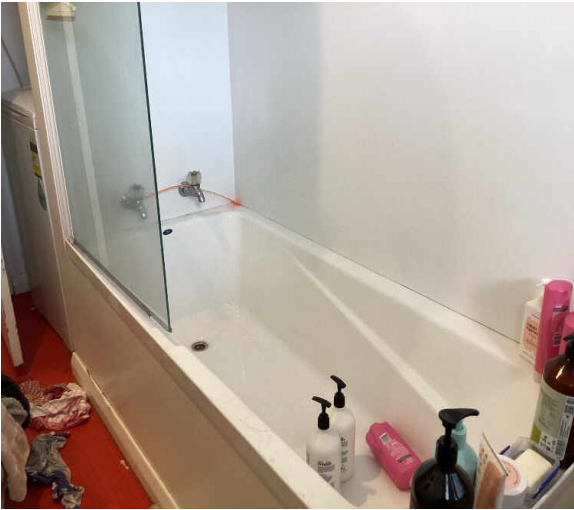
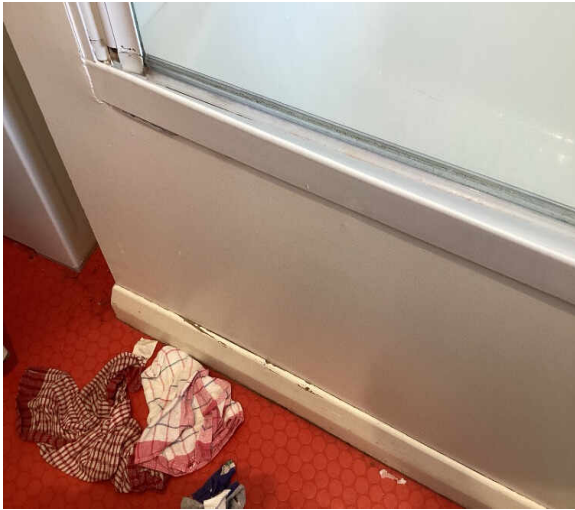
Shower over baths are prone to maintenance issues, failing and leaking were the wall linings meet the bath unit. Depending on the quality of the wall linings, sealant and the installation workmanship and how the bath has been maintained depends on how water tight it remains and how much future maintenance it will require. Moisture testing cannot be undertaken around the base or internal bath/shower linings due to inconsistencies in the readings. Typical failure points are in the corners where the wall meets the bath base and around the bath tap fixtures. It is recommended you constantly monitor these junctions to ensure damage is not occurring to the adjacent walls.

Monitor for water spillage when the shower is in use, dry the floor after showering.

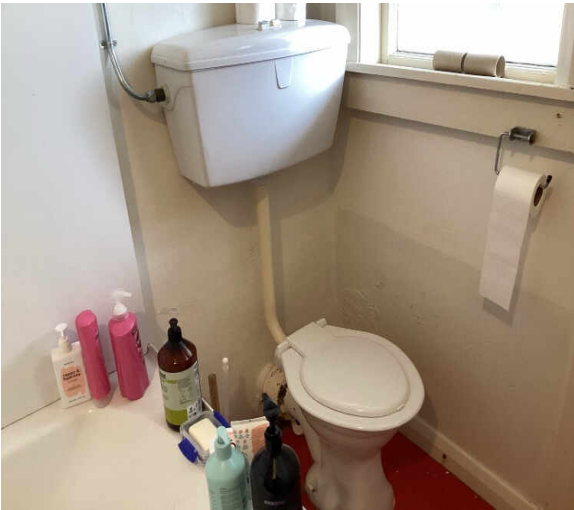
The toilet bowl and cistern are functioning as intended. We recommend this is checked annually as it is a high use plumbing fixture.

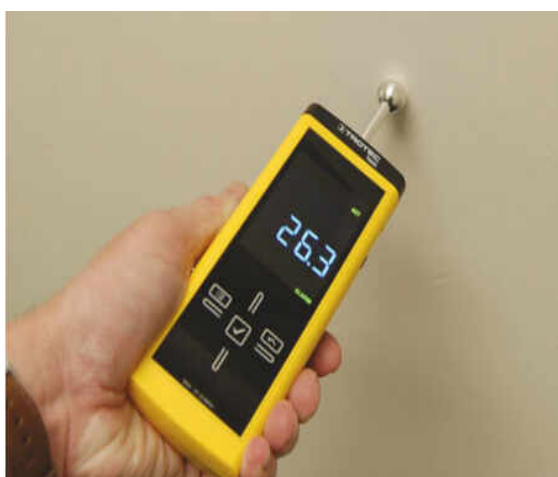
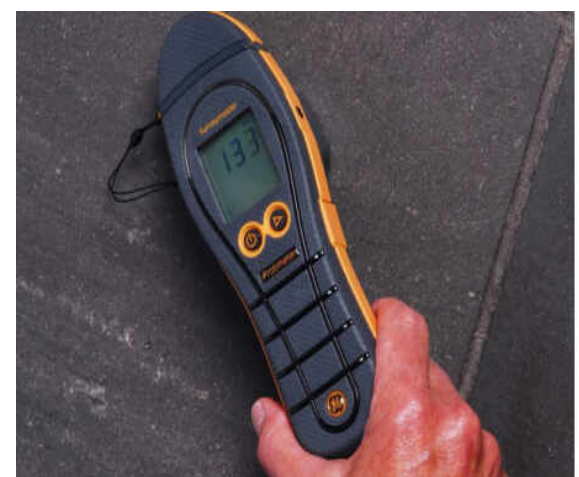
As part of our standard inspection, our inspectors use a protimeter Surveymaster or Trotec T660 moisture meter in it's non invasive search mode.

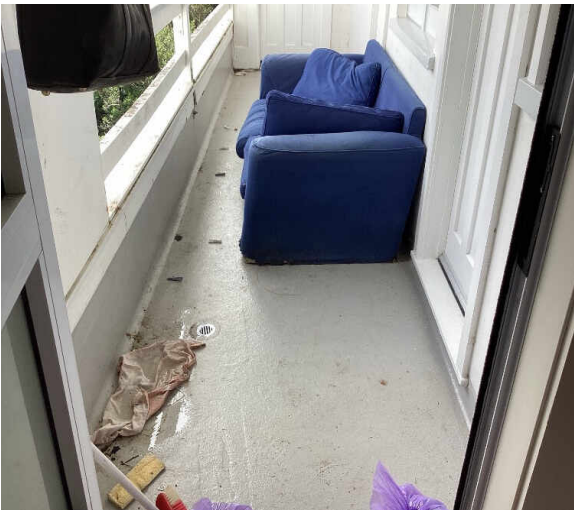
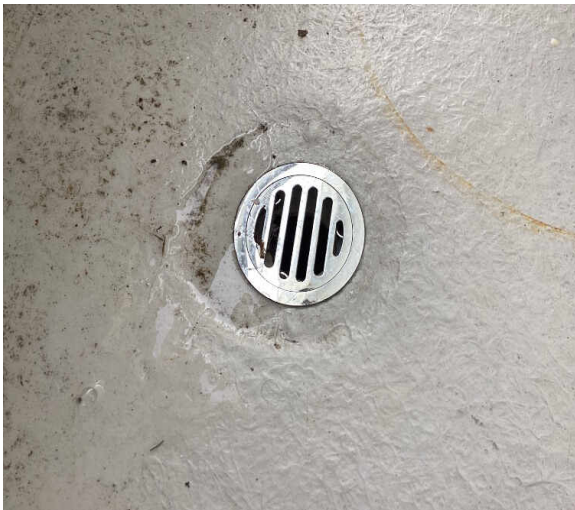
The internal membrane decking system only has one storm water (rain water) outlet to allow water to escape. With only one outlet, there is a risk if this outlet blocks that the area will overflow and cause significant damage. There does not appear to be a secondary overflow outlet, we recommend to install a secondary water outlet to drain water if the primary drain becomes blocked.

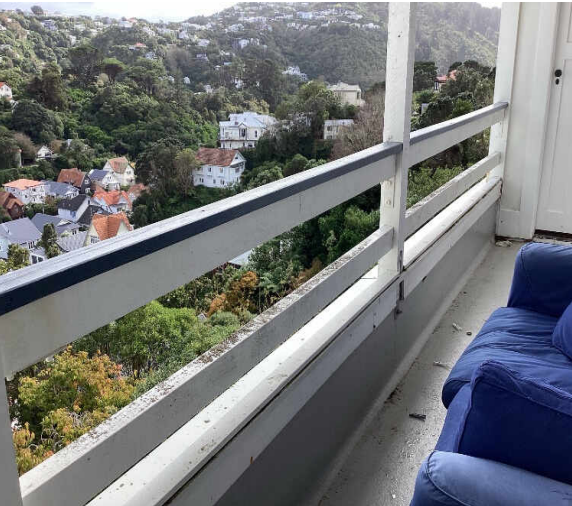
The balustrades do not appear to comply with the current New Zealand Building Code for height and spacing. Although this report does not generally comment on items of compliance, this issue may become a safety issue and therefore was included in this report.

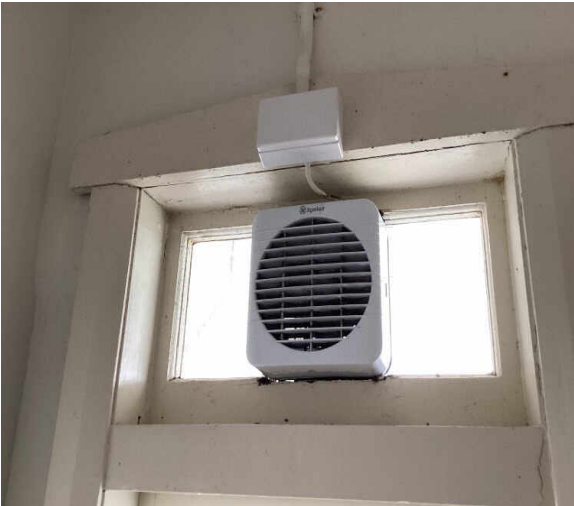
I strong wind conditions at the time of inspection, wind was coming in through the fan, despite it running to push air out. Improvement is needed.
