**Initial Evaluation Procedure (IEP) Assessment - Completed for Client****Page 1**

| Street Number & Name: | 29 Kenepuru Drive | Job No.: | 20252104 |
| Name of building: | Flooring Xtra | Date: | 6/11/2025 |
| City: | Porirua | Revision No.: | 1 |

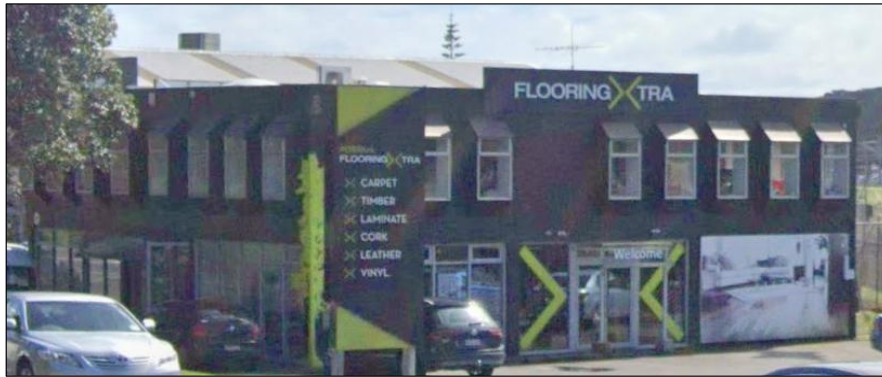
**Table IEP-1 Initial Evaluation Procedure Step 1****Step 1 - General Information****1.1 Photos (attach sufficient to describe building)**

- Building is a two-storey reinforced concrete moment frame building. Believed to have been constructed in 1976, probable design 1975 though some design work may have been done in 1976.
- Ground floor columns appear to be 300 x 300, with the exception of two ground floor columns on the north face which are 700x300 and two on the east face which are 400x300, first floor columns appear to be 300 x 300.
- First floor comprises a 150 mm reinforced concrete slab, details unknown but D12s at 200 centers would have been common practice at the time.
- Light roof supported by steel beam (welded together and bolted into column) and timber rafters.
- Northeast face includes 150 concrete block panels in lower level bays between columns.
- Ply panel shed adjacent to building but does not form part of structure.
- Both levels include timber frame walls.
