# **Detailed Seismic Assessment**

**Woburn House  
40-44 Bloomfield Terrance  
Lower Hutt**

**Date: 22/12/2015  
Revision: 1**

**J40166**

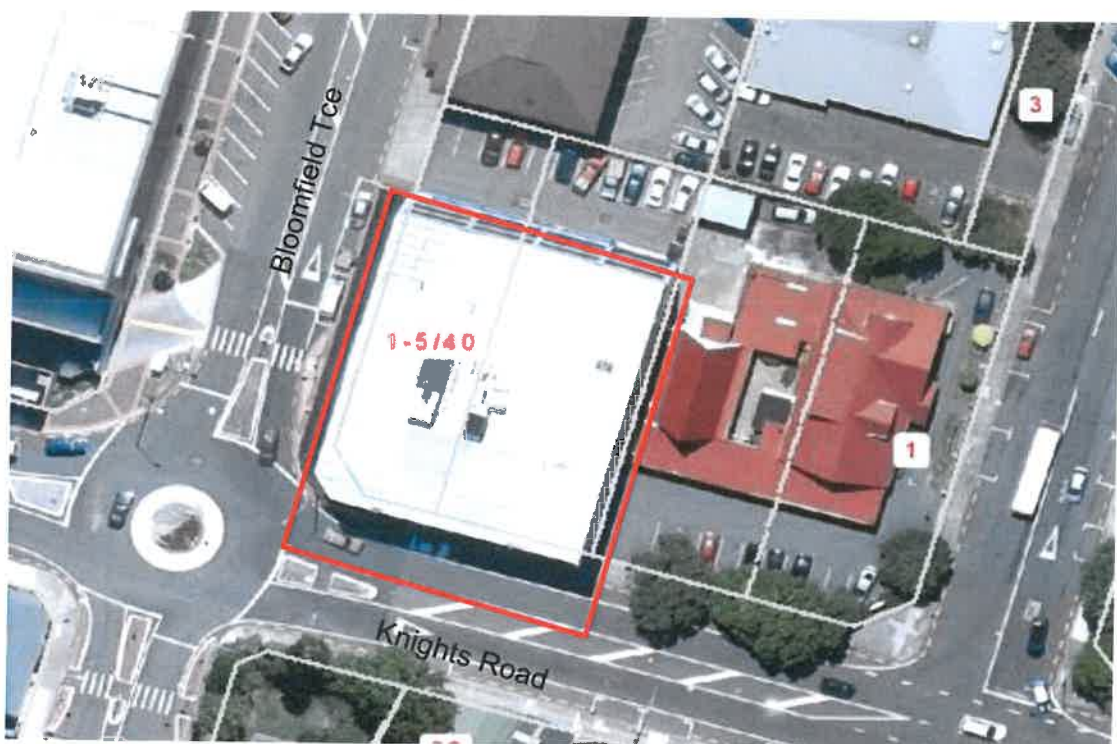
Photo 1: Aerial Photo of Woburn House at 44-45 Bloomfield Terrace, Lower Hutt

The site has been assessed as Category D (i.e. deep and soft) subsoil classification as described in NZS1170:2005. This may be subject to review on the receipt of more detailed geotechnical information. As shown in the photo 1 the building located at corner of the Bloomfield Tce and the Knights Road. A single storey church building is located at the Eastern end of the building. Our site inspection of the building revealed that a seismic gap of approximately 90mm is present.
