78 BYRON ST – DETAILED SEISMIC ASSESSMENT REPORT  
BUILDING A – SHEER ADVENTURE WORKSHOP

Prepared For:  
STEWART FAMILY TRUST

Date: 27 June 2014  
Project No: 111702  
Revision No: 1

Holmes Consulting Group LP  
Christchurch Office

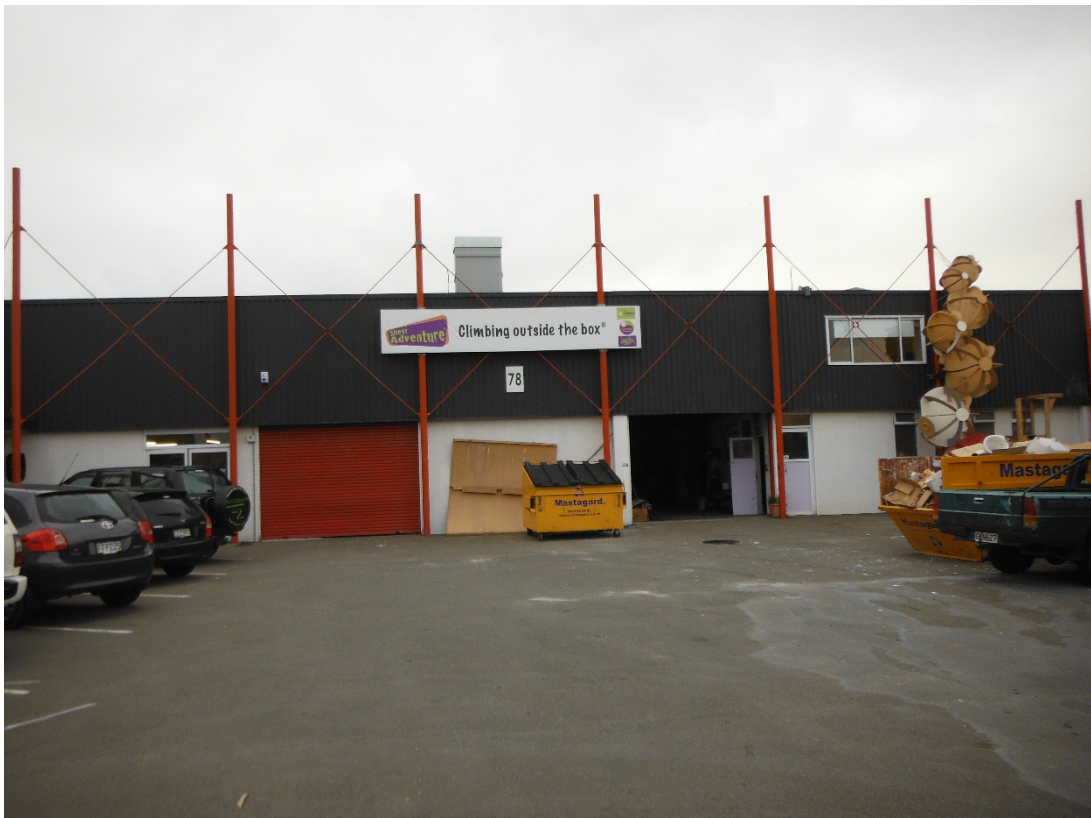
Figure 3-1: Sheer Adventure Workshop – 78 Byron St

This section discusses the form and capacity of the building prior to the Canterbury Earthquakes. The Sheer Adventures Workshop building at 78 Byron Street was constructed in two different time periods. The main structure was constructed in the 1960's with an addition along the eastern side of the building constructed in 1988. The original structural design for the 1988 addition was completed by Buchanan and Fletcher Ltd. Designers of the 1960's section are unknown. The street facing side of the structure is shown in Figure 3-1.

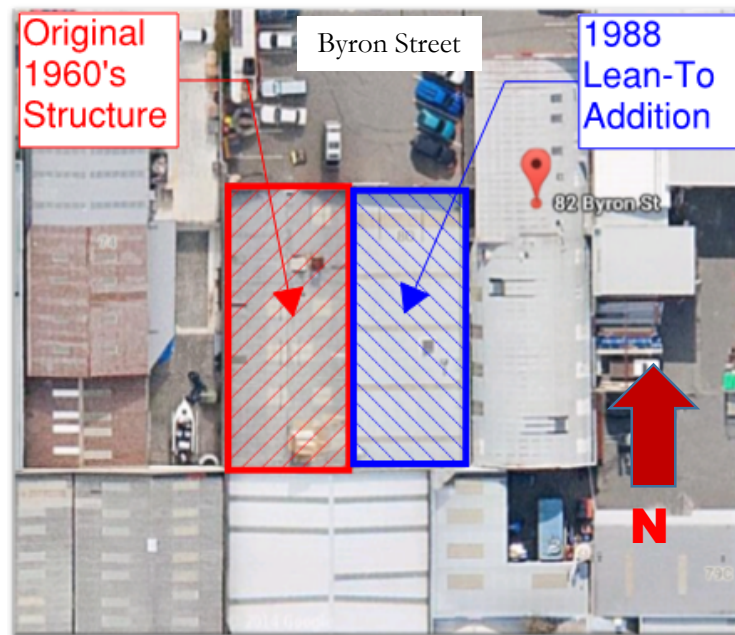
Figure 3-2: Sheer Adventure Workshop – Original Structure and Eastern Addition

direct observation of the gap. There was originally a link (door opening) between the eastern addition and the building to the south. This has since been filled in with a fire rated concrete block wall. The block wall appears to be attached to the southern building and separated from this building. The overall building footprint is illustrated in Figure 3-2.

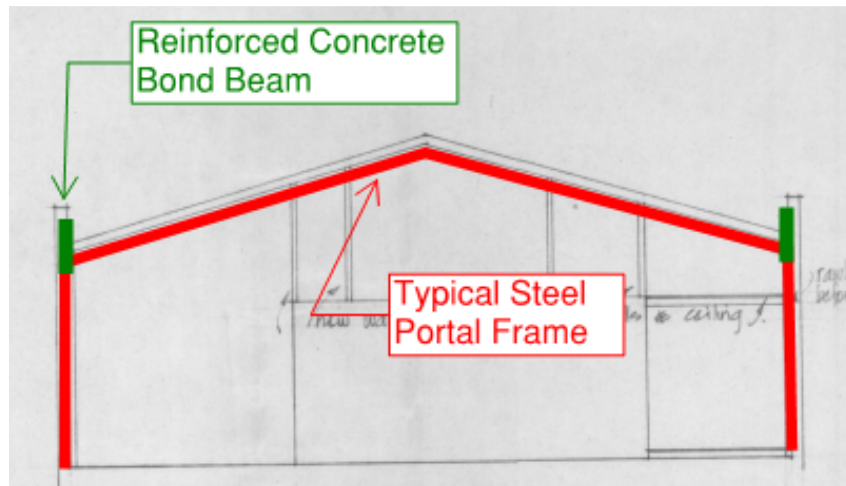
Figure 3-4: Section 1 - 1960's Original Steel Building Cross Section

The original structure, the western section, was designed and constructed in the 1960's (Figures 3-3 and 3-4). The building was likely designed to predecessor standards of the current NZ Building Code, comprising principally NZS1900:1965. The building is a single story structure, with an internal timber framed mezzanine at the north end of the building. The structure is an open warehouse with steel portal frames running across the building in the east-west direction. The portal frames are composed of I-sections with the columns encased in concrete. Infill walls around the west, south, and original 1960's eastern perimeter of the building are constructed of ungrouted concrete blockwork. There is a solid bond beam along the top of these walls that appears to be reinforced concrete. The roof is composed of diagonal sarking on timber framing with numerous skylights. There is no foundation information available to review however given the type of building and damage observed, the likely construction is concrete slab on grade with shallow pads under portal legs and shallow strip foundations under the walls.

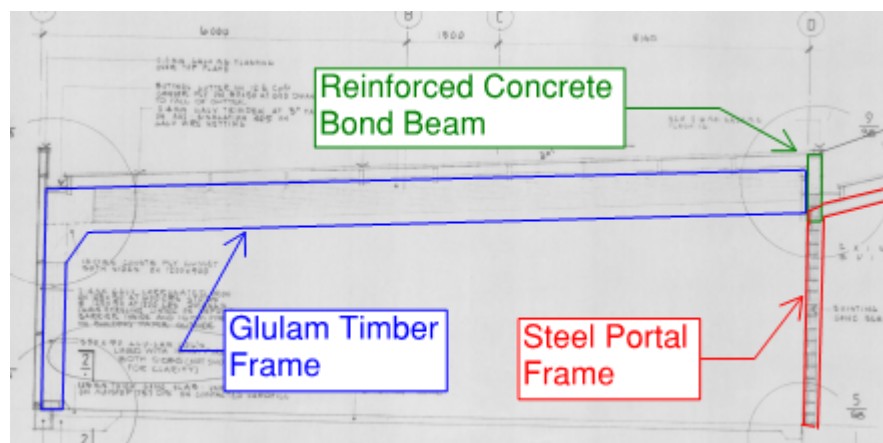
Figure 3-5: Section 2 - 1980's Eastern Addition

The lean-to addition, the eastern section, was designed and constructed in 1988 (Figures 3-3 and 3-5). This addition was likely designed to the NZS4203 (1984) loadings standard. The structure consists of glulam cantilevered L-shaped frames which span in the east-west direction and are pinned to the original structure's reinforced concrete bond beam. The roof is composed of light gage metal roofing and insulation supported by timber purlins. The south, north, and east walls are composed of light timber framing. A connection doorway to the building adjacent to the south wall has been in-filled with a grout filled concrete block wall. The wall appears to be tied into the structural concrete blockwork walls of the adjacent structure, and are therefore not a part of this building. There is a short height timber framed mezzanine at the north end.

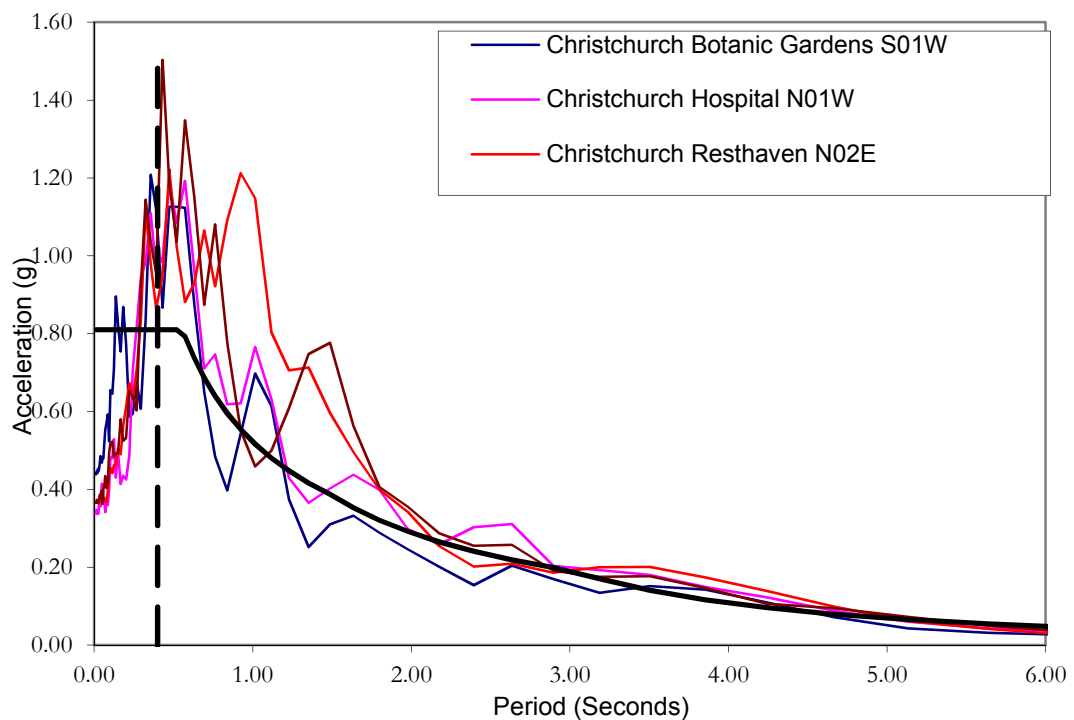
Figure 4-2: 5% Damped Spectra – North-South

It is apparent that in both directions there is significant variation in the shaking experienced at the different monitoring sites. This is due to the highly variable ground conditions around Christchurch.

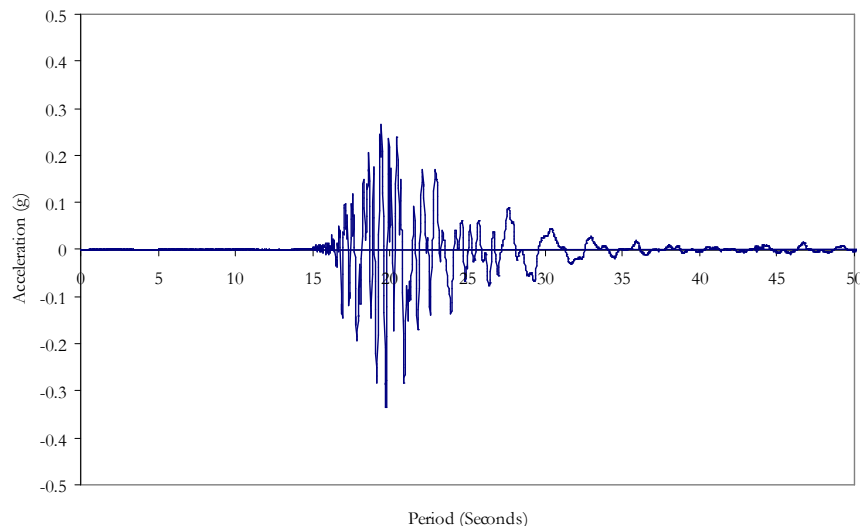
Figure 4-4: Earthquake Record from Christchurch Hospital Site

However it should also be noted that this earthquake was relatively short in terms of the strong shaking produced. The following plot of the earthquake record from the Christchurch Hospital monitoring station at 12:51 pm on the 22<sup>nd</sup> of February shows that the strong motion only lasted for a duration of approximately 5-10 seconds.

Because of this the building has only gone through a limited number of inelastic cycles. A full design earthquake for Christchurch (eg rupture of the Alpine Fault) is expected to have a significantly longer record of shaking, although the accelerations are not expected to be as strong. As an indication, rupture of the Alpine Fault is expected to contain in excess of 60 seconds of strong motion.
