| PROJECT NO | C11090.00 | DATE | 6 <sup>th</sup> June, 2011 |
| PROJECT NAME | Gary Lee Electrical | ADJUSTER: | Crawford and Company – Stuart Mintz |
| PROJECT LOCATION | 7 Elmdale Lane<br>Christchurch, New Zealand | INSURER: | Chartis |

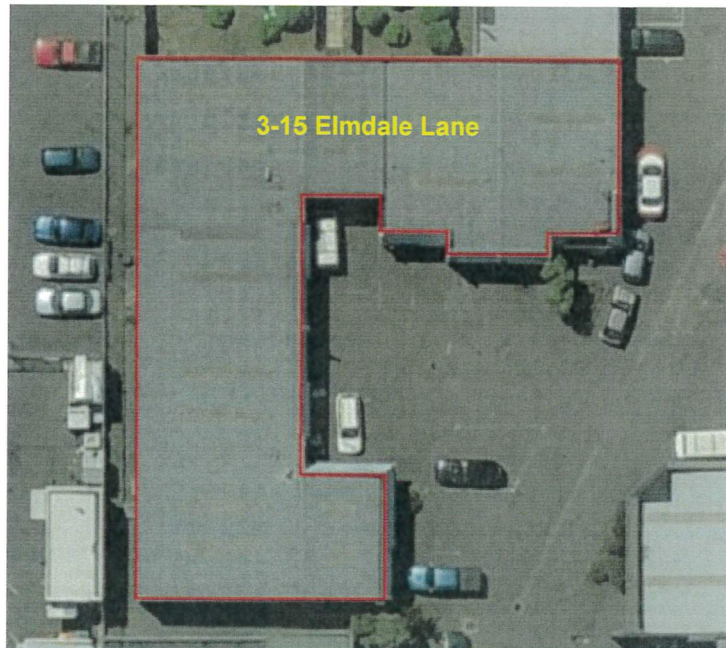
Each unit is separated by concrete tilt-up wall panels, and the majority of the exterior walls are concrete tilt-up panels. At each exterior wall panel joint observed, TT observed concrete columns, or concrete-encased steel columns, that extend to roughly half of the panel height (Photo 2). The ground floor of each unit is a concrete slab on grade. The roof structure consists of light gauge steel purlins that span in the north-south direction and are supported by steel ledger angles bolted to the tilt-up concrete walls. Lateral loads are resisted by the concrete wall panels.
