Christchurch Property Inspections Report

18 Sandwich Road,
Beckenham

04/06/2025

Pre-Sale Visual Non-Invasive Property Inspection

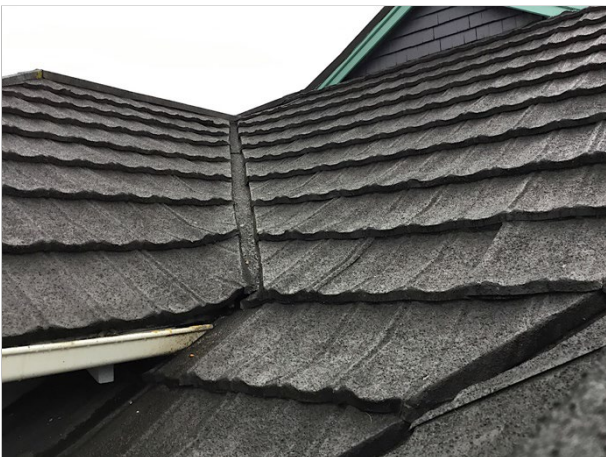
5. Typical roof

Downpipes, G/T & Stormwater	<p>PVC downpipes fall to storm water risers, appear sound usable condition. Gully traps clear.</p> <p>No guarantees can be given as to the state of the underground piping due in part to the ongoing nature of seismic activity in the Canterbury region. No pipework tests were undertaken during this inspection.</p>	
Guttering	<p>PVC and Coloured steel. Generally sound, typical for age.</p> <p>Damaged gutter above garage</p> <p>Note: It is important to maintain clean guttering to eliminate blockages that may cause moisture ingress into the wall framing.</p>	29
Roofing	<p>Decramastic tiled roofing with flathead nail fixings. Generally sound, typical for age.</p> <p>This type of fixing will need to be occasionally checked for general maintenance purposes.</p> <p>Restrictions: Due to current NZ Health & Safety at Work Act 2015 in regard to working alone and at height: We will provide only a very limited visual inspection of the exterior roofing which can be seen from a ladder (3.6m) at several locations around the building. If you have concerns about the quality of the roof cladding or roof structure, we recommend further investigation by a qualified roofing professional.</p> <p>(No watertightness or weathertightness tests are carried out during visual, non-invasive inspections of this kind so all comments regarding these issues are on the basis of observation only. Furthermore for health and safety reasons (as specified above) the inspector does not walk on the roof and all comments are based on the limitations of line-of-sight observations made from laddertop positions or in the case of two or more storey buildings from scaffolding, if present, or from vantage points either on the ground or inside the building).</p>	5, 6

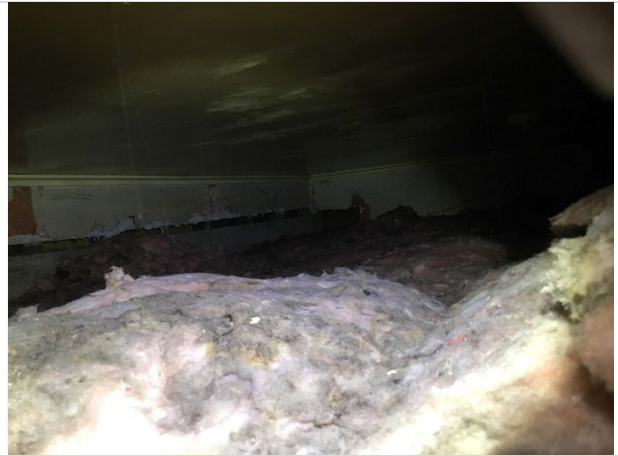
8.Ceiling Insulation

Floor Levels	<p>Spot checked throughout using a Bosch GLL 3-80 mini laser. Findings below.</p> <p>25mm variation over 10m well within guidelines below.</p> <p>MBIE GUIDELINES: 1. The floor slope between two points greater than 2m apart is less than 0.5% (1:200)</p> <p>Floor levels are spot checked using a Bosch GLL 3-80 mini laser. This is not a comprehensive floor level survey and is not designed to replace an engineer's assessment. These measurements are to be treated as indicative readings only. Floors are spot checked at different areas of the house. If a more in depth survey is required, a zip level survey should be commissioned to capture the exact floor level condition.</p>	Photo 13
Insulation Ceiling	<p>Fibreglass batts 100mm thick where installed. Generally sound, typical for age. Would benefit from installing second layer. Full height ceilings have no insulation.</p> <p>Strong smell and signs of vermin.</p>	8

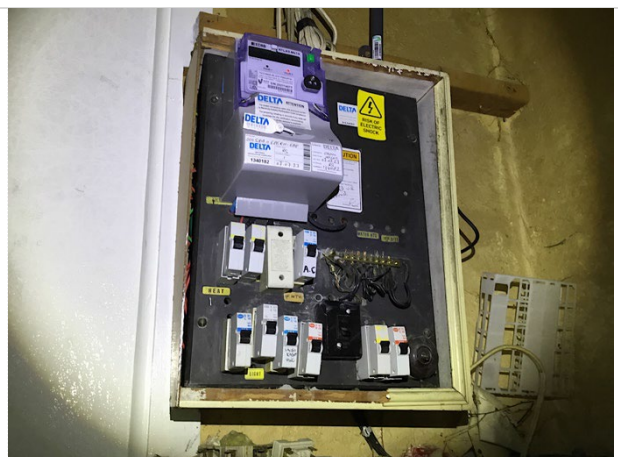
12.Switchboard

Hot Water	Low pressure electric hot water cylinder located in the garage. Generally sound, typical for age. Untested. No seismic strapping installed.	Photo 11
Electrical Services	Mini circuit breakers on original switchboard. (See switchboard photo) Power was on at time of inspection. Untested.	12
Plumbing Services	Some polybutylene pipework visible. No Qest Dux plumbing observed.	
Ventilation System	N/A.	
Smoke Alarms	N/A.	
Intruder Alarms	N/A.
