| <b>IAG Claim Number</b> | LG07645067 | <b>Date/Time</b> | 15 November 2017 |
| <b>Address</b> | 34B Upland Rd, Kelburn | <b>Loss Adjuster</b> | Sam Bell |

## DAMAGED PROPERTY SITE SURVEY

**Customer:** Wallcork Upland Ltd  
**Address:** 34B Upland Rd, Kelburn

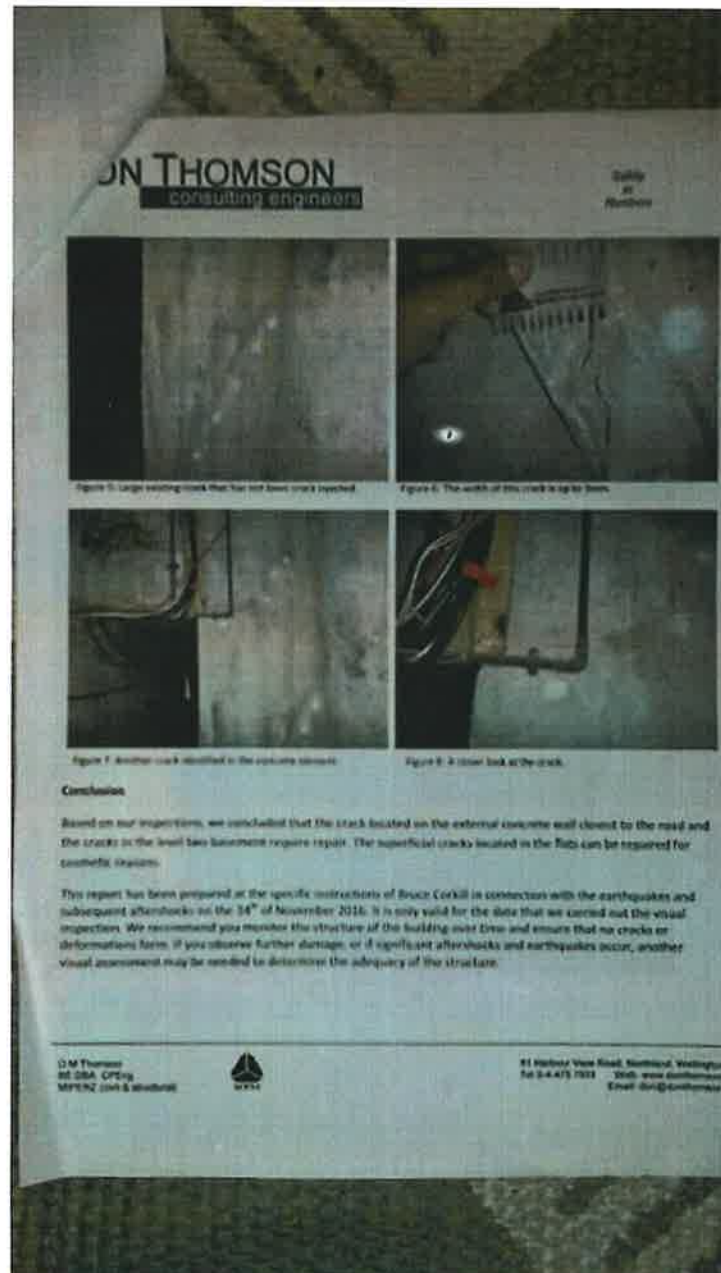
Engineers report

There were a number of existing cracks in the floor two basement. Some of these cracks had been previously repaired. One pre-existing crack has not been repaired (see Figure 5). The south (front) of this crack might have occurred due to the ground movement.

There is another crack located in the same concrete element. This crack is at the bottom of the concrete column and a beam (see Figure 6). We recommend that these cracks be injected with epoxy grout similar to the existing repair work.
