# **KOWHAI TIMBER (1990) LIMITED**

**SOIL CONTAMINATION INVESTIGATION  
MATAKANA VALLEY ROAD ROAD,  
MATAKANA**

**Prepared by:  
Groundwater and Environmental Services  
PO Box 17273  
Greenlane  
Auckland 1005  
10 November 2003**

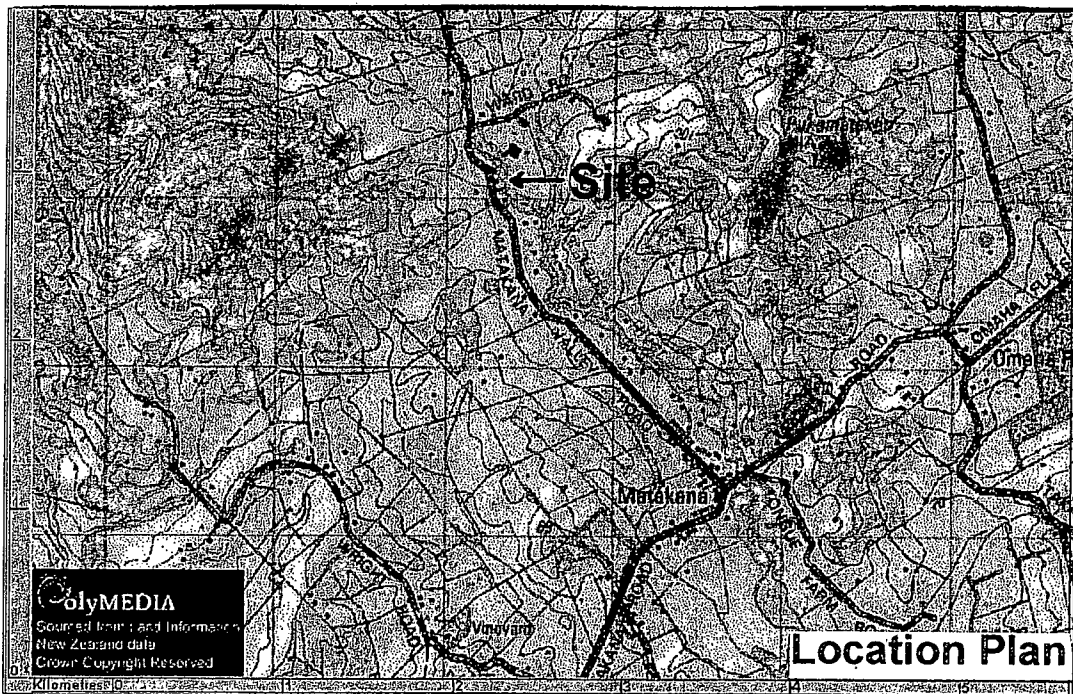
# Site Layout

On 9 April 1997, a 4,500L diesel underground storage tank was removed from near the sawmill, adjacent to Matakana Valley Road (Figure 1). According to the Mobil tank removal report, the tank was in good condition with paint still intact. The soil profile in the tankpit was described as clay. Total petroleum hydrocarbon (TPH) concentrations were below detection limits in two soil samples taken from the base of the tankpit by the Mobil engineer. (Mobil, 1996)

The site investigation was focussed around the end of the sawmill containing the diesel engine and the Mobil storage tank (Figure 1). The area beneath the diesel engine and Mobil tank was unsurfaced prior to the April 9 excavation. At the time of the PDP site visit, the area was sealed with a concrete floor. A bund, 60 to 300mm high, surrounds the concrete floor (Figure 1). Hydrocarbon staining was noted on the concrete beneath the diesel engine (Photo 3). The engine appeared to be leaking a small amount of diesel and possibly lubricating oil. The concrete beneath the Mobil storage tank appeared clean.

According to the Mobil tank removal report, the tankpit excavation, approximately 15m from the sawmill (Figure 1), was excavated in clay. The clay extended to the base of the tankpit at about 2.5m depth. No groundwater was observed in the tankpit. It is expected that similar geological conditions exist beneath the sawmill.
