# Asbestos Management Survey

Petone Club  
Ministry for Primary Industries  
40 Bouverie Street  
Petone  
Lower Hutt  
5012

Report Number: S-16625/44636 Rev 1

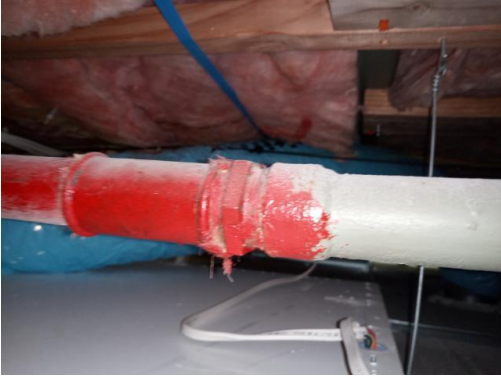
Building / Floor	Ministry for Primary Industries / Void	
	Location	016	Roof void

Sample Number	S012/44647	
	Item / Position	Sealant to screwed pipework joints	
	Material	Textile	
	Extent (approx.)	4 lin m	
	Product Type	AIB, textiles, gaskets, ropes, paper etc.	2
	Condition	Medium damage - significant breakage of materials or several small areas where material has been damaged revealing loose asbestos fibres	2
	Surface Treatment	Unsealed AIB, textiles or encapsulated lagging and sprays	2
	Asbestos Type	<b>Chrysotile</b>	1
	Material Assessment	<b>Medium</b>	<b>7</b>
	Recommendation	Label & Manage	
Comments	Material should not be disturbed through actions such as sanding, cutting, drilling etc. without appropriate measures taken to suppress fibre release.

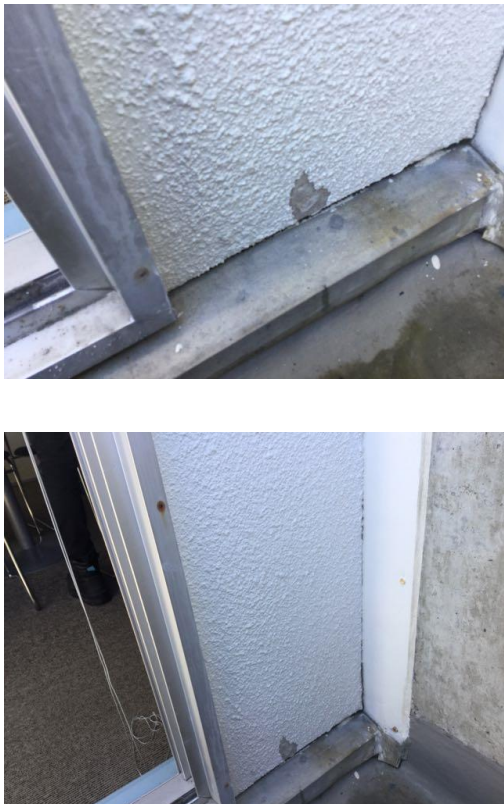
Building / Floor	Ministry for Primary Industries / 2nd Floor	
	Location	001	External
	Sample Number	S011/44646	
	Item / Position	Wall panels - Insulating board panel with a render coating. Present in various places around perimeter Large section of the concrete walls have a modern pebble dash coating.	
	Material	Insulation board	
	Extent (approx.)	6 m <sup>2</sup>	
	Product Type	-	-
	Condition	-	-
	Surface Treatment	-	-
	Asbestos Type	<b>NAD</b>	-
	Material Assessment	<b>N/A</b>	<b>0</b>
	Recommendation	No recommendation required	
Comments

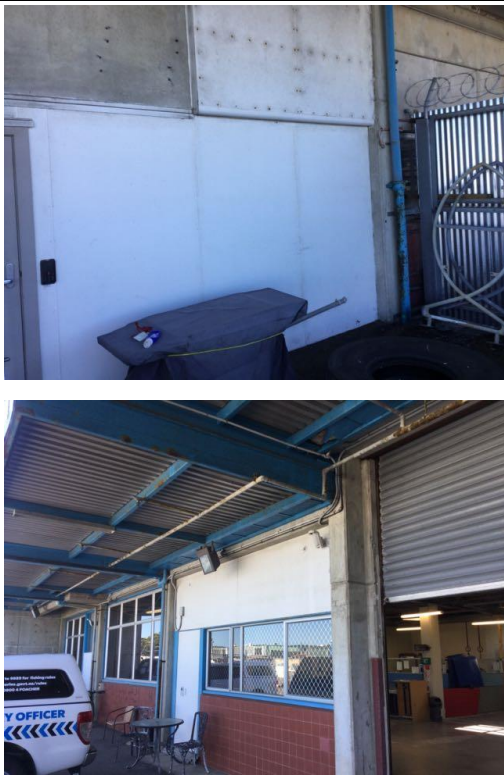
Building / Floor	Ministry for Primary Industries / External	
	Location	001	External
	Sample Number	S027/44661	
	Item / Position	Wall lining to rear of garage	
	Material	Insulation board	
	Extent (approx.)	10 m <sup>2</sup>	
	Product Type	-	-
	Condition	-	-
	Surface Treatment	-	-
	Asbestos Type	NAD	-
	Material Assessment	N/A	0
	Recommendation	No recommendation required	
Comments

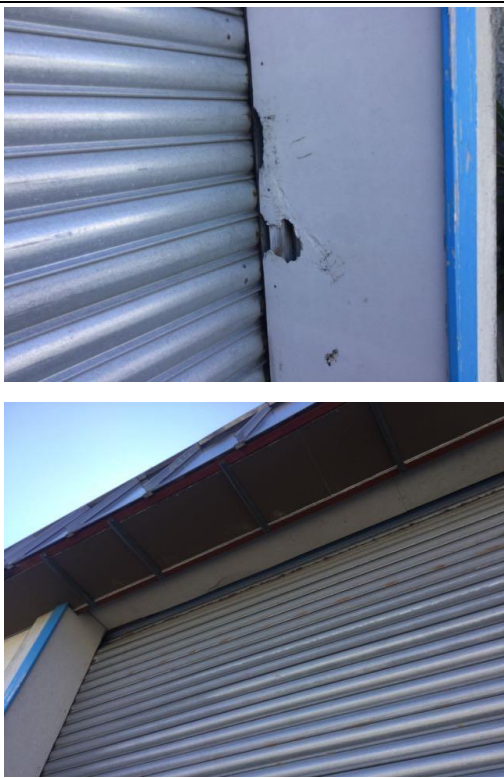
Building / Floor	Ministry for Primary Industries / External	
	Location	001	External
	Sample Number	S037/44671	
	Item / Position	Cladding around front shutter	
	Material	Insulation board	
	Extent (approx.)	14 m <sup>2</sup>	
	Product Type	-	-
	Condition	-	-
	Surface Treatment	-	-
	Asbestos Type	NAD	-
	Material Assessment	N/A	0
	Recommendation	No recommendation required	
Comments

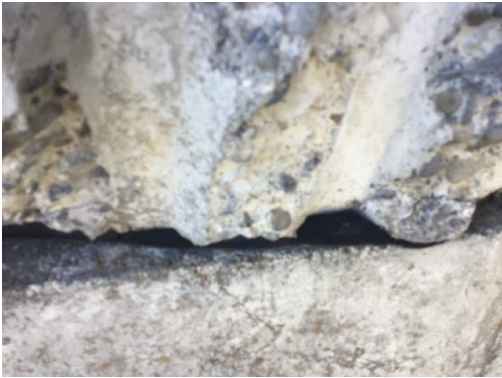
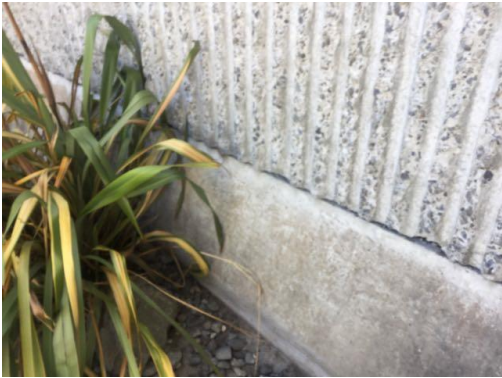
Building / Floor	Ministry for Primary Industries / External	
	Location	001	External
	Sample Number	S038/44672	
	Item / Position	Sealant at expansion joint	
	Material	Mastic	
	Extent (approx.)	150 lin m	
	Product Type	-	-
	Condition	-	-
	Surface Treatment	-	-
	Asbestos Type	NAD	-
	Material Assessment	N/A	0
	Recommendation	No recommendation required

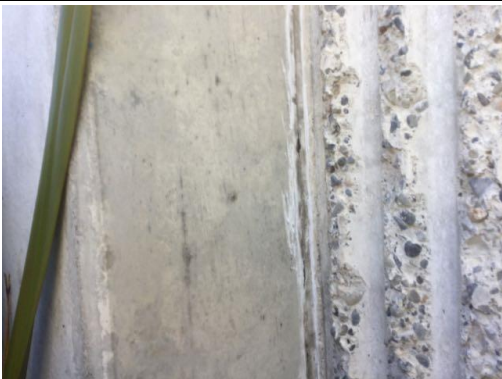
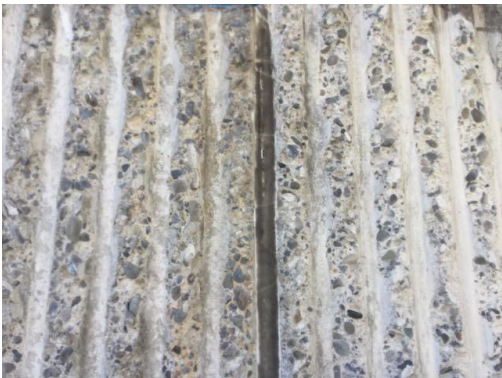
Building / Floor	Ministry for Primary Industries / External	
	Location	001	External
	Sample Number	S039/44673	
	Item / Position	Sealant to expansion joints	
	Material	Mastic	
	Extent (approx.)	120 lin m	
	Product Type	-	-
	Condition	-	-
	Surface Treatment	-	-
	Asbestos Type	NAD	-
	Material Assessment	N/A	0
	Recommendation	No recommendation required

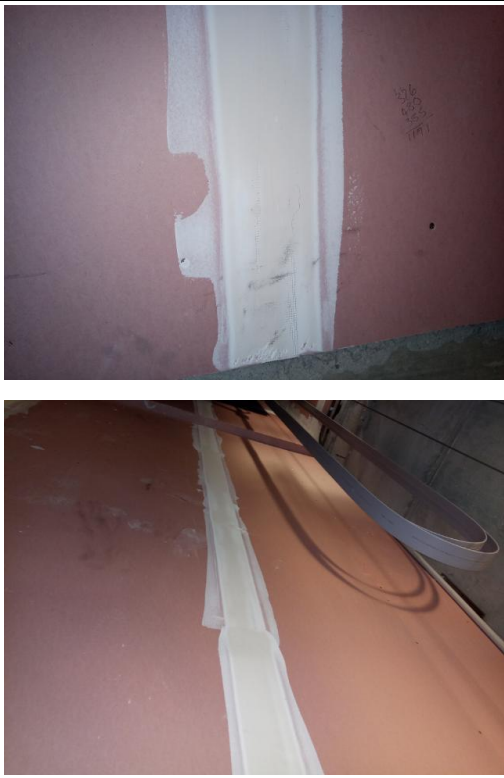
Building / Floor	Ministry for Primary Industries / Lift Shaft	
	Location	002	Lift shaft
	Sample Number	S001/44636	
	Item / Position	Sealant to plasterboard panels	
	Material	Gypsum joint compound	
	Extent (approx.)	20 m <sup>2</sup>	
	Product Type	-	-
	Condition	-	-
	Surface Treatment	-	-
	Asbestos Type	NAD	-
	Material Assessment	N/A	0
	Recommendation	No recommendation required	
Comments

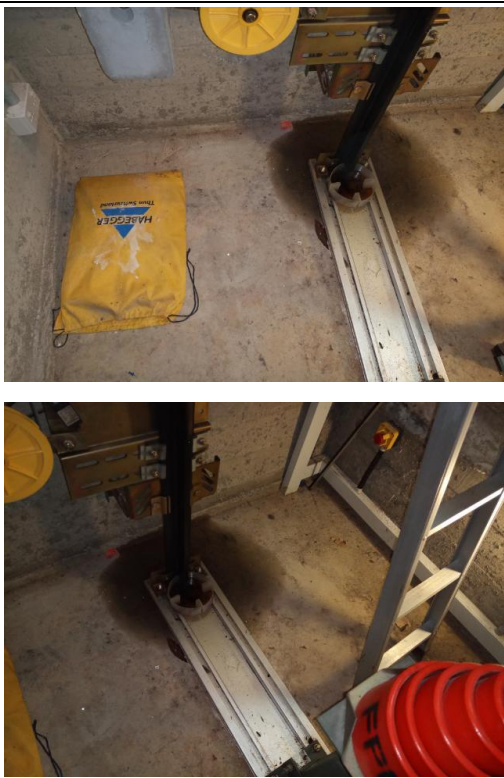
Building / Floor	Ministry for Primary Industries / Lift Shaft	
	Location	002	Lift shaft
	Sample Number	S002/44637	
	Item / Position	Dust to floor of pit	
	Material	Dust Wipe	
	Extent (approx.)	1 m <sup>2</sup>	
	Product Type	-	-
	Condition	-	-
	Surface Treatment	-	-
	Asbestos Type	NAD	-
	Material Assessment	N/A	0
	Recommendation	No recommendation required	
Comments

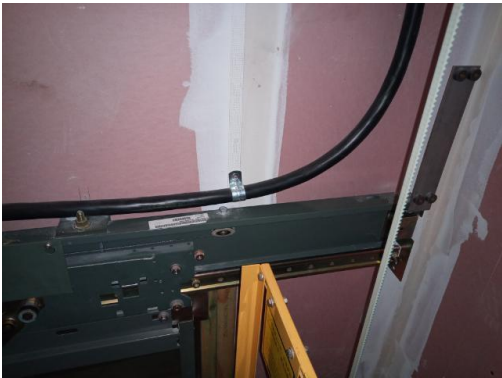
Building / Floor	Ministry for Primary Industries / Lift Shaft	
	Location	002	Lift shaft
	Sample Number	S003/44638	
	Item / Position	Dust to flat surface level 1 - Photo is representative of area swabbed	
	Material	Dust Wipe	
	Extent (approx.)	1 m <sup>2</sup>	
	Product Type	-	-
	Condition	-	-
	Surface Treatment	-	-
	Asbestos Type	NAD	-
	Material Assessment	N/A	0
	Recommendation	No recommendation required	
	Comments

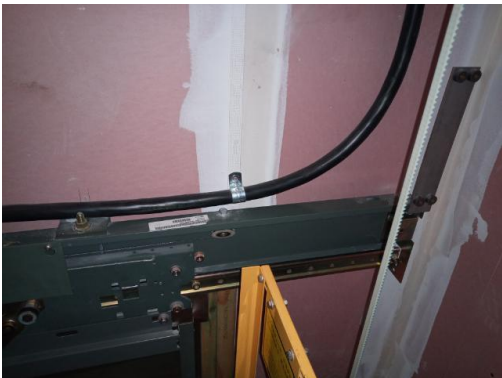
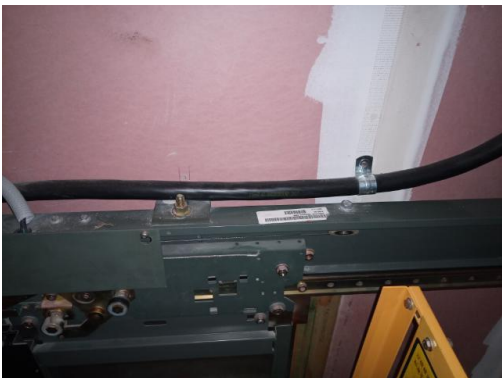
Building / Floor	Ministry for Primary Industries / Lift Shaft	
	Location	002	Lift shaft
	Sample Number	S004/44639	
	Item / Position	Dust to flat surface level 2	
	Material	Dust Wipe	
	Extent (approx.)	1 m <sup>2</sup>	
	Product Type	-	-
	Condition	-	-
	Surface Treatment	-	-
	Asbestos Type	NAD	-
	Material Assessment	N/A	0
	Recommendation	No recommendation required	
	Comments

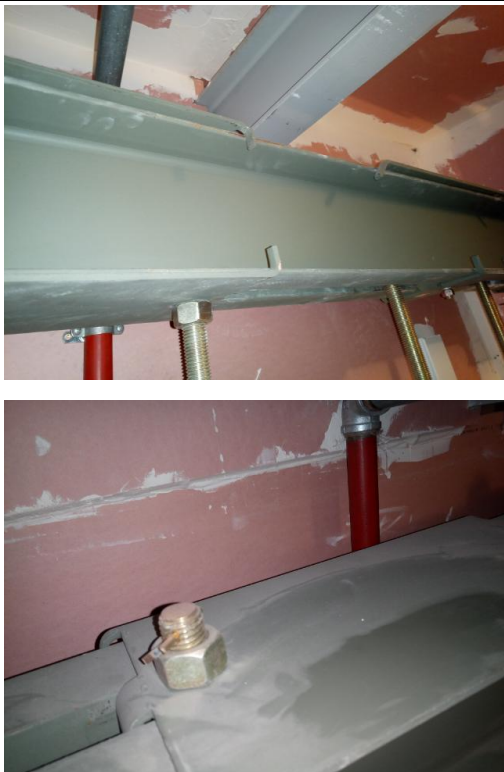
Building / Floor	Ministry for Primary Industries / Lift Shaft	
	Location	002	Lift shaft
	Sample Number	S005/44640	
	Item / Position	Dust to flat surface at top of shaft	
	Material	Dust Wipe	
	Extent (approx.)	1 m <sup>2</sup>	
	Product Type	-	-
	Condition	-	-
	Surface Treatment	-	-
	Asbestos Type	NAD	-
	Material Assessment	N/A	0
	Recommendation	No recommendation required	
Comments

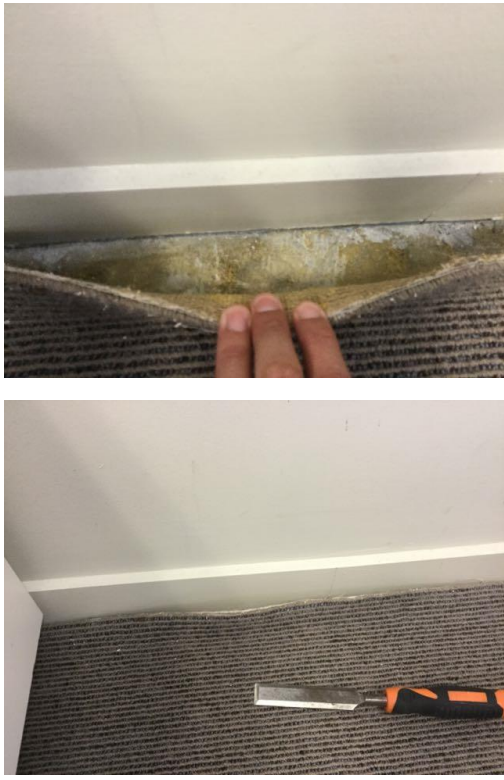
Building / Floor	Ministry for Primary Industries / 2nd Floor	
	Location	003	Open plan office
	Sample Number	S006/44641	
	Item / Position	Coating beneath carpet - Sporadic throughout floor witnessed in some places but not everywhere	
	Material	Levelling compound	
	Extent (approx.)	25 m <sup>2</sup>	
	Product Type	-	-
	Condition	-	-
	Surface Treatment	-	-
	Asbestos Type	NAD	-
	Material Assessment	N/A	0
	Recommendation	No recommendation required	
Comments

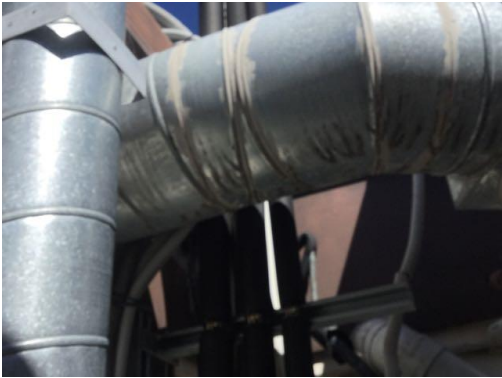
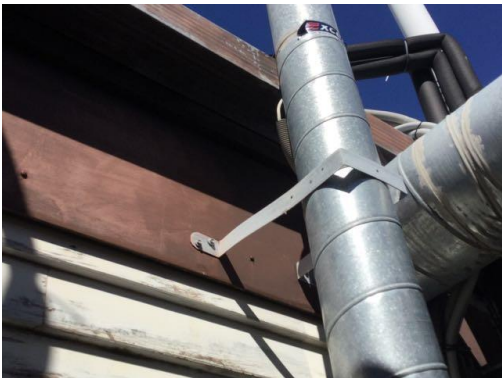
Building / Floor	Ministry for Primary Industries / 2nd Floor	
	Location	012	Light well
	Sample Number	S008/44643	
	Item / Position	Sealant to venting	
	Material	Mastic	
	Extent (approx.)	5 lin m	
	Product Type	-	-
	Condition	-	-
	Surface Treatment	-	-
	Asbestos Type	NAD	-
	Material Assessment	N/A	0
	Recommendation	No recommendation required	
	Comments

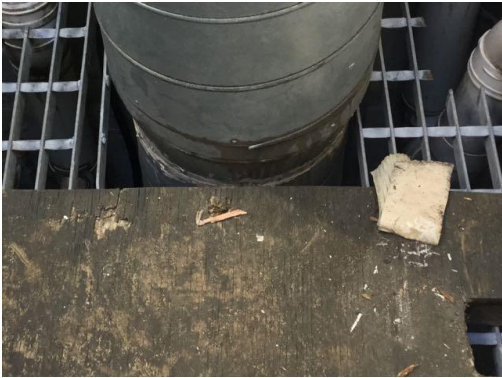
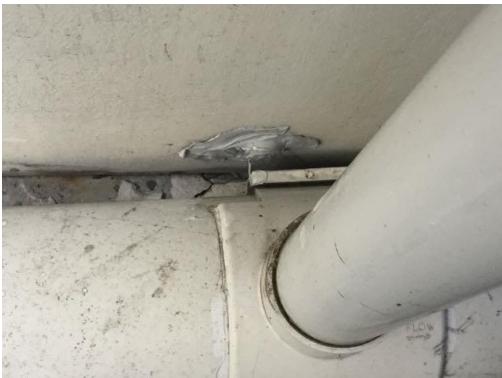
Building / Floor	Ministry for Primary Industries / 2nd Floor	
	Location	012	Light well
	Sample Number	S009/44644	
	Item / Position	Loose on floor	
	Material	Bitumen/tar	
	Extent (approx.)	Very small amounts m <sup>2</sup>	
	Product Type	-	-
	Condition	-	-
	Surface Treatment	-	-
	Asbestos Type	NAD	-
	Material Assessment	N/A	0
	Recommendation	No recommendation required	
	Comments

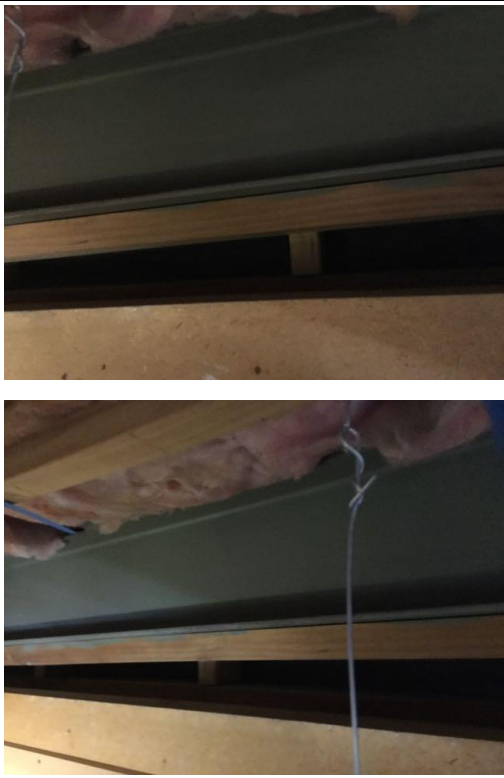
Building / Floor	Ministry for Primary Industries / Void	
	Location	016	Roof void
	Sample Number	S013/44648	
	Item / Position	Dust to flat surfaces	
	Material	Dust Wipe	
	Extent (approx.)	1 m <sup>2</sup>	
	Product Type	-	-
	Condition	-	-
	Surface Treatment	-	-
	Asbestos Type	NAD	-
	Material Assessment	N/A	0
	Recommendation	No recommendation required	
	Comments

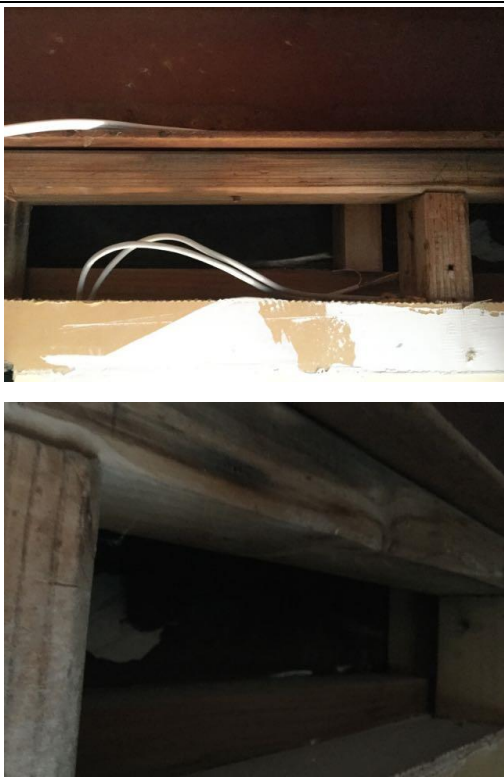
Building / Floor	Ministry for Primary Industries / Void	
	Location	016	Roof void
	Sample Number	S014/44649	
	Item / Position	Lining to perimeter wall (render board sections)	
	Material	Bitumen paper	
	Extent (approx.)	4 m <sup>2</sup>	
	Product Type	-	-
	Condition	-	-
	Surface Treatment	-	-
	Asbestos Type	NAD	-
	Material Assessment	N/A	0
	Recommendation	No recommendation required	
	Comments

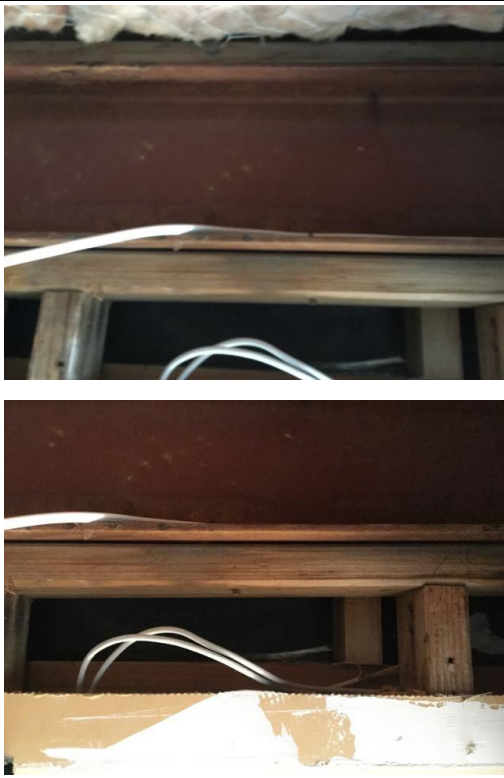
Building / Floor	Ministry for Primary Industries / Void	
	Location	016	Roof void
	Sample Number	S015/44650	
	Item / Position	Dust to flat surfaces	
	Material	Dust Wipe	
	Extent (approx.)	1 m <sup>2</sup>	
	Product Type	-	-
	Condition	-	-
	Surface Treatment	-	-
	Asbestos Type	NAD	-
	Material Assessment	N/A	0
	Recommendation	No recommendation required	
Comments

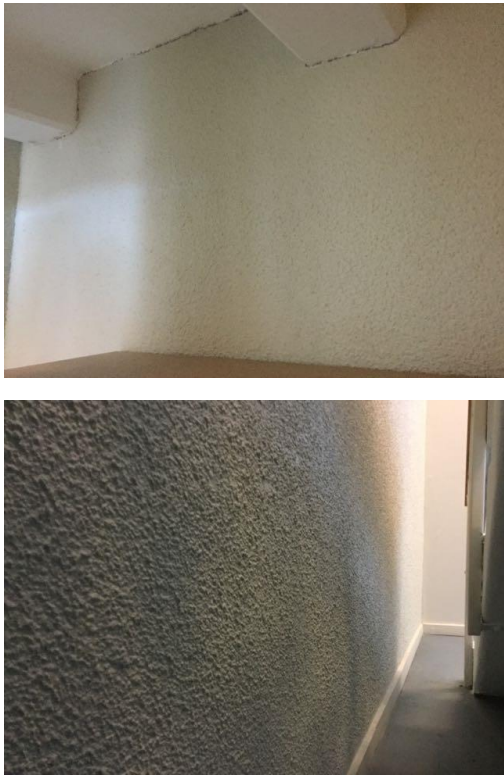
Building / Floor	Ministry for Primary Industries / Stairwell	
	Location	018	Stairwell (main)
	Sample Number	S017/44652	
	Item / Position	Coating to concrete walls - Concrete walls section are to the ground floor section.	
	Material	Render	
	Extent (approx.)	20 m <sup>2</sup>	
	Product Type	-	-
	Condition	-	-
	Surface Treatment	-	-
	Asbestos Type	NAD	-
	Material Assessment	N/A	0
	Recommendation	No recommendation required	
	Comments

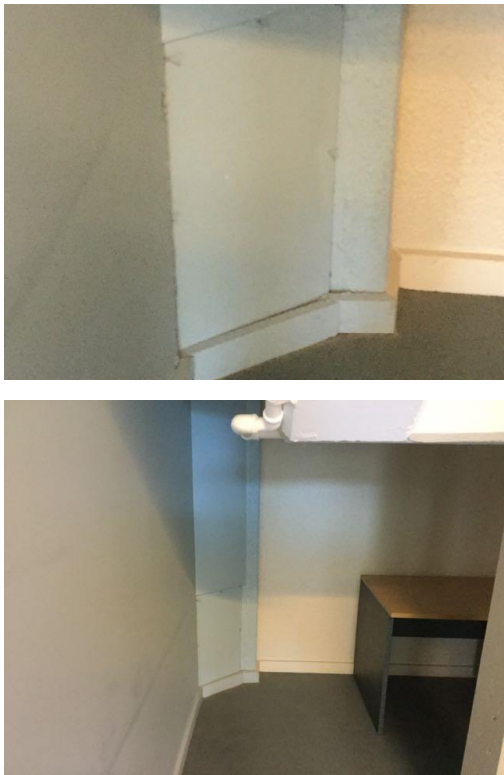
Building / Floor	Ministry for Primary Industries / Stairwell	
	Location	018	Stairwell (main)
	Sample Number	S018/44653	
	Item / Position	Panels to bottom of boxing	
	Material	Insulation board	
	Extent (approx.)	1 m <sup>2</sup>	
	Product Type	-	-
	Condition	-	-
	Surface Treatment	-	-
	Asbestos Type	NAD	-
	Material Assessment	N/A	0
	Recommendation	No recommendation required	
	Comments

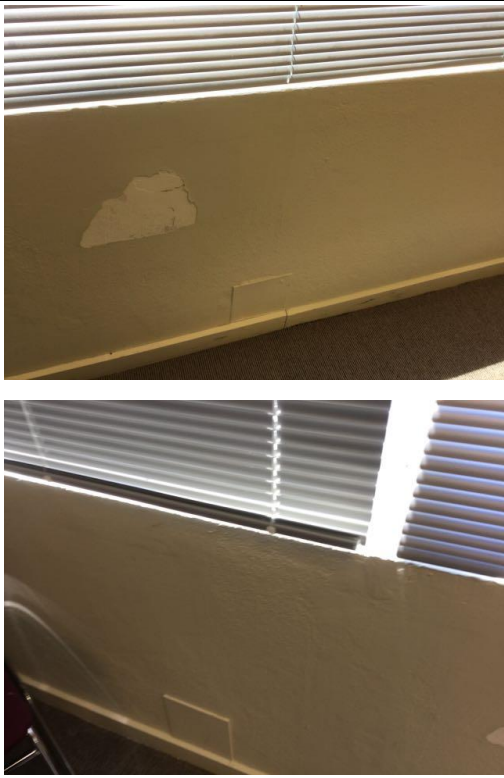
Building / Floor	Ministry for Primary Industries / 1st Floor	
	Location	022	Meeting room
	Sample Number	S020/44655	
	Item / Position	Coating to concrete wall and column	
	Material	Textured coating	
	Extent (approx.)	6 m <sup>2</sup>	
	Product Type	-	-
	Condition	-	-
	Surface Treatment	-	-
	Asbestos Type	NAD	-
	Material Assessment	N/A	0
	Recommendation	No recommendation required	
	Comments

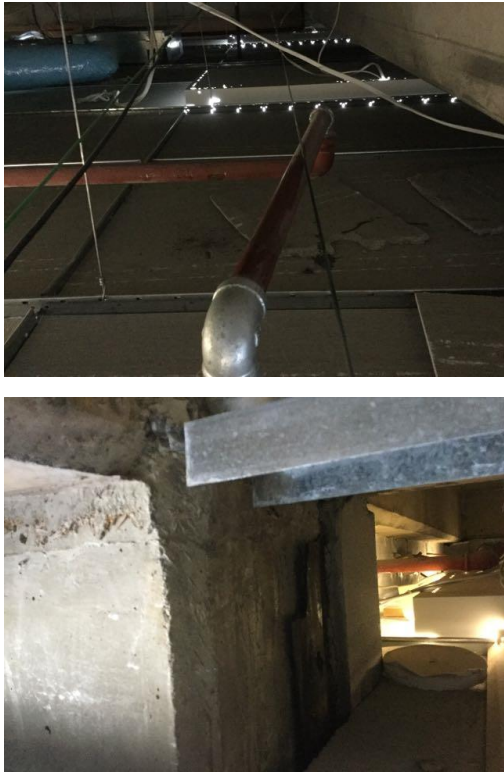
Building / Floor	Ministry for Primary Industries / Void	
	Location	033	1st floor Ceiling void
	Sample Number	S021/44656	
	Item / Position	Dust to flat surfaces and pipework	
	Material	Dust Wipe	
	Extent (approx.)	1 m <sup>2</sup>	
	Product Type	-	-
	Condition	-	-
	Surface Treatment	-	-
	Asbestos Type	NAD	-
	Material Assessment	N/A	0
	Recommendation	No recommendation required	
	Comments

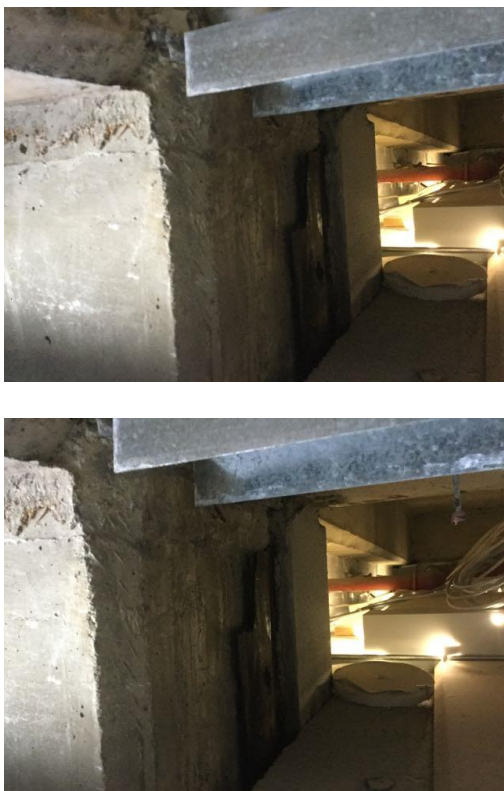
Building / Floor	Ministry for Primary Industries / Void	
	Location	033	1st floor ceiling void
	Sample Number	S022/44657	
	Item / Position	DPC to framework - Small amounts witnessed further instances are likely present behind framework and wall linings etc.	
	Material	Bitumen/tar	
	Extent (approx.)	1 m <sup>2</sup>	
	Product Type	-	-
	Condition	-	-
	Surface Treatment	-	-
	Asbestos Type	NAD	-
	Material Assessment	N/A	0
	Recommendation	No recommendation required	
	Comments

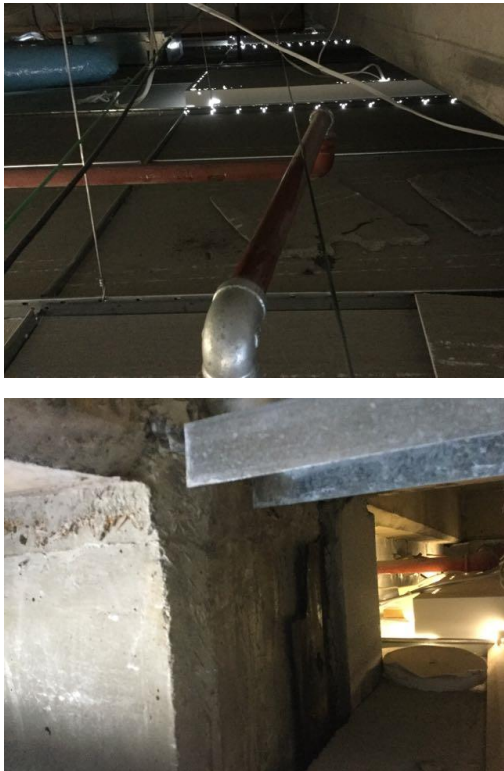
Building / Floor	Ministry for Primary Industries / Void	
	Location	034	1st floor Ceiling void
	Sample Number	S023/44658	
	Item / Position	Dust to flat surfaces and pipework	
	Material	Dust Wipe	
	Extent (approx.)	1 m <sup>2</sup>	
	Product Type	-	-
	Condition	-	-
	Surface Treatment	-	-
	Asbestos Type	NAD	-
	Material Assessment	N/A	0
	Recommendation	No recommendation required	
	Comments

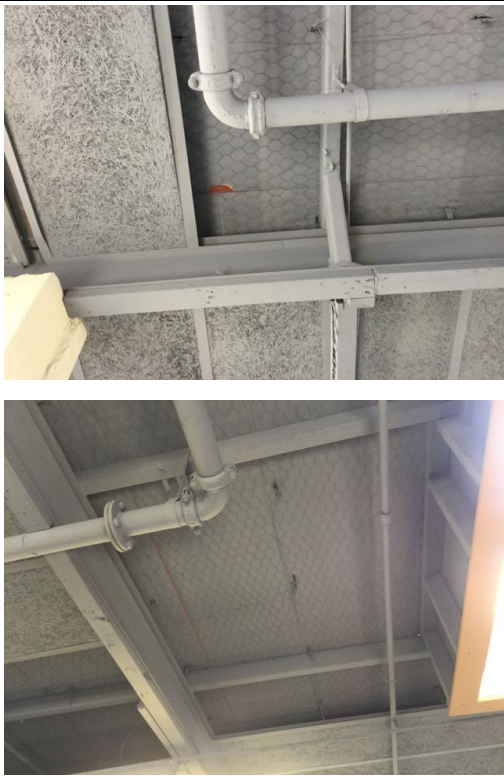
Building / Floor	Ministry for Primary Industries / Ground Floor	
	Location	044	Garage
	Sample Number	S026/44660	
	Item / Position	Lining to roof	
	Material	Bitumen paper	
	Extent (approx.)	325 m <sup>2</sup>	
	Product Type	-	-
	Condition	-	-
	Surface Treatment	-	-
	Asbestos Type	NAD	-
	Material Assessment	N/A	0
	Recommendation	No recommendation required	
Comments

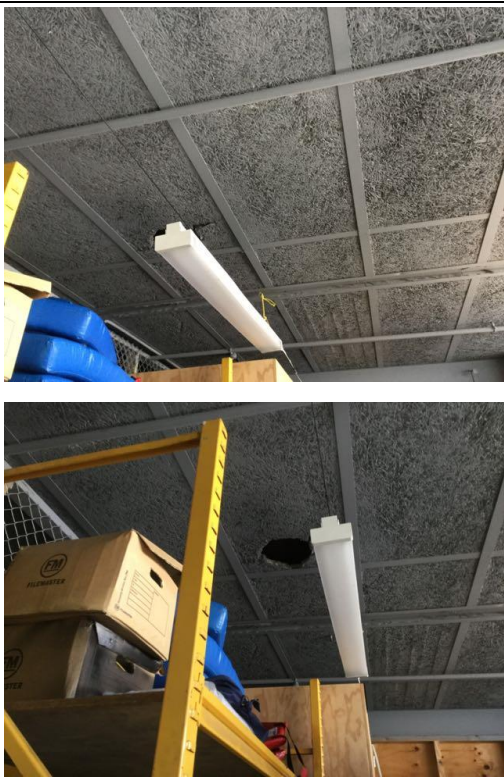
Building / Floor	Ministry for Primary Industries / Mezzanine	
	Location	052	Mezzanine store
	Sample Number	S024/44659	
	Item / Position	Strawboard ceiling	
	Material	Insulation board	
	Extent (approx.)	25 m <sup>2</sup>	
	Product Type	-	-
	Condition	-	-
	Surface Treatment	-	-
	Asbestos Type	NAD	-
	Material Assessment	N/A	0
	Recommendation	No recommendation required	
Comments

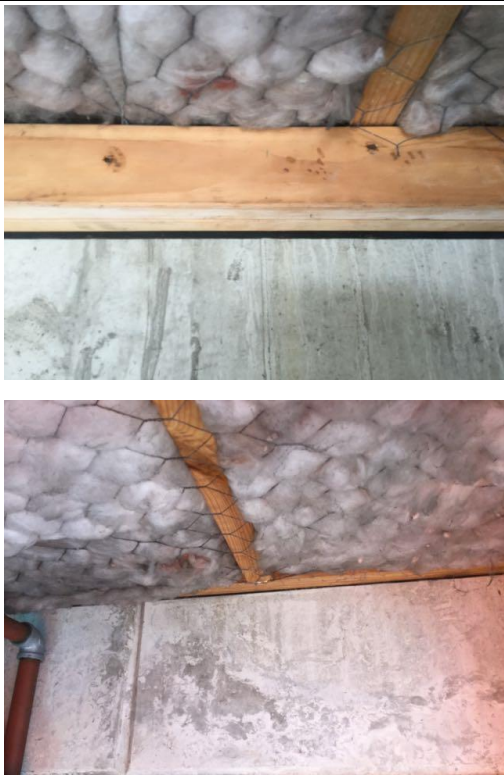
Building / Floor	Ministry for Primary Industries / Ground Floor	
	Location	054	External store
	Sample Number	S030/44664	
	Item / Position	DPC to framework	
	Material	Bitumen/tar	
	Extent (approx.)	6 lin m	
	Product Type	-	-
	Condition	-	-
	Surface Treatment	-	-
	Asbestos Type	NAD	-
	Material Assessment	N/A	0
	Recommendation	No recommendation required	
	Comments

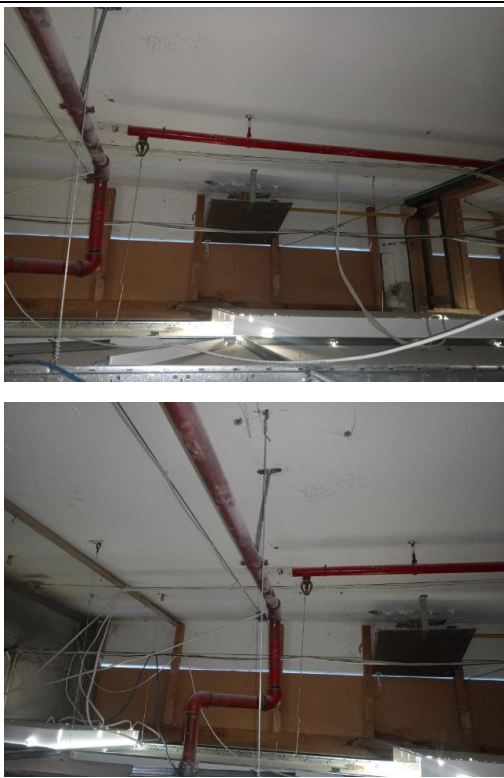
Building / Floor	Ministry for Primary Industries / Void	
	Location	055	Ceiling void
	Sample Number	S034/44668	
	Item / Position	Dust to flat surface and metal pipework	
	Material	Dust Wipe	
	Extent (approx.)	1 m <sup>2</sup>	
	Product Type	-	-
	Condition	-	-
	Surface Treatment	-	-
	Asbestos Type	NAD	-
	Material Assessment	N/A	0
	Recommendation	No recommendation required	
	Comments

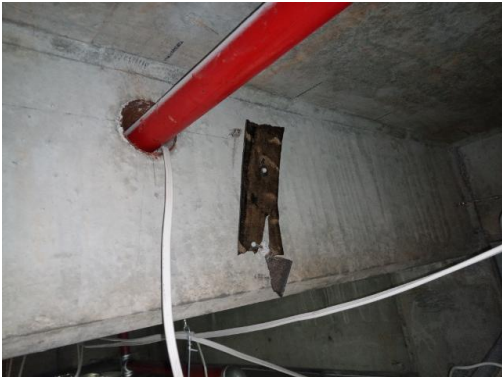
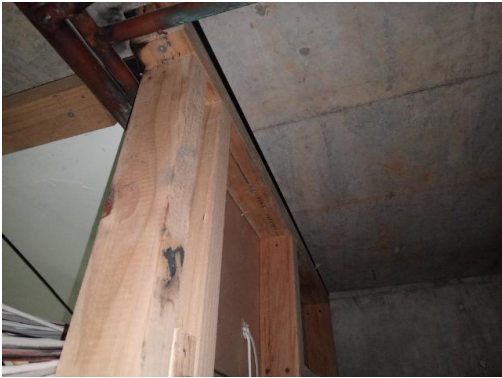
Building / Floor	Ministry for Primary Industries / Void	
	Location	055	Ceiling void
	Sample Number	S035/44669	
	Item / Position	DPC to framework	
	Material	Bitumen/tar	
	Extent (approx.)	80 lin m	
	Product Type	-	-
	Condition	-	-
	Surface Treatment	-	-
	Asbestos Type	NAD	-
	Material Assessment	N/A	0
	Recommendation	No recommendation required	
Comments

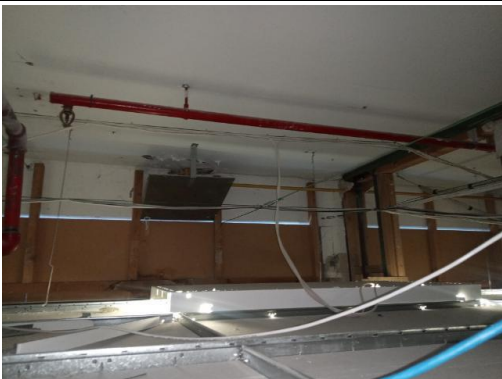
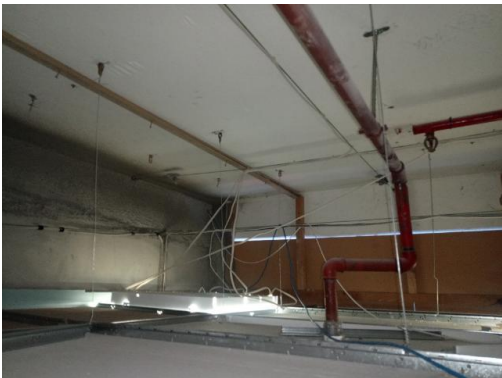
Building / Floor	Ministry for Primary Industries / Void	
	Location	055	Ceiling void
	Sample Number	S036/44670	
	Item / Position	Dust to flat surfaces and metal pipework	
	Material	Dust Wipe	
	Extent (approx.)	1 m <sup>2</sup>	
	Product Type	-	-
	Condition	-	-
	Surface Treatment	-	-
	Asbestos Type	NAD	-
	Material Assessment	N/A	0
	Recommendation	No recommendation required	
Comments

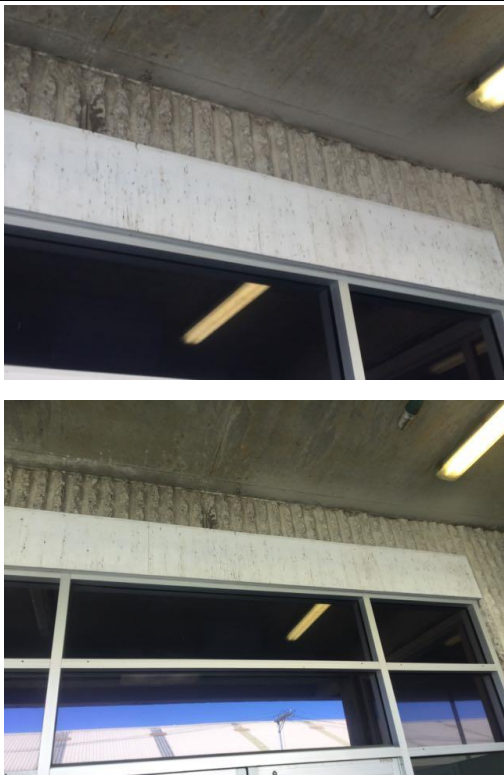
Building / Floor	Ministry for Primary Industries / External	
	Location	001	External
	Sample Number	X027/44661	
	Item / Position	High level lining above front doors	
	Material	Insulation board	
	Extent (approx.)	4 lin m	
	Product Type	-	-
	Condition	-	-
	Surface Treatment	-	-
	Asbestos Type	NAD	-
	Material Assessment	N/A	0
	Recommendation	No recommendation required	
	Comments

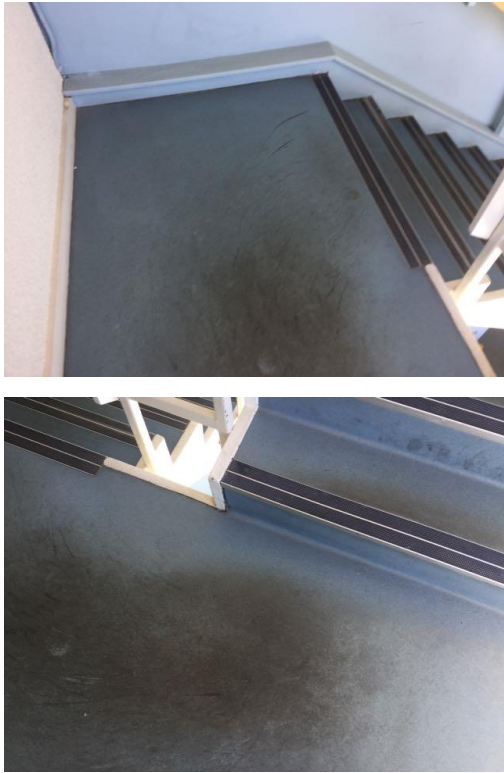
Building / Floor	Ministry for Primary Industries / Stairwell	
	Location	017	Stairwell (rear)
	Sample Number	X006/44641	
	Item / Position	Coating beneath vinyl	
	Material	Levelling compound	
	Extent (approx.)	4 m <sup>2</sup>	
	Product Type	-	-
	Condition	-	-
	Surface Treatment	-	-
	Asbestos Type	NAD	-
	Material Assessment	N/A	0
	Recommendation	No recommendation required	
	Comments

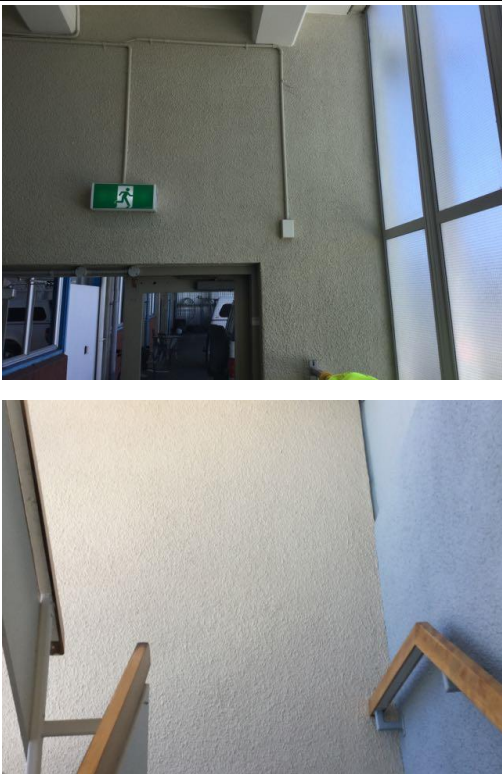
Building / Floor	Ministry for Primary Industries / Stairwell	
	Location	017	Stairwell (rear)
	Sample Number	X017/44652	
	Item / Position	Coating to concrete walls	
	Material	Render	
	Extent (approx.)	60 m <sup>2</sup>	
	Product Type	-	-
	Condition	-	-
	Surface Treatment	-	-
	Asbestos Type	NAD	-
	Material Assessment	N/A	0
	Recommendation	No recommendation required	
	Comments

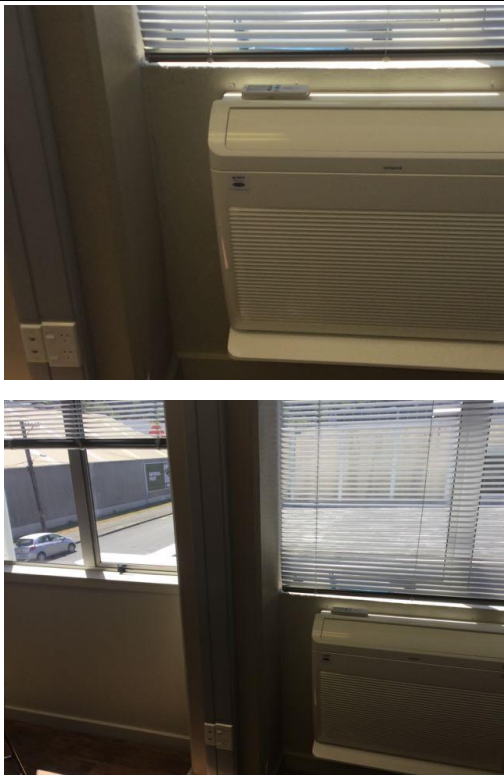
Building / Floor	Ministry for Primary Industries / 1st Floor	
	Location	019	Open plan area
	Sample Number	X020/44655	
	Item / Position	Coating to concrete wall and column	
	Material	Textured coating	
	Extent (approx.)	4 m <sup>2</sup>	
	Product Type	-	-
	Condition	-	-
	Surface Treatment	-	-
	Asbestos Type	NAD	-
	Material Assessment	N/A	0
	Recommendation	No recommendation required

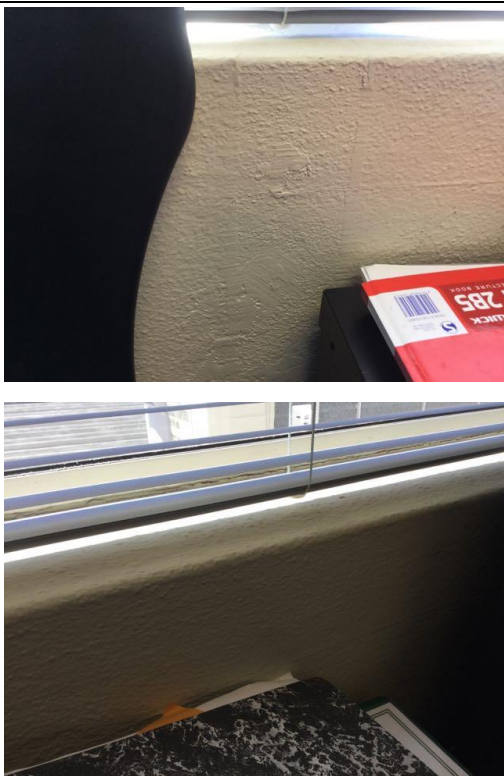
Building / Floor	Ministry for Primary Industries / 1st Floor	
	Location	023	Office
	Sample Number	X020/44655	
	Item / Position	Coating to concrete wall and column	
	Material	Textured coating	
	Extent (approx.)	2 m <sup>2</sup>	
	Product Type	-	-
	Condition	-	-
	Surface Treatment	-	-
	Asbestos Type	NAD	-
	Material Assessment	N/A	0
	Recommendation	No recommendation required

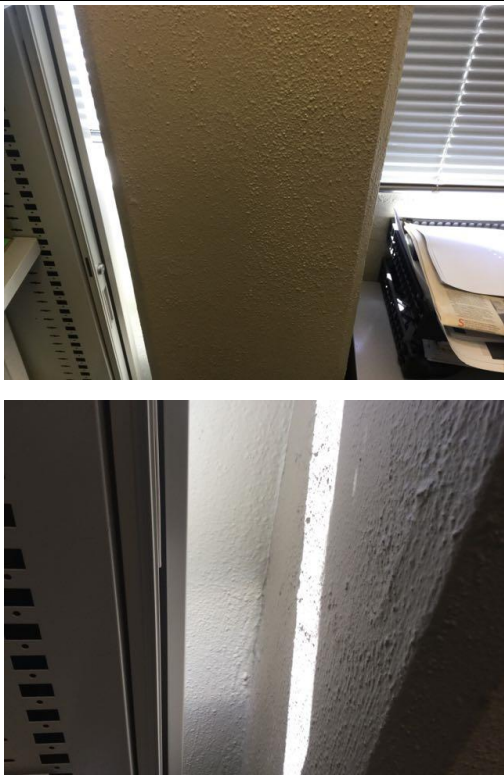
Building / Floor	Ministry for Primary Industries / 1st Floor	
	Location	024	Office
	Sample Number	X020/44655	
	Item / Position	Coating to concrete wall and column	
	Material	Textured coating	
	Extent (approx.)	2 m <sup>2</sup>	
	Product Type	-	-
	Condition	-	-
	Surface Treatment	-	-
	Asbestos Type	NAD	-
	Material Assessment	N/A	0
	Recommendation	No recommendation required

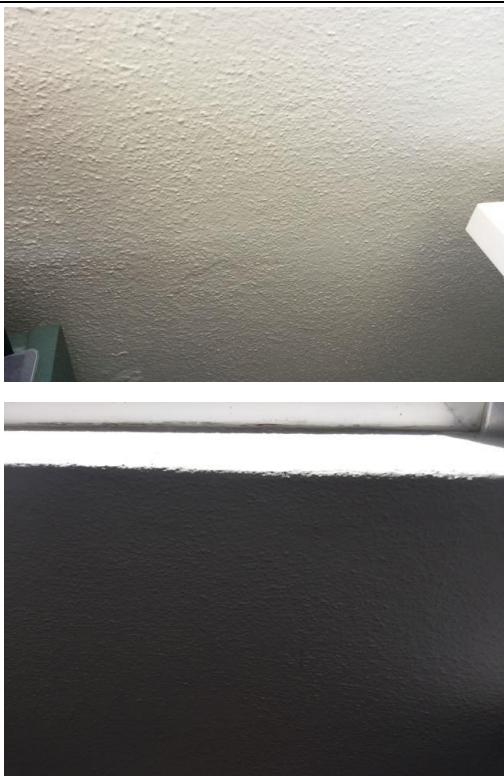
Building / Floor	Ministry for Primary Industries / 1st Floor	
	Location	025	Office
	Sample Number	X020/44655	
	Item / Position	Coating to concrete wall and column	
	Material	Textured coating	
	Extent (approx.)	8 m <sup>2</sup>	
	Product Type	-	-
	Condition	-	-
	Surface Treatment	-	-
	Asbestos Type	NAD	-
	Material Assessment	N/A	0
	Recommendation	No recommendation required

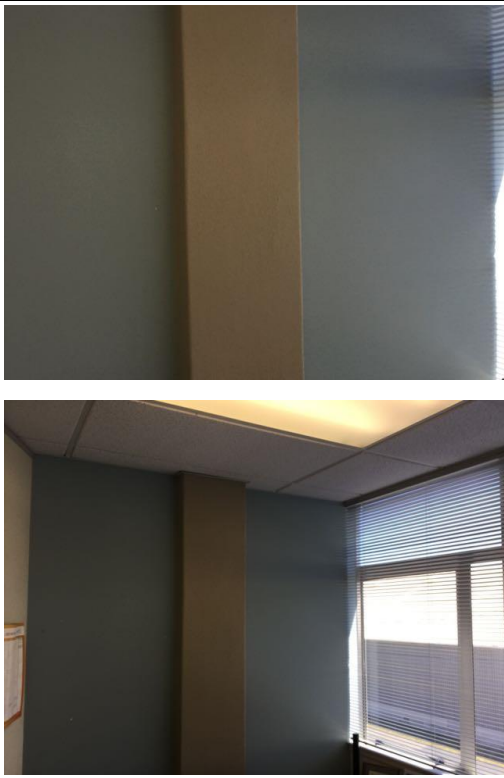
Building / Floor	Ministry for Primary Industries / 1st Floor	
	Location	028	Office
	Sample Number	X020/44655	
	Item / Position	Coating to concrete column	
	Material	Textured coating	
	Extent (approx.)	8 m <sup>2</sup>	
	Product Type	-	-
	Condition	-	-
	Surface Treatment	-	-
	Asbestos Type	NAD	-
	Material Assessment	N/A	0
	Recommendation	No recommendation required

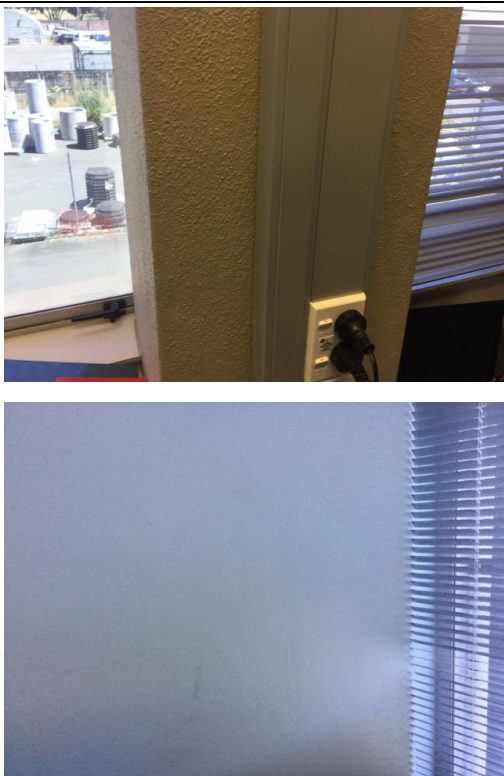
Building / Floor	Ministry for Primary Industries / 1st Floor	
	Location	029	Open plan office
	Sample Number	X020/44655	
	Item / Position	Coating to concrete column	
	Material	Textured coating	
	Extent (approx.)	8 m <sup>2</sup>	
	Product Type	-	-
	Condition	-	-
	Surface Treatment	-	-
	Asbestos Type	NAD	-
	Material Assessment	N/A	0
	Recommendation	No recommendation required

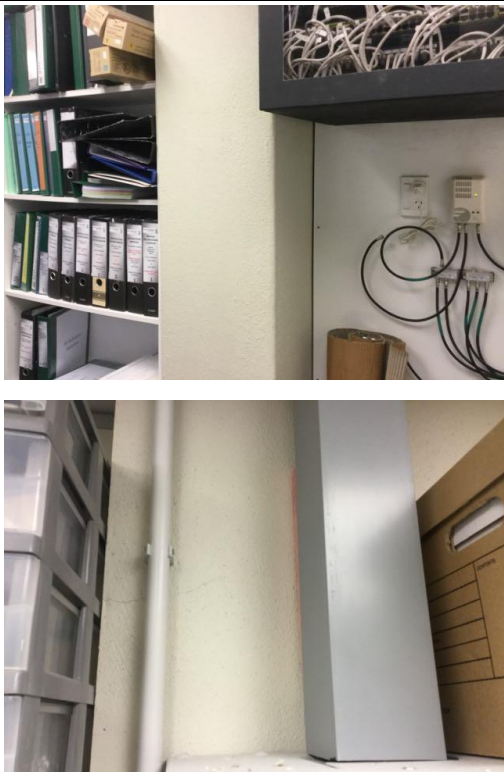
Building / Floor	Ministry for Primary Industries / 1st Floor	
	Location	032	Office
	Sample Number	X020/44655	
	Item / Position	Coating to concrete column	
	Material	Textured coating	
	Extent (approx.)	2 m <sup>2</sup>	
	Product Type	-	-
	Condition	-	-
	Surface Treatment	-	-
	Asbestos Type	NAD	-
	Material Assessment	N/A	0
	Recommendation	No recommendation required	
Comments

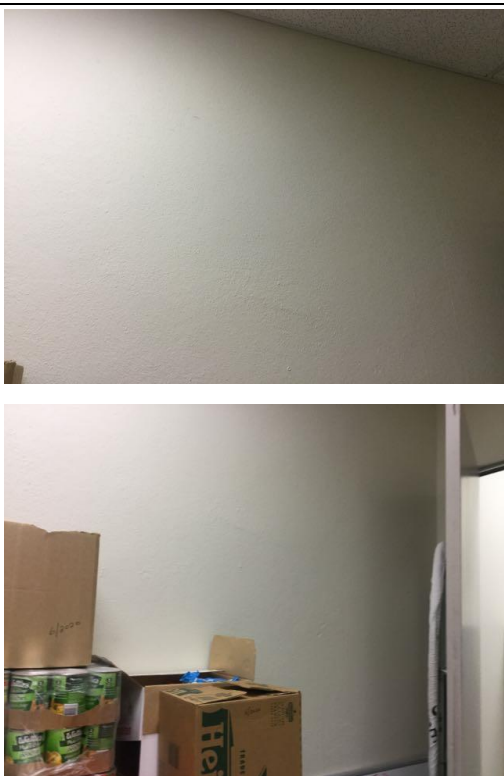
Building / Floor	Ministry for Primary Industries / Ground Floor	
	Location	039	Store
	Sample Number	X020/44655	
	Item / Position	Coating to concrete wall	
	Material	Textured coating	
	Extent (approx.)	4 m <sup>2</sup>	
	Product Type	-	-
	Condition	-	-
	Surface Treatment	-	-
	Asbestos Type	NAD	-
	Material Assessment	N/A	0
	Recommendation	No recommendation required	
Comments

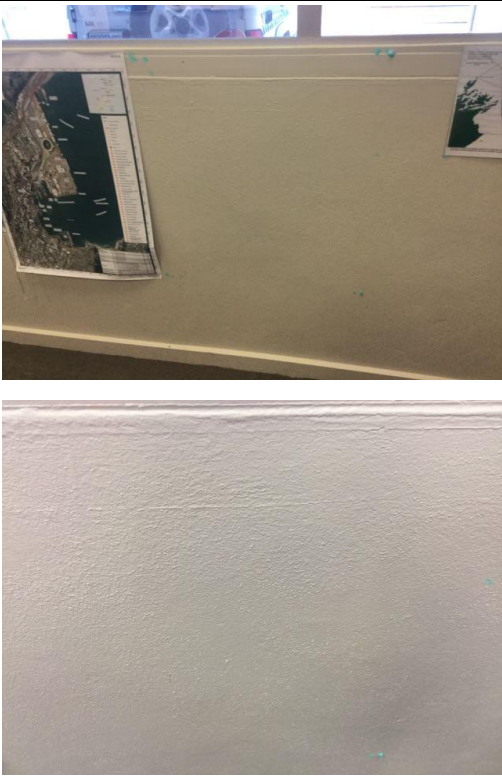
Building / Floor	Ministry for Primary Industries / Ground Floor	
	Location	042	Meeting room
	Sample Number	X020/44655	
	Item / Position	Coating to concrete wall	
	Material	Textured coating	
	Extent (approx.)	3 m <sup>2</sup>	
	Product Type	-	-
	Condition	-	-
	Surface Treatment	-	-
	Asbestos Type	NAD	-
	Material Assessment	N/A	0
	Recommendation	No recommendation required	
	Comments

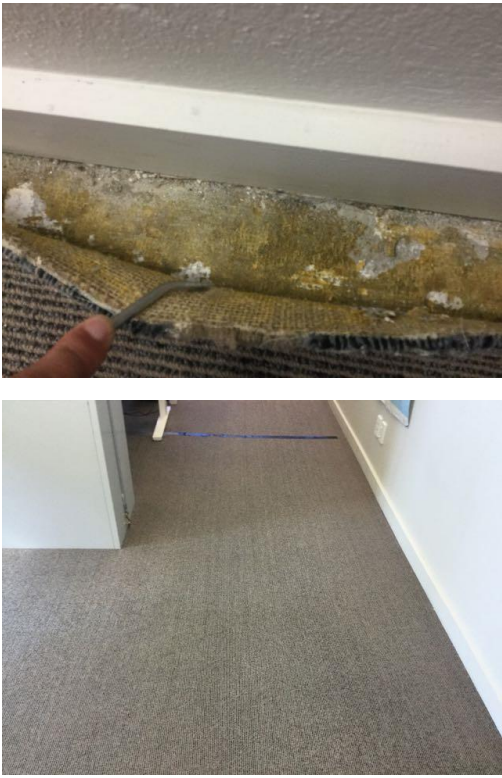
Building / Floor	Ministry for Primary Industries / Ground Floor	
	Location	043	Open plan office
	Sample Number	X006/44641	
	Item / Position	Coating beneath vinyl - Sporadically witnessed beneath the carpet.	
	Material	Levelling compound	
	Extent (approx.)	20 m <sup>2</sup>	
	Product Type	-	-
	Condition	-	-
	Surface Treatment	-	-
	Asbestos Type	NAD	-
	Material Assessment	N/A	0
	Recommendation	No recommendation required	
	Comments

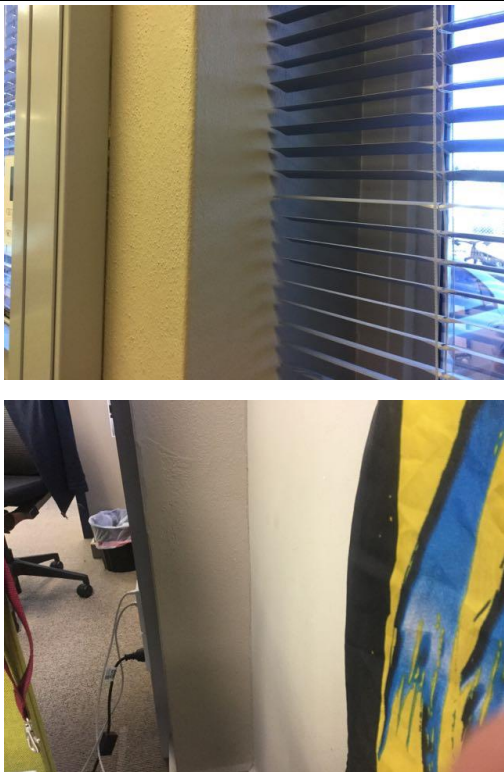
Building / Floor	Ministry for Primary Industries / Ground Floor	
	Location	043	Open plan office
	Sample Number	X020/44655	
	Item / Position	Coating to concrete column	
	Material	Textured coating	
	Extent (approx.)	6 m <sup>2</sup>	
	Product Type	-	-
	Condition	-	-
	Surface Treatment	-	-
	Asbestos Type	NAD	-
	Material Assessment	N/A	0
	Recommendation	No recommendation required	
Comments

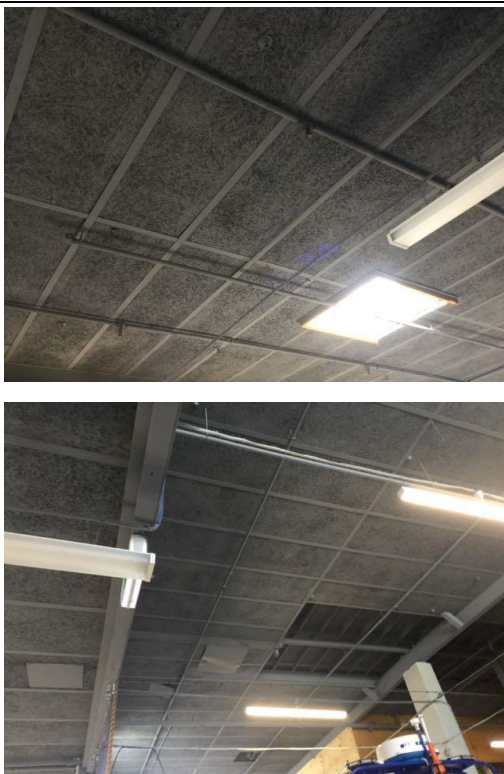
Building / Floor	Ministry for Primary Industries / Ground Floor	
	Location	044	Garage
	Sample Number	X024/44659	
	Item / Position	Strawboard ceiling panels	
	Material	Insulation board	
	Extent (approx.)	325 m <sup>2</sup>	
	Product Type	-	-
	Condition	-	-
	Surface Treatment	-	-
	Asbestos Type	NAD	-
	Material Assessment	N/A	0
	Recommendation	No recommendation required	
Comments
