PROJECT: Clip n Climb EQ Strengthening and Extension  
FILE No: 16175CC  
DATE: 04 November 2016  
SHEET: 1 of 1

## Proposed EQ Strengthening and Office Extension 80 Byron St Fire Strategy Report

**Issue B: Consent**  
**November 2016**  
**Reference: 16175CC**

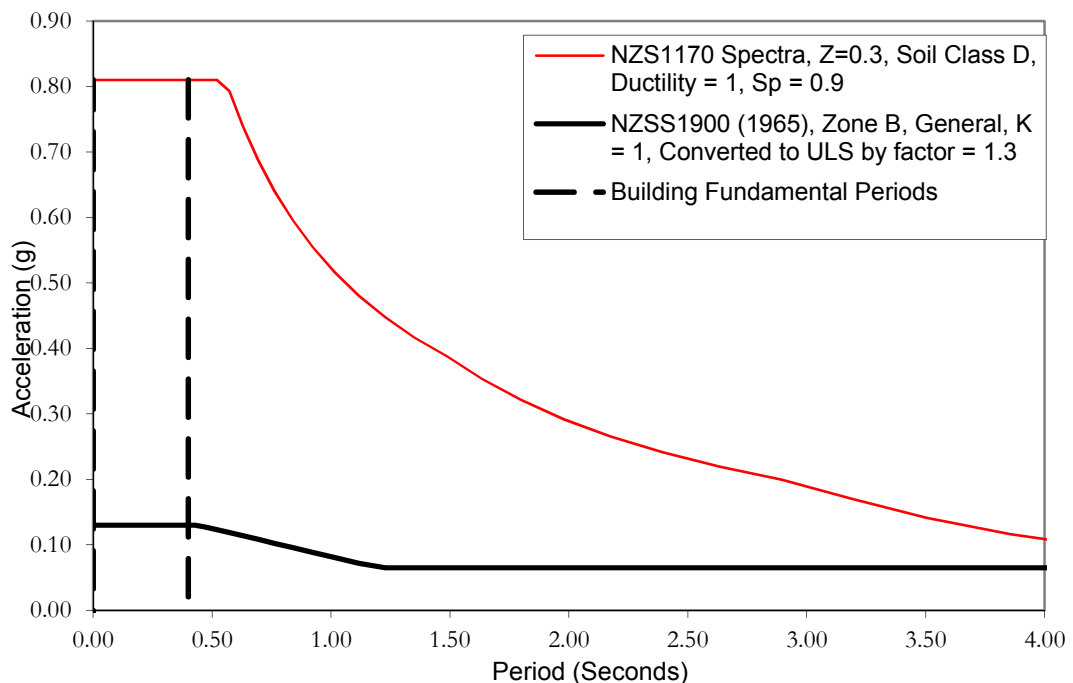
Figure 3-6: Comparison of Design Codes (NZSS1900 to NZS1170)

Comparisons of the load levels represented by the original loading standards to the current loading standard are plotted below for a building fundamental period of 0.4s. The seismic design loads from NZS1900:1965 are approximately 15% of current design loads. Seismic loads from NZS4203(1984) are approximately 35% of current design loads.

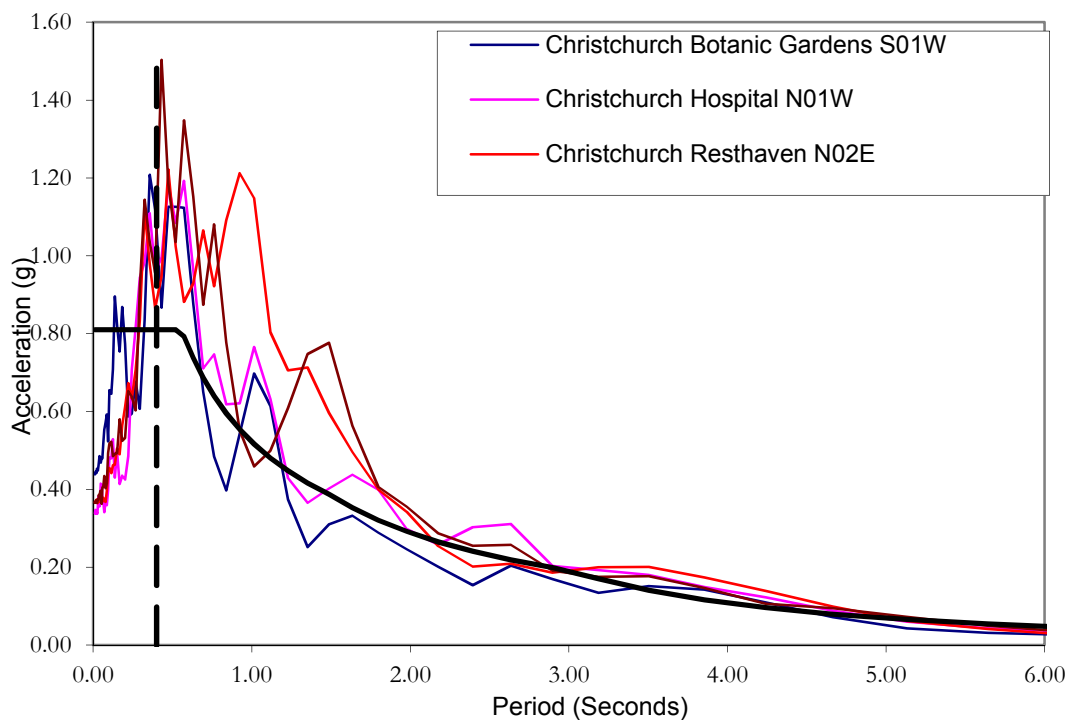
Figure 4-2: 5% Damped Spectra – North-South

It is apparent that in both directions there is significant variation in the shaking experienced at the different monitoring sites. This is due to the highly variable ground conditions around Christchurch.

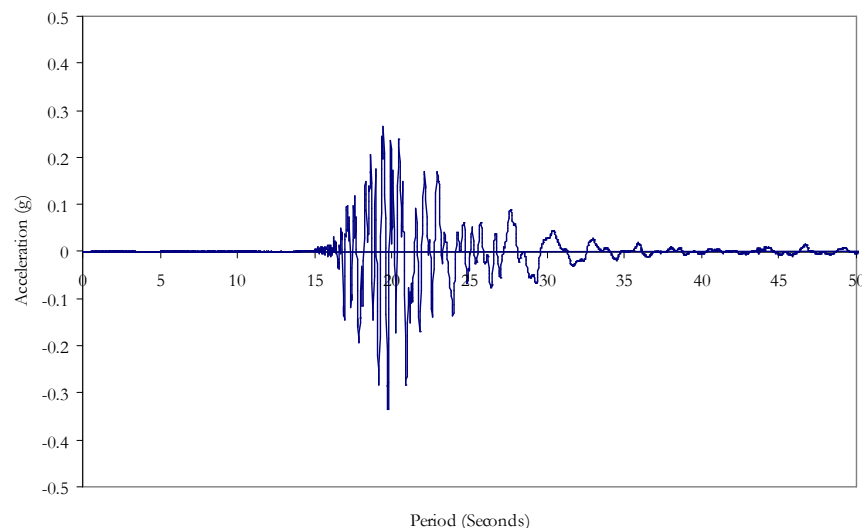
Figure 4-4: Earthquake Record from Christchurch Hospital Site

However it should also be noted that this earthquake was relatively short in terms of the strong shaking produced. The following plot of the earthquake record from the Christchurch Hospital monitoring station at 12:51 pm on the 22<sup>nd</sup> of February shows that the strong motion only lasted for a duration of approximately 5-10 seconds.

Because of this the building has only gone through a limited number of inelastic cycles. A full design earthquake for Christchurch (eg rupture of the Alpine Fault) is expected to have a significantly longer record of shaking, although the accelerations are not expected to be as strong. As an indication, rupture of the Alpine Fault is expected to contain in excess of 60 seconds of strong motion.
