re: ALDAN LODGE, WELLINGTON STREET, PICTON (BC: 011291)

ALDAN LODGE
 STORMWATER INVESTIGATION
 PICTON.

Building Consent No. 011291

Foundation inspection, two new motel units

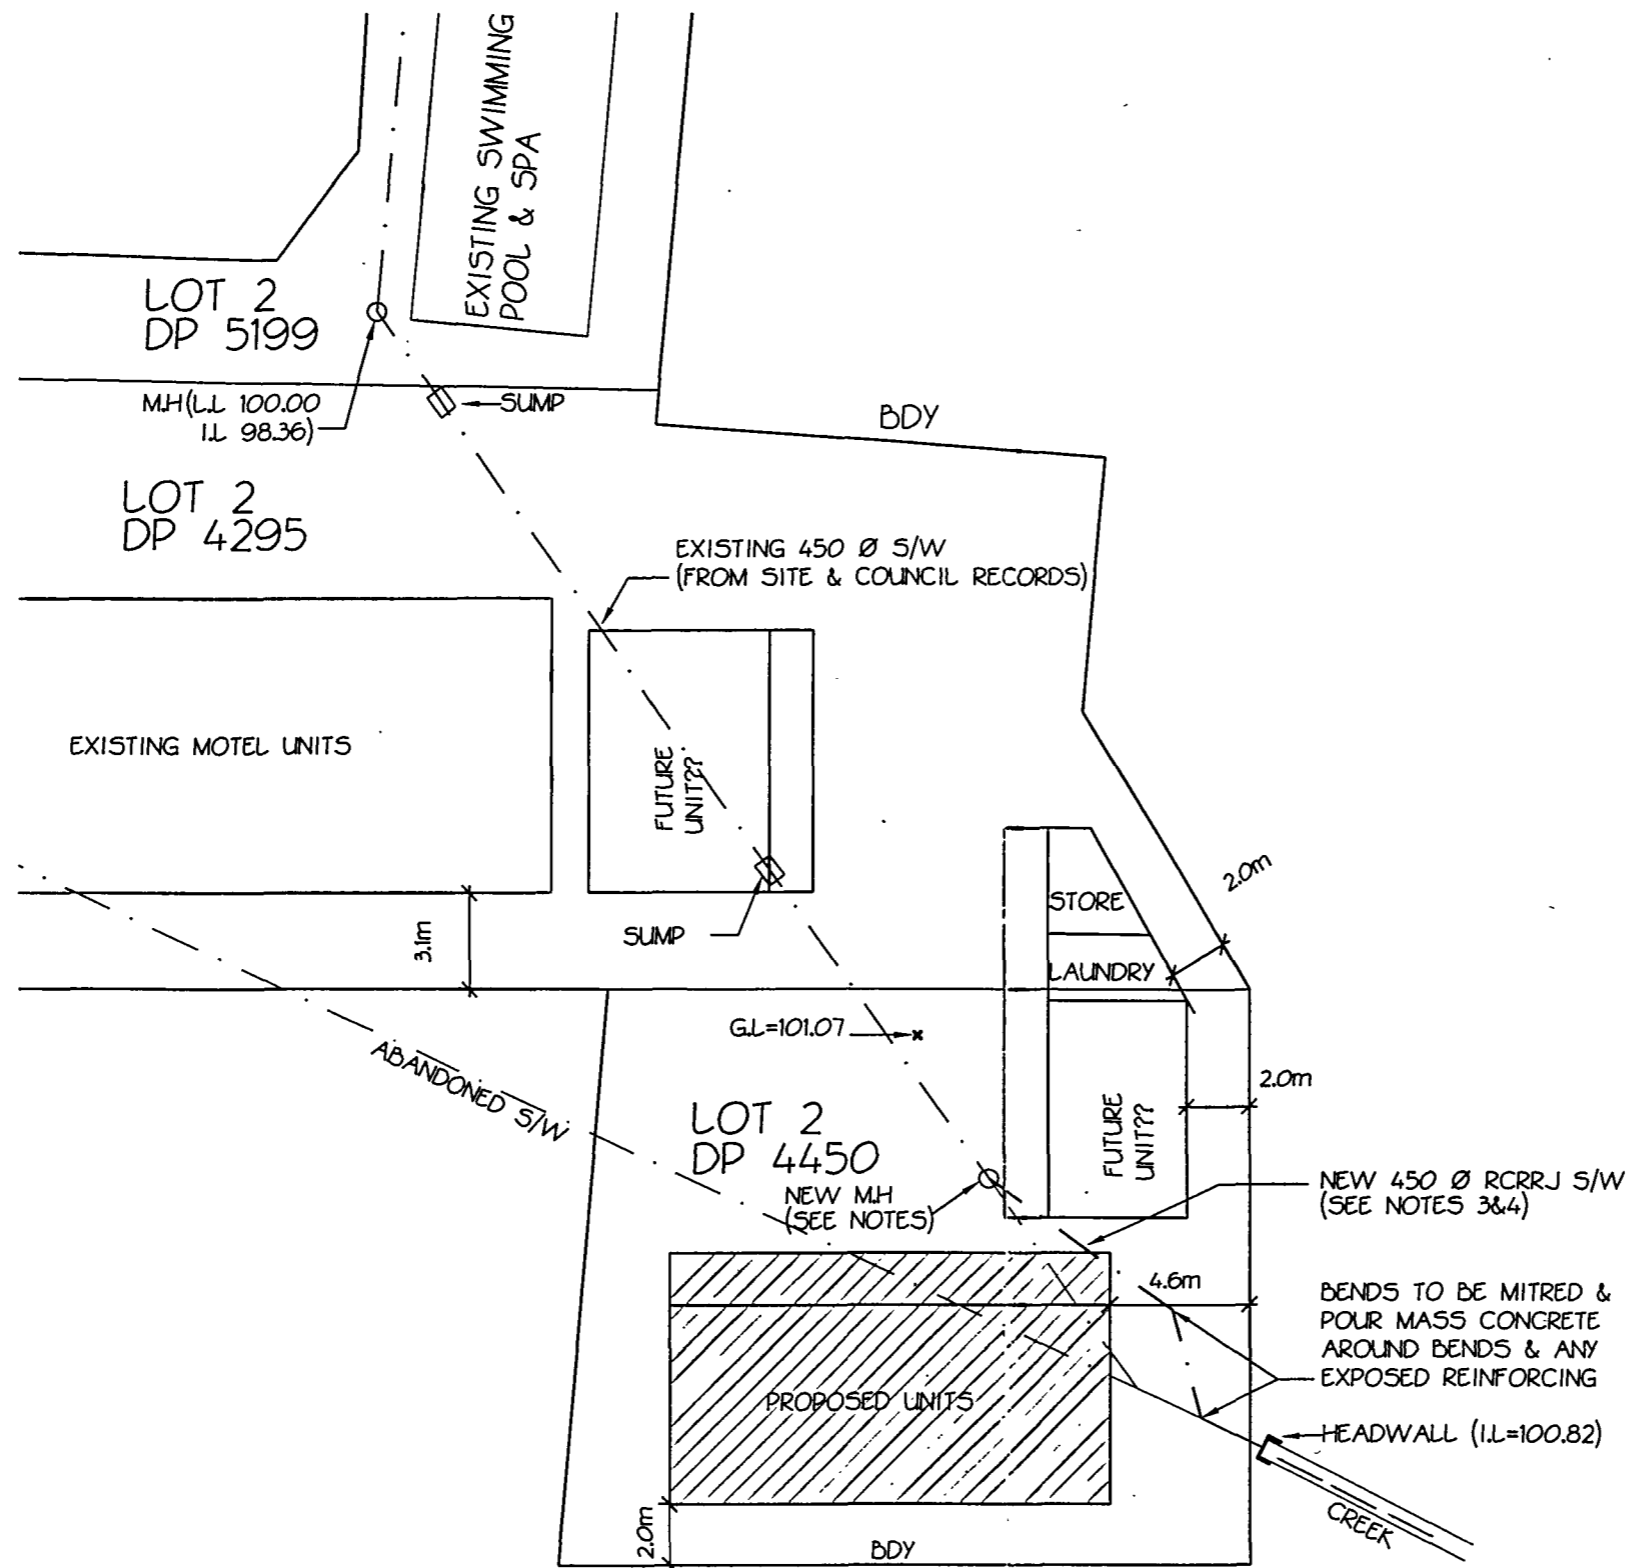
SITE PLAN
 1:250

Please find attached three copies of plan number 22040/S1 showing the proposed work to the existing 450 mm diameter stormwater culvert to avoid passing under the building.

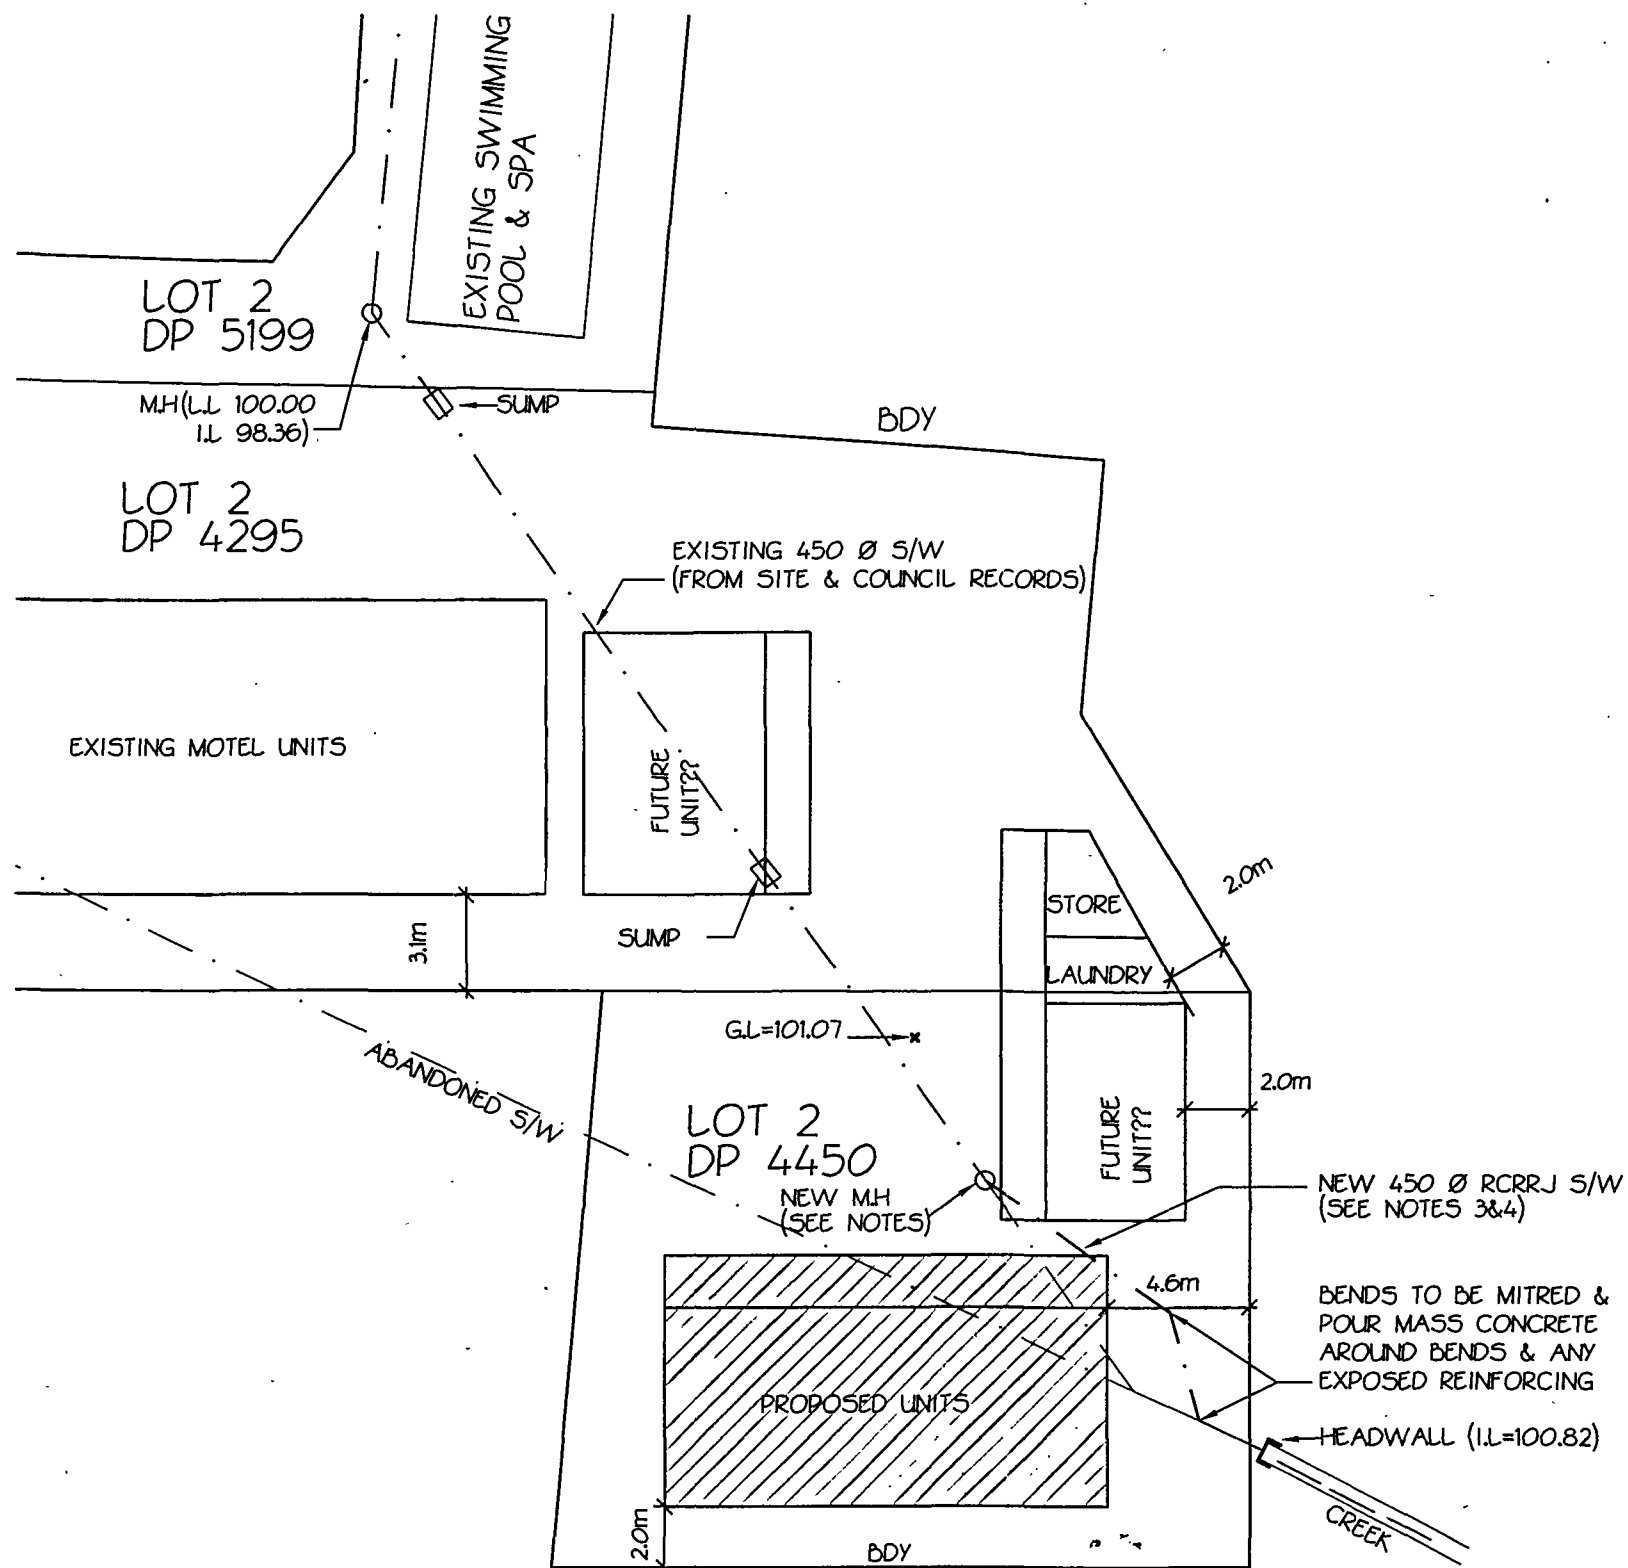
SITE PLAN
 1:250

10/10/01
Kerry Walsh has approved this drainage amendment.
