433 PUKEHINA PARADE EASTERN

Land Information Memorandum

Repair No. 1 – Laundry bulkhead

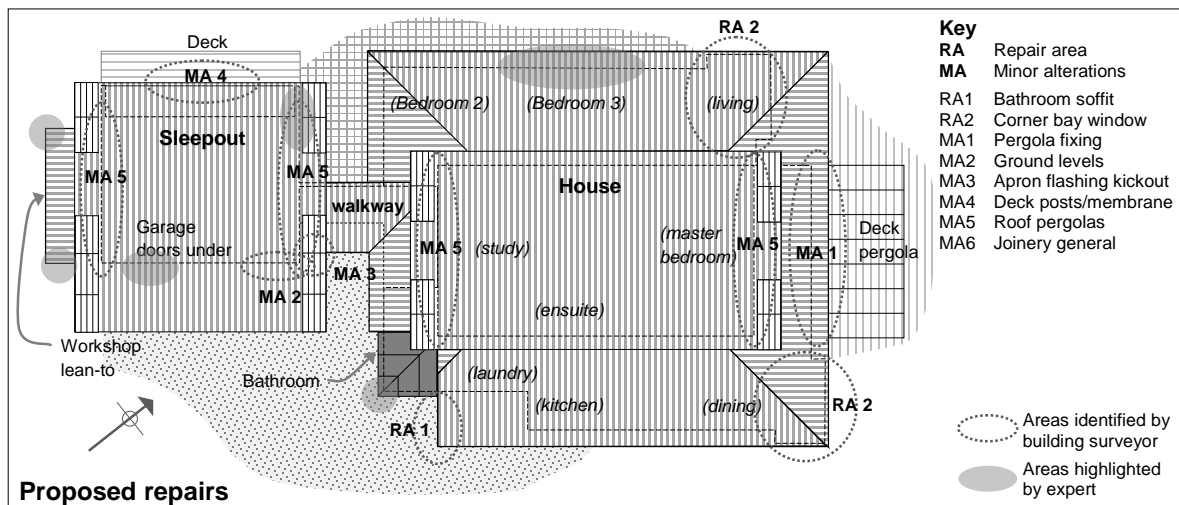
Figure 2: Locations of proposed repairs (not to scale)

2.6 The proposed cladding repairs described in paragraph 3.6 are shown in Figure 2

Areas of repair (see Figure 2)		Expert's comments	Expert's conclusion
RA1	Laundry soffit framing	<ul style="list-style-type: none"> • Lower plywood proud of upper • Framing to clad end of soffit decayed • No visible sign of damage to lower walls, but framing needs to be exposed to check 	Scope of proposed repair sufficient to address defect, but further investigation of the framing below the bulkhead is required to check for damage
RA2	Corner bay windows	<ul style="list-style-type: none"> • Cladding removed to expose framing • Framing below north window decayed • Framing below east window stained • No metal flashing under corner cladding • Battens were in poor condition, with tops exposed to rain penetration • Sill flashing detail still exposes batten tops • (I also note battens lack weathergrooves) 	Proposed details insufficient Further bay window and corner details required
MA1	Pergola to NE deck	<ul style="list-style-type: none"> • Pergola plate now spaced off cladding 	Satisfactory

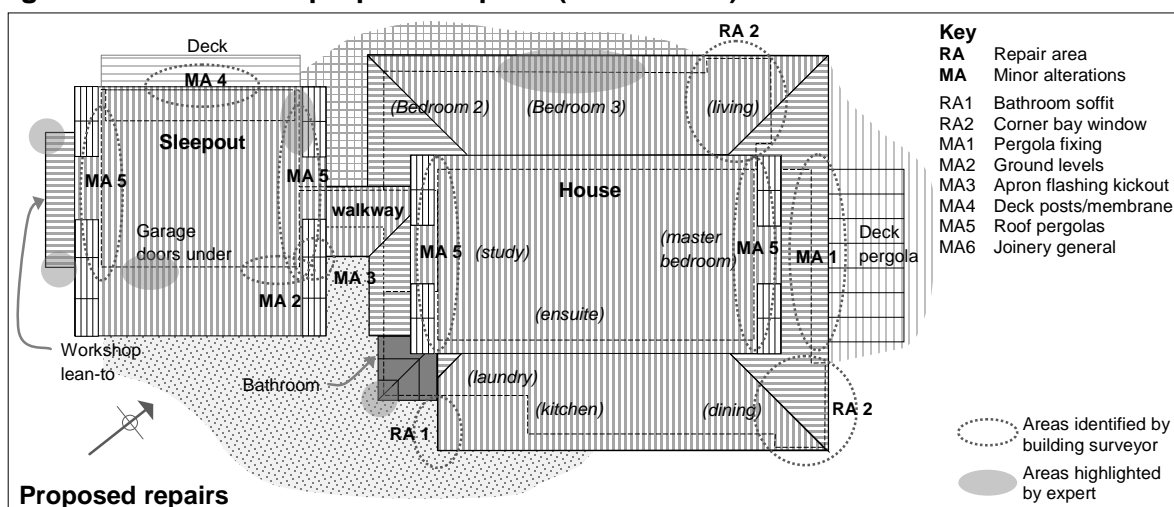
Figure 2: Locations of proposed repairs (not to scale)

2.6 The proposed cladding repairs described in paragraph 3.6 are shown in Figure 2

Areas of repair (see Figure 2)		Expert's comments	Expert's conclusion
RA1	Laundry soffit framing	<ul style="list-style-type: none"> Lower plywood proud of upper Framing to clad end of soffit decayed No visible sign of damage to lower walls, but framing needs to be exposed to check 	Scope of proposed repair sufficient to address defect, but further investigation of the framing below the bulkhead is required to check for damage
RA2	Corner bay windows	<ul style="list-style-type: none"> Cladding removed to expose framing Framing below north window decayed Framing below east window stained No metal flashing under corner cladding Battens were in poor condition, with tops exposed to rain penetration Sill flashing detail still exposes batten tops (I also note battens lack weathergrooves) 	Proposed details insufficient Further bay window and corner details required
MA1	Pergola to NE deck	<ul style="list-style-type: none"> Pergola plate now spaced off cladding 	Satisfactory

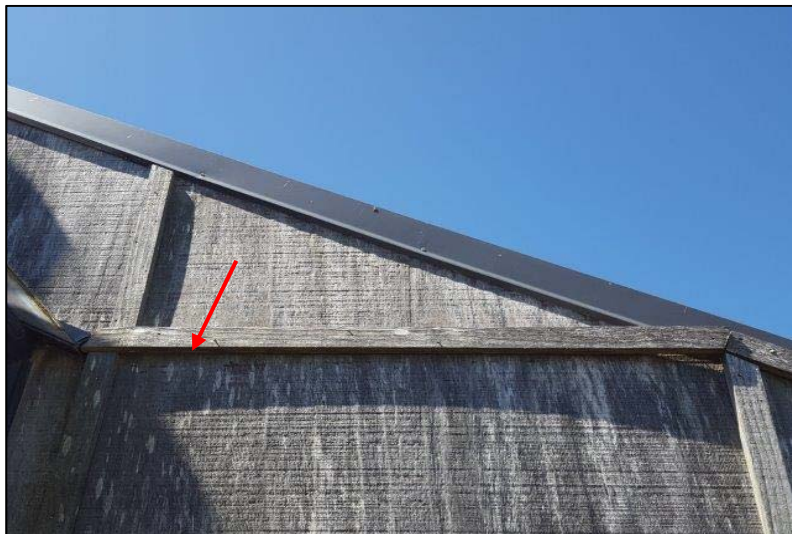
Photo 2: Laundry bulkhead on SW elevation. The plywood cladding has been poorly installed, with the lower cladding sitting proud of the upper cladding, allowing water penetration, refer next photo for view inside bulkhead

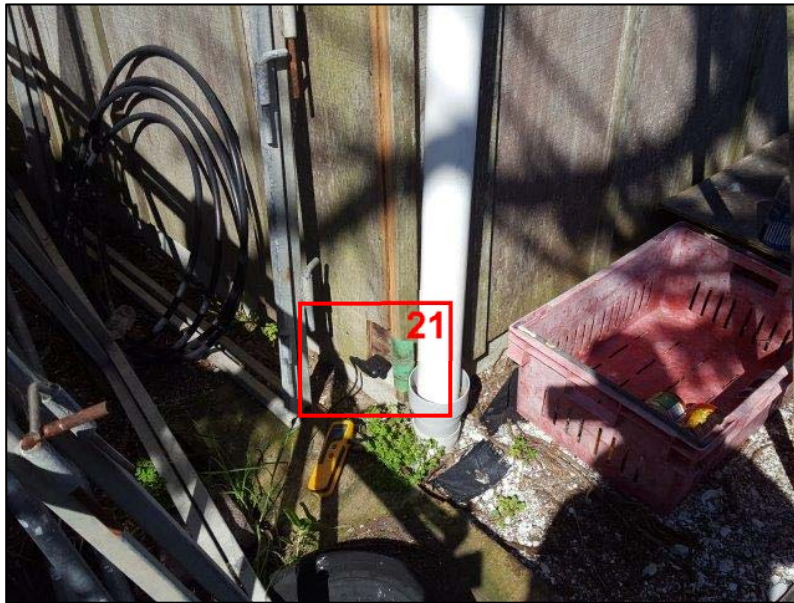
Photo 19: External corner junction at bottom plate, west corner of workshop. Refer following photo

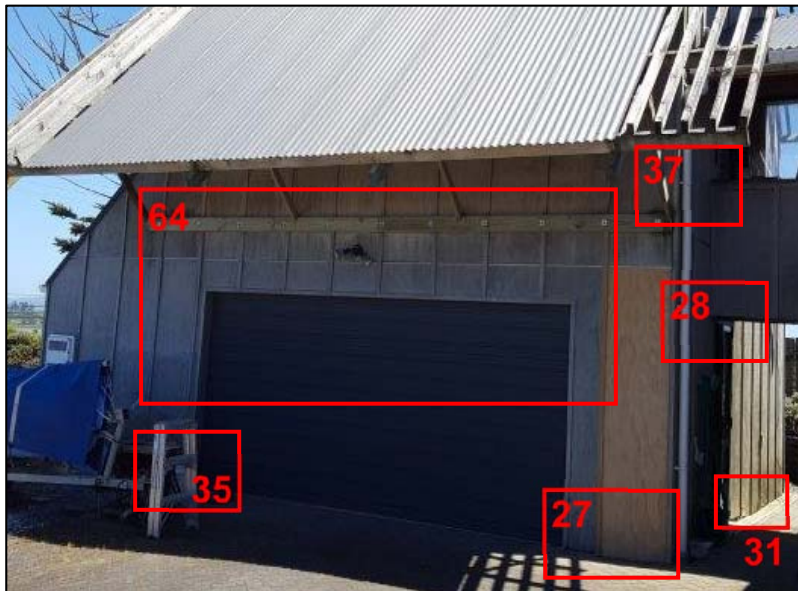
Photo 26: Garage SE elevation. Refer following indicated photos

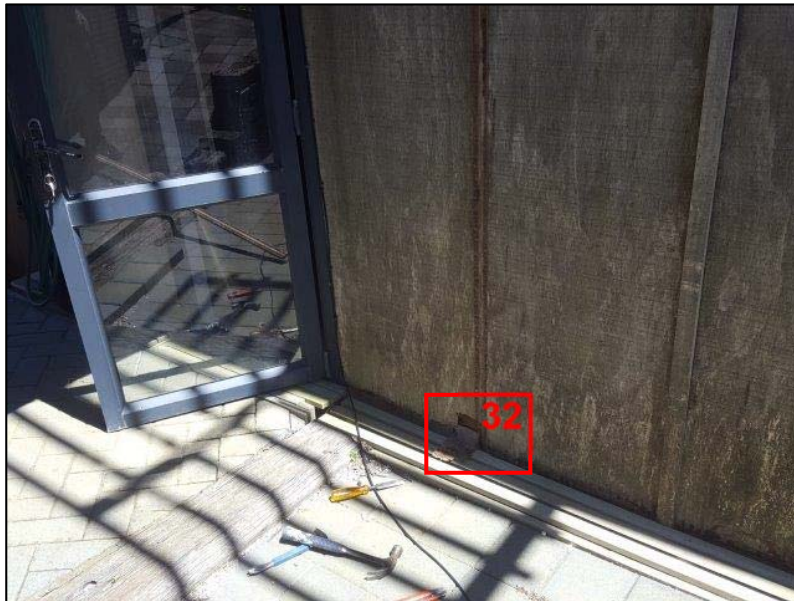
The cladding further along the garage NE elevation also appeared to be at risk due to minimal ground clearance. A small cladding cutout was made at bottom plate level, exposing visible decay to the bottom plate framing and the rear face of the cladding (photos 31-33). The Ecoply technical manual in 1999 stated that H3 treated plywood is not ground contact treated and must be kept at least 150mm away from ground contact. The cladding adjacent to the garage vehicle door is also in contact with unfinished ground (photo 35). The ground clearances in various locations

Photo 31: Cladding cutout at bottom plate on garage NE elevation. Refer photo 26 for location and next photo for cutout

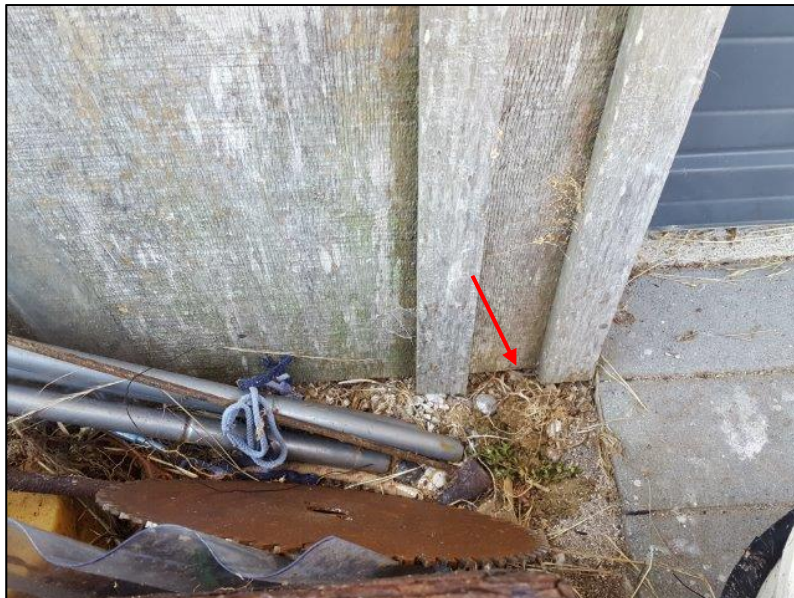
Photo 35: Cladding adjacent to garage door is in contact with unfinished ground. Refer Dodd drawings for planned remediation (Minor Alterations 2) and photo 26 for location

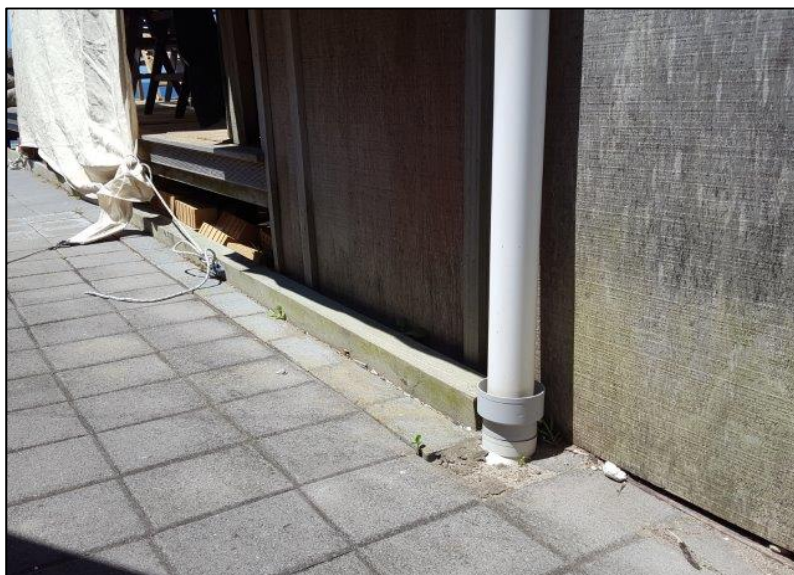
Photo 36: Minimal ground clearances on rear NW house elevation. Refer Dodd drawings for planned remediation (Minor Alterations 2)

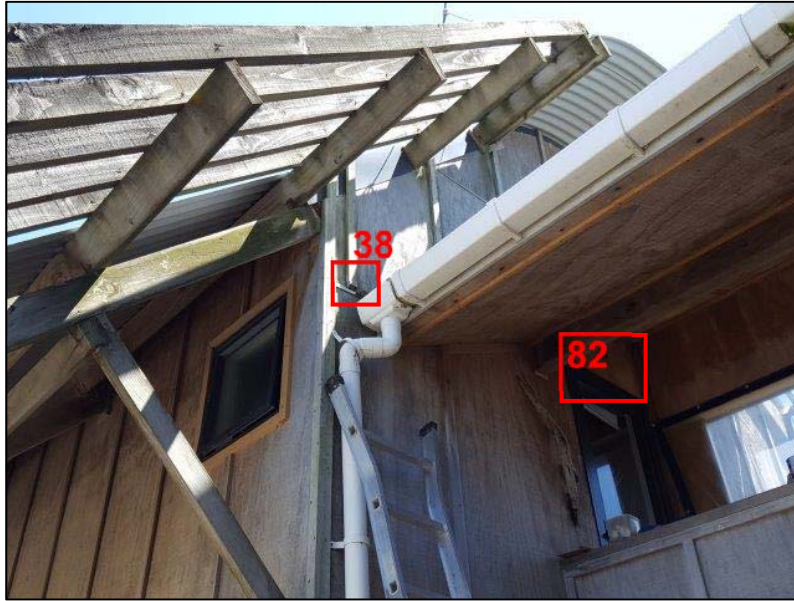
Photo 37: East corner of sleepout.
Refer next photo for closeup of apron flashing termination

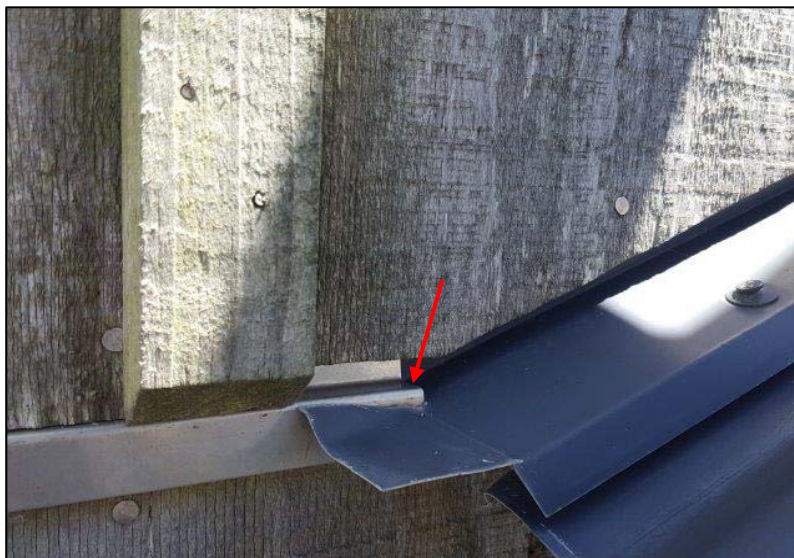
Photo 38: End of apron flashing terminates behind horizontal flashing. No kickout flashing is installed. Refer Dodd drawings for planned remediation (Minor Alterations 3)

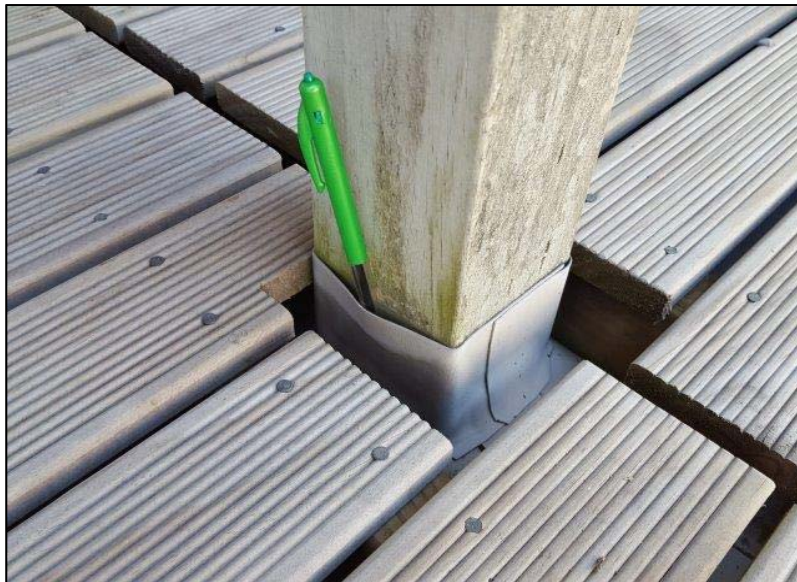
Photo 41: Unsealed butyl rubber turnup at verandah post. Refer Dodd drawings for planned remediation (Minor Alterations 4). Refer following photo with floating decking lifted

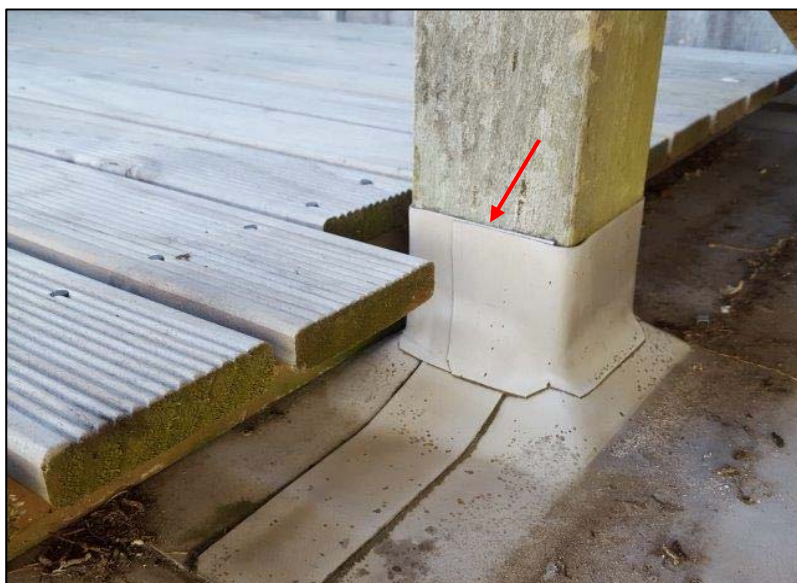
Photo 42: Butyl deck cladding appears to be reasonably well detailed apart from the unsealed turnup

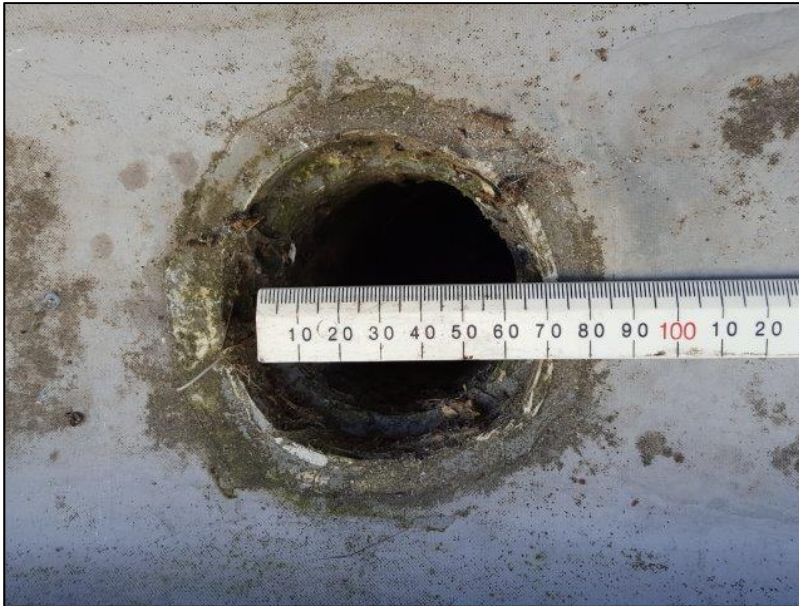
Photo 43: 65mm diameter deck outlet. No overflow is installed, but is not considered necessary, refer next photo

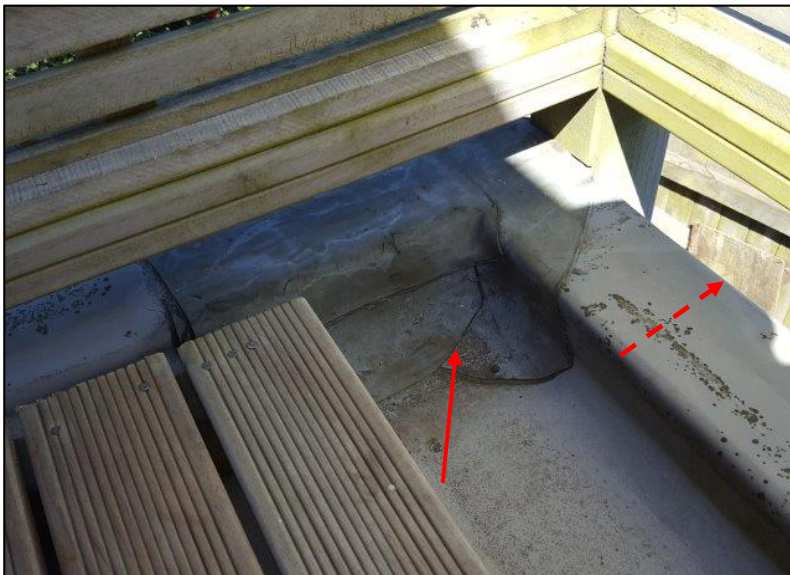
Photo 44: Butyl rubber deck cladding appears to be reasonably well detailed at west corner. No overflow is installed, but is not considered necessary, as any overrun will be to the exterior over the fully waterproofed nib upstands

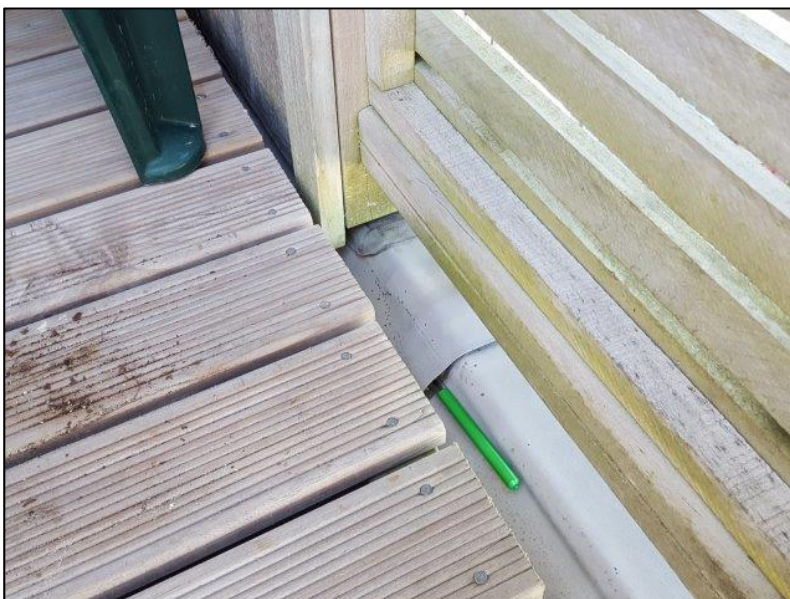
Photo 45: Butyl rubber deck cladding needs sealing on SW elevation. Refer Dodd drawings for planned remediation (Minor Alterations 4).

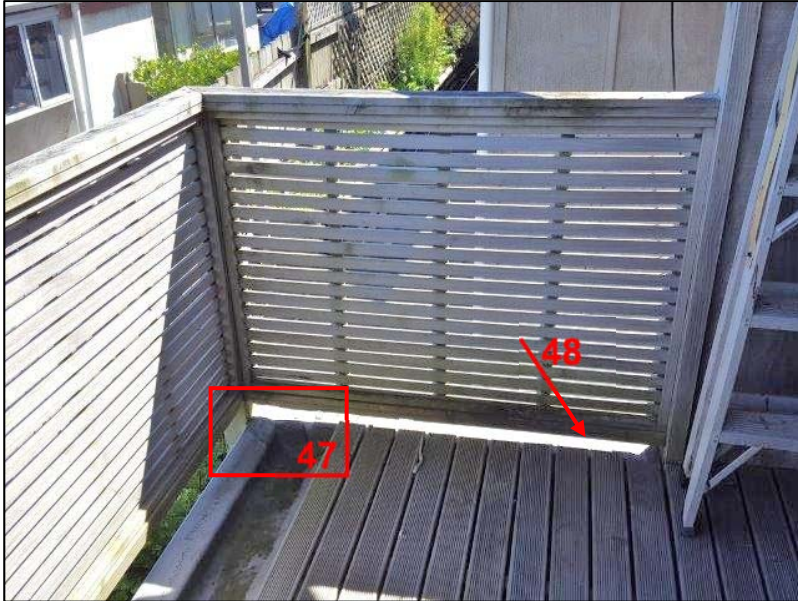
Photo 46: North end of deck. Refer indicated photos below

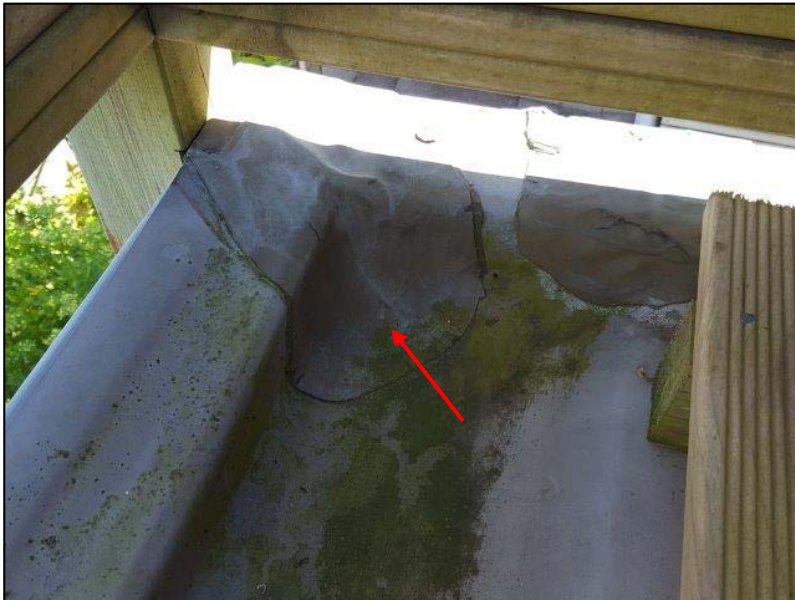
Photo 47: Butyl rubber deck cladding appears to be reasonably well detailed at north corner

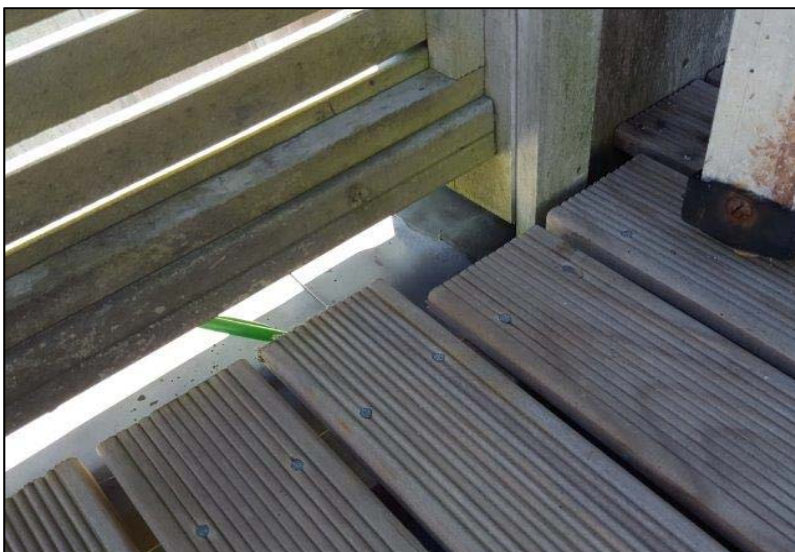
Photo 48: Butyl rubber deck cladding needs sealing on SW elevation (location indicated by pen). Refer Dodd drawings for planned remediation (Minor Alterations 4).

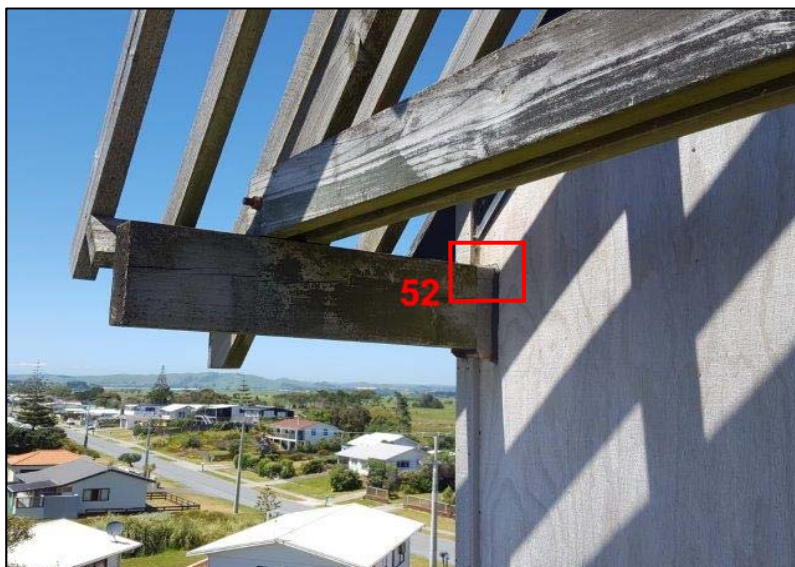
Photo 51: Typical beam penetration through gable cladding. Refer closeup of junction in next photo

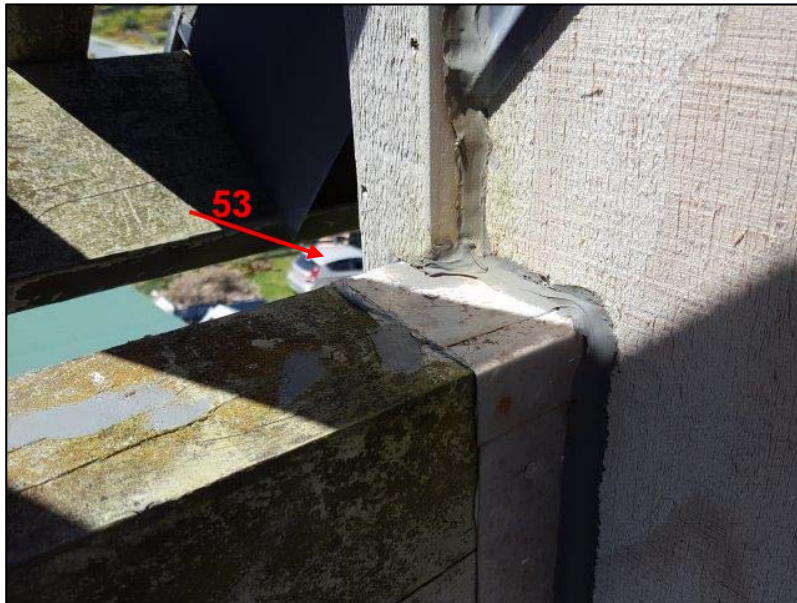
Photo 52: Vulnerable cladding penetration junction at east corner of master bedroom (typical). Refer next photo for view of other side of junction. Refer Dodd drawings for planned remediation (Minor Alterations 5)

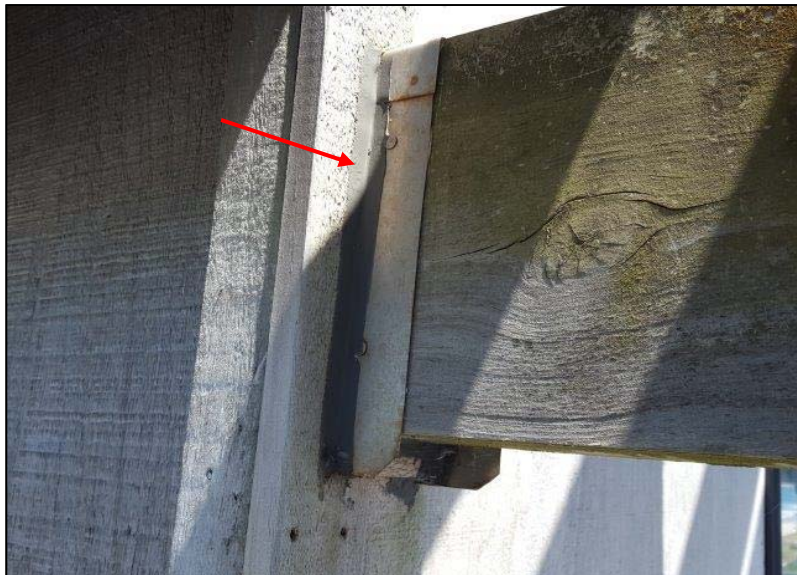
Photo 53: View of vulnerable beam penetration junction

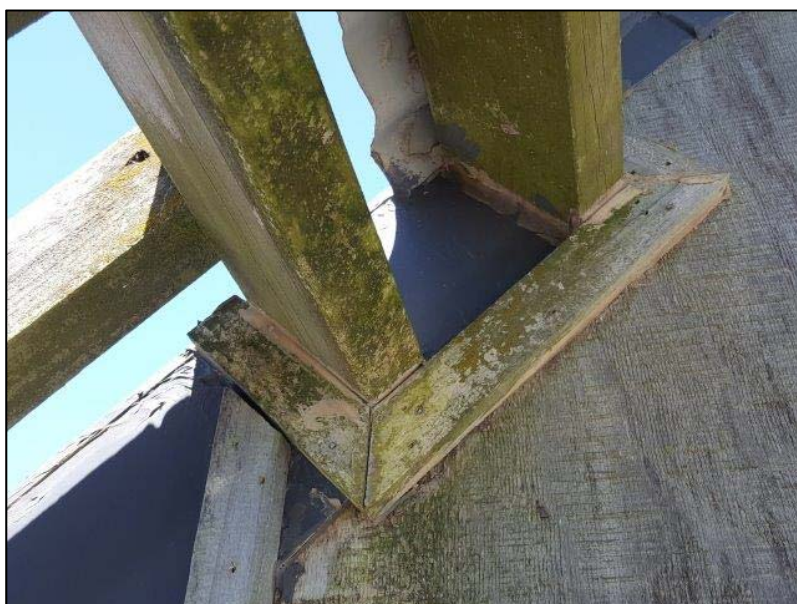
Photo 54: Vulnerable double cladding penetration junctions above master bedroom. Refer Dodd drawings for planned remediation (Minor Alterations 5)

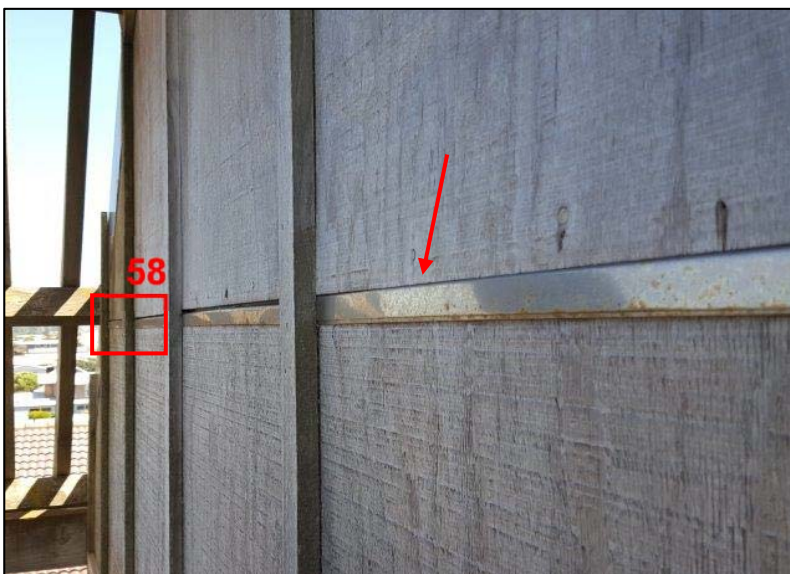
Photo 57: The plywood cladding is finished hard down on the metal horizontal flashings in some locations, which does not comply with the manufacturer's instructions. Also refer next photo

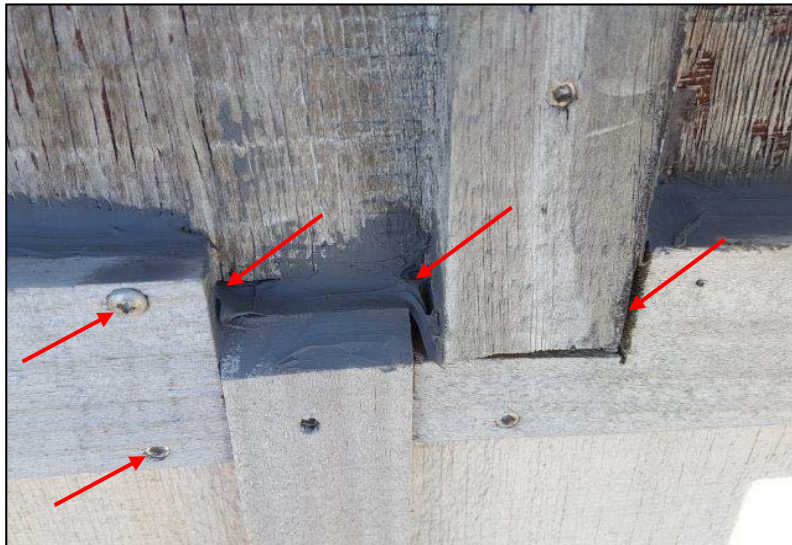
Photo 61: Battens have been fixed over horizontal metal flashing (assumed) to upper and lower cladding sheets and sealant has been poorly applied, restricting sheet expansion and reducing drainage away from the joint.

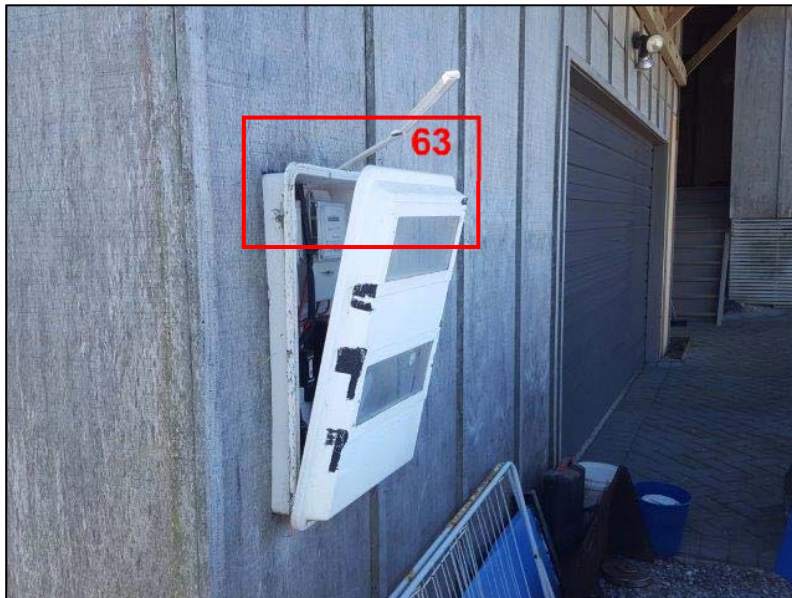
Photo 62: Meterbox on SE garage elevation. Refer to closeup in next photo

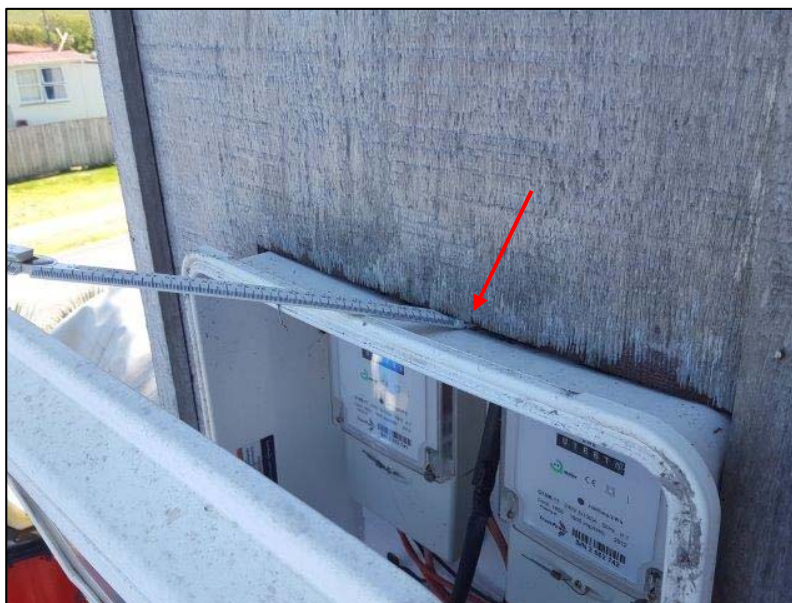
Photo 63: No flashings installed around meter box – rule penetrates into workshop

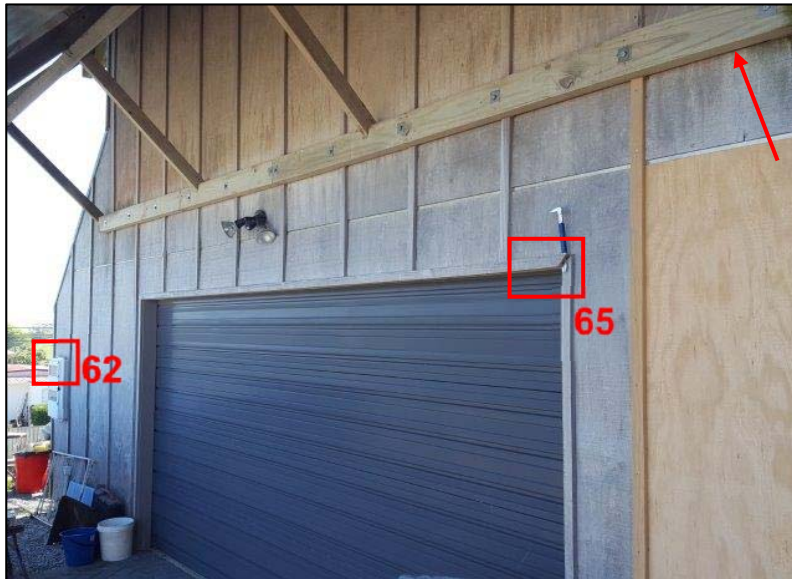
Photo 25: The pergola on the NE beach elevation has been spaced off the cladding as per the Dodd drawings (Minor Alterations 1, photo 25). The pergola on the SE garage elevation has also been spaced off the cladding, but is in any case well protected by the wide roof eaves over the garage door area (photo 64). The undertaken work has addressed the defect.

Photo 64: SE garage elevation. Pergola (indicated) has been spaced off cladding. Refer head flashing closeup in next photo, and general elevation on photo 26

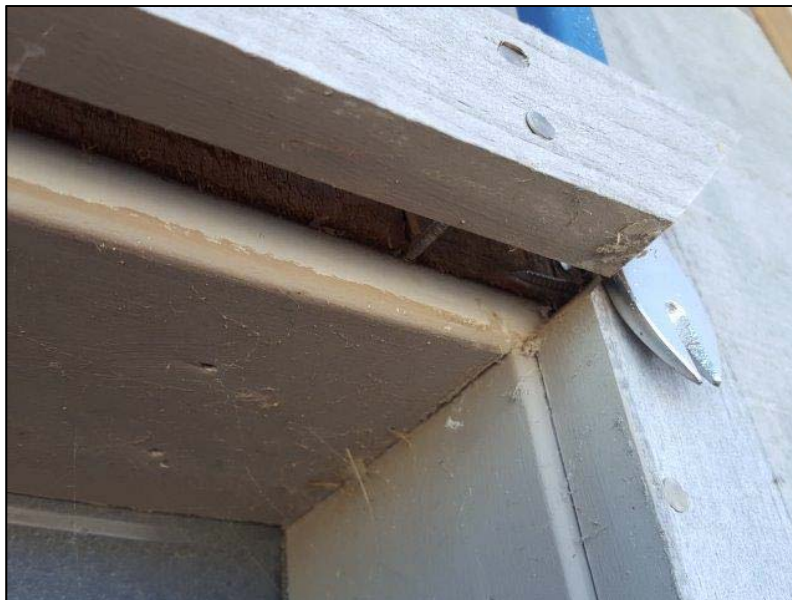
Photo 65: No head flashing has been installed to garage door head. Not considered a weathertightness risk with wide canopy protection overhead

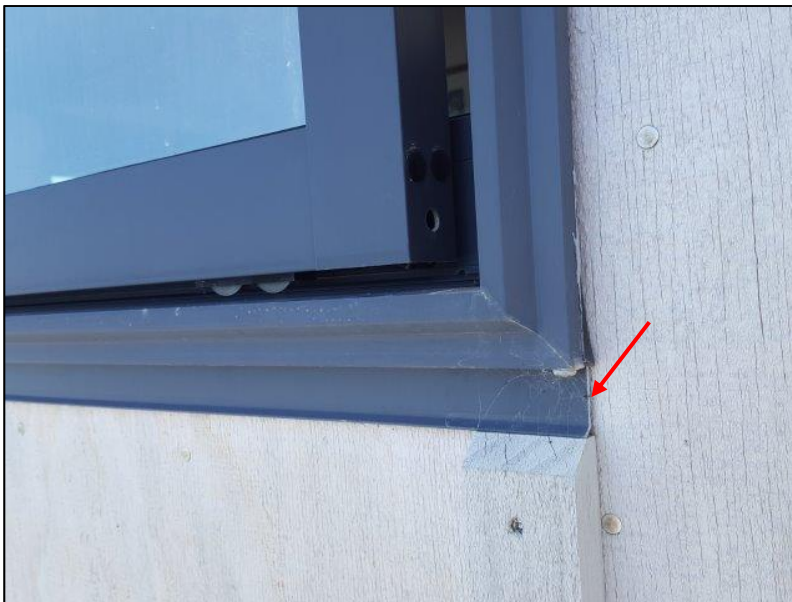
Photo 68: Sill flashing has been installed to master bedroom window

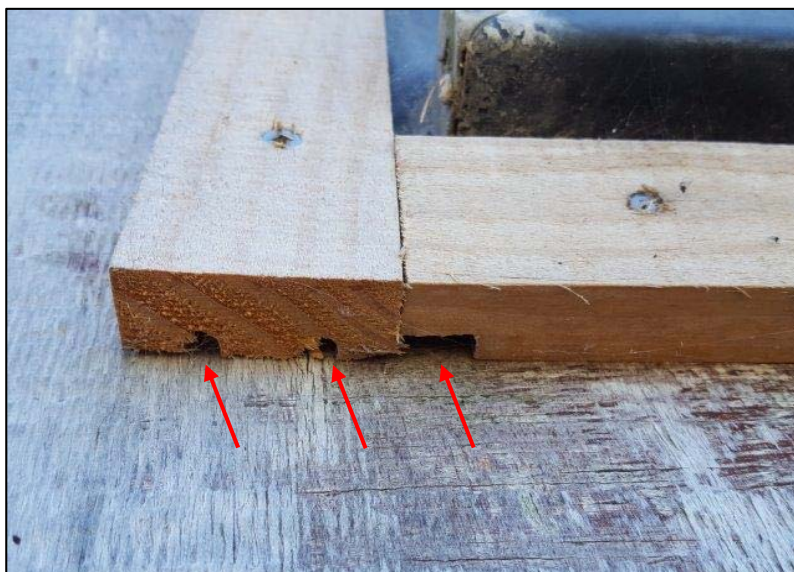
Photo 72: View from below new jamb and sill trim. Jamb trim has rebated grooves. Rear face of end of sill trim has been rebated by builder prior to installation. Refer following photos for typical view behind trim

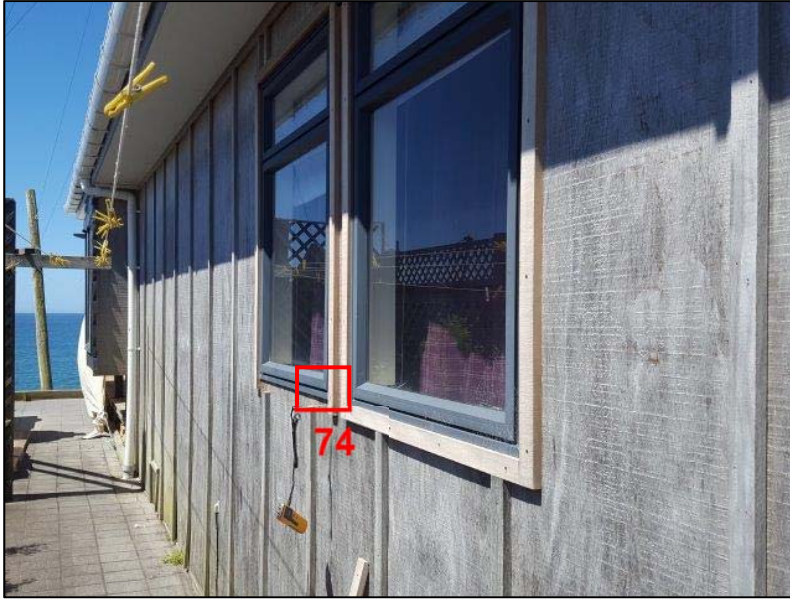
Photo 73: Bedroom window on rear NW elevation. Refer indicated photo below

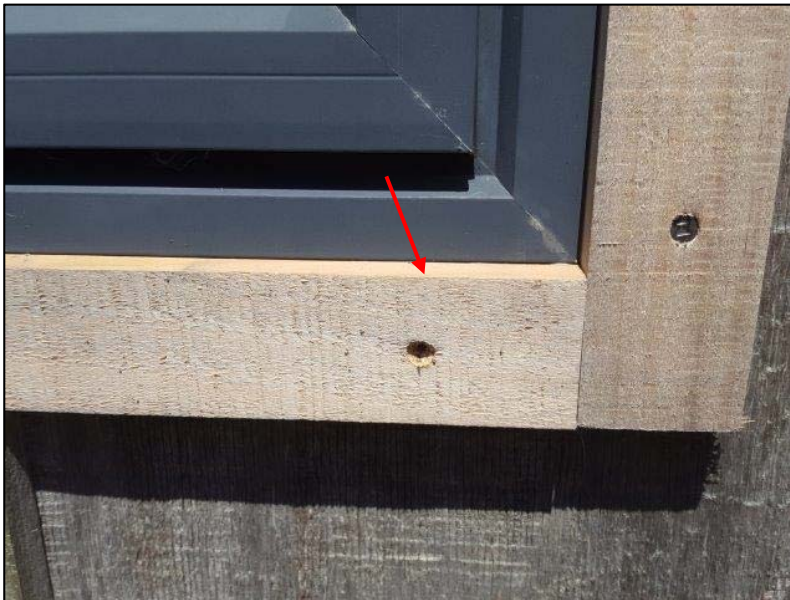
Photo 74: Sill trim with flat top surface. Refer next photo

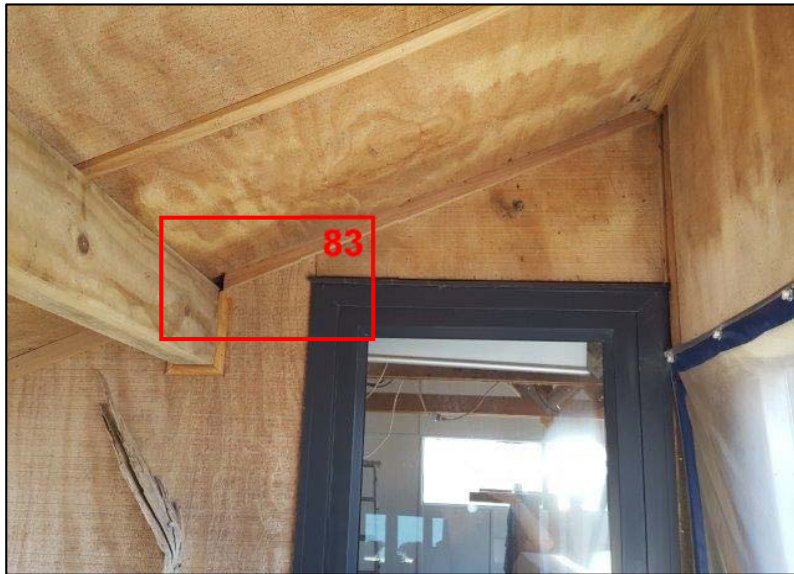
Photo 82: Sleepout entry on NE elevation above garage. Refer indicated closeup in next photo

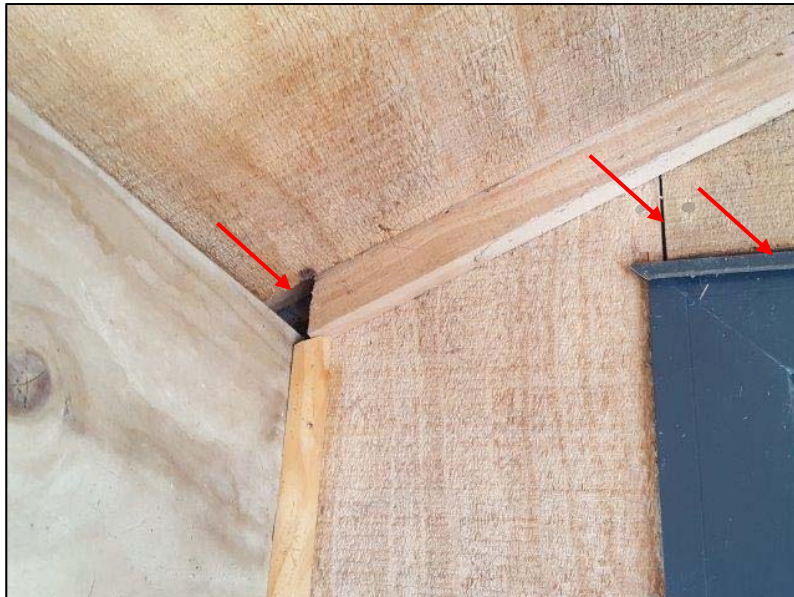
Photo 83: Head flashing is installed over sleepout door. No trim is installed over vertical junction above head flashing. End of soffit trim is poorly finished, leaving gap at beam junction

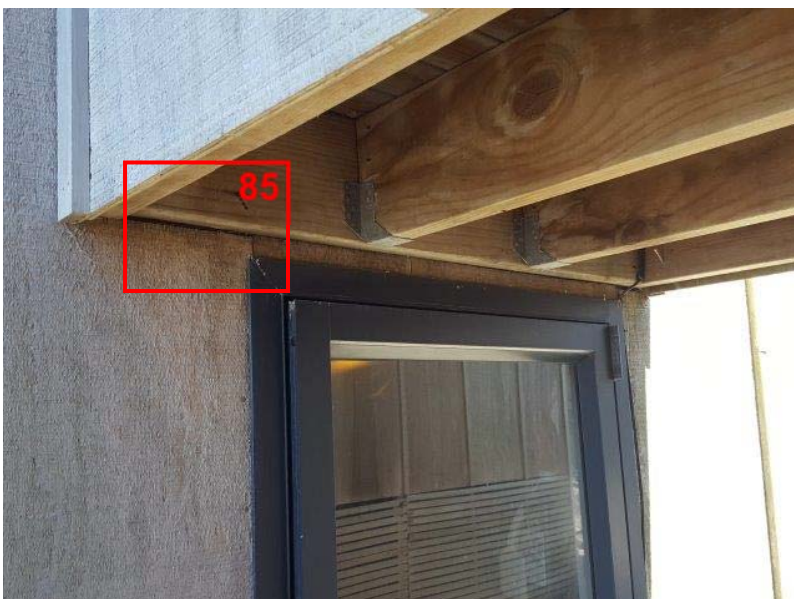
Photo 84: Garage entry door on NE elevation below sleepout entry. Refer indicated closeup in next photo

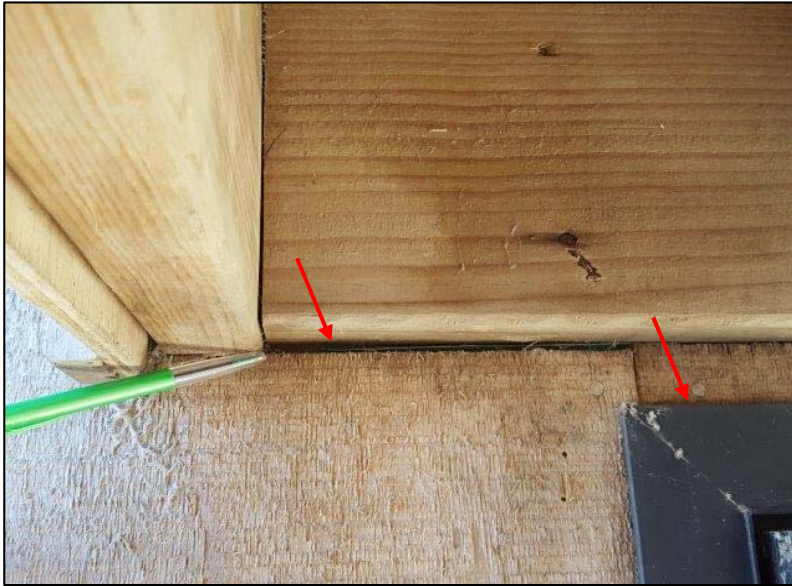
Photo 85: No head flashing is installed over the sheltered garage entry door. No trim is installed at the cladding junction, leaving a clear gap through to the garage interior. Maintenance activity such as washing down the cladding will result in water penetration behind the cladding

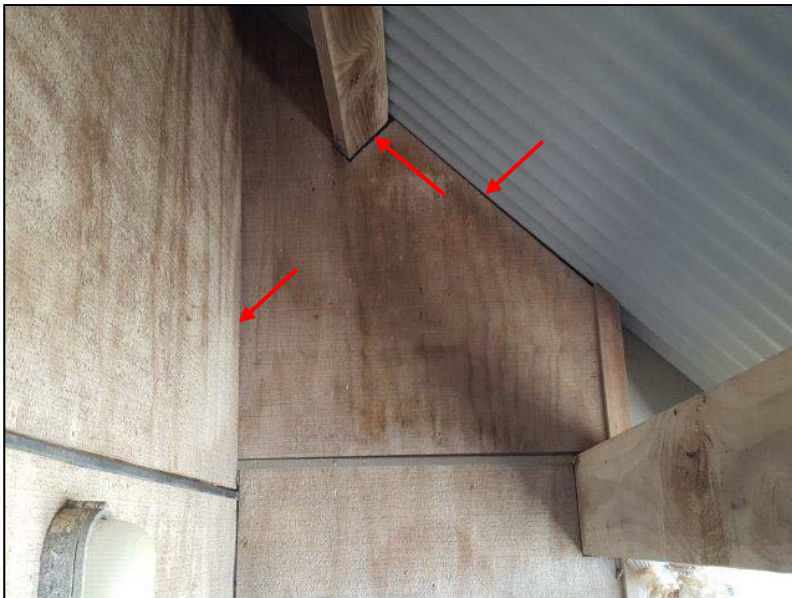
Photo 86: Sleepout deck end wall. No trims are installed to internal corner and cladding junctions to beam and roof

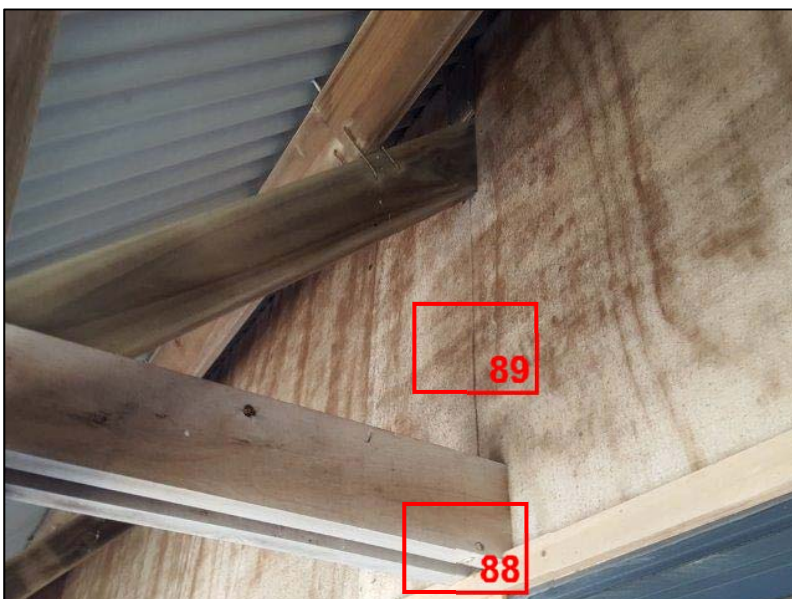
Photo 87: Sleepout wall above deck doors. Refer indicated closeups in following photos

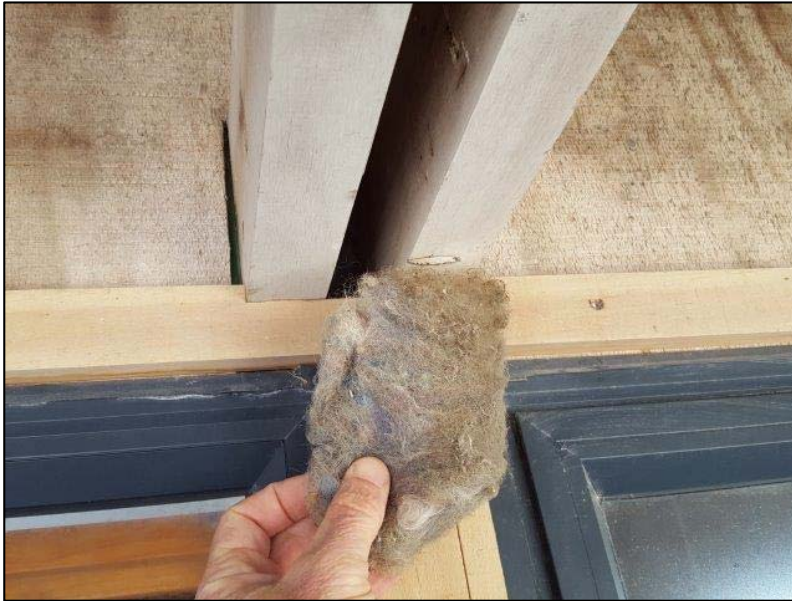
Photo 88: Piece of insulation only in large gap between timber truss bottom chords

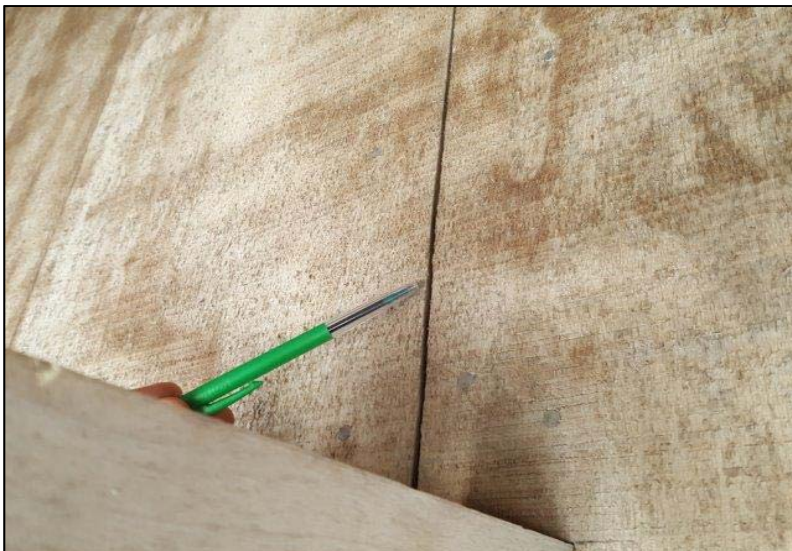
Photo 89: No trim installed over butted plywood cladding junction

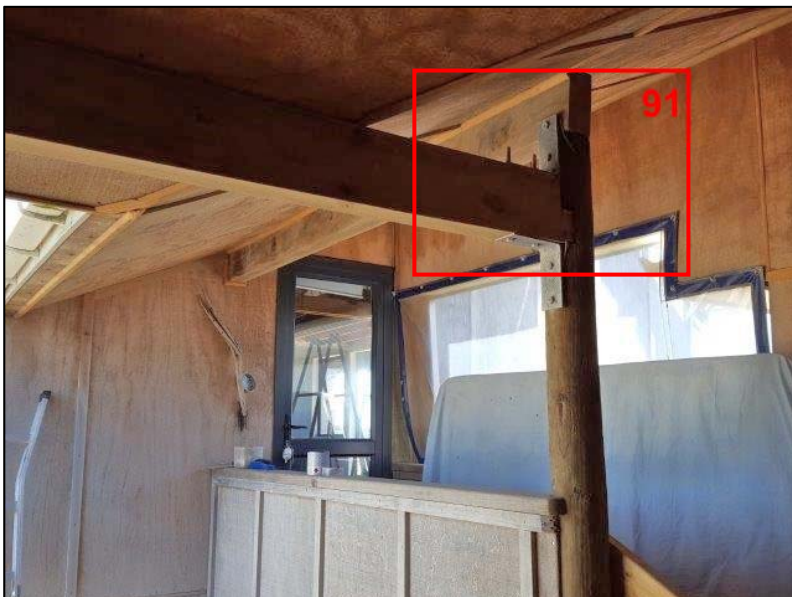
Photo 90: Pole and beam junction in entry area between house and garage. Refer indicated closeups in following photos

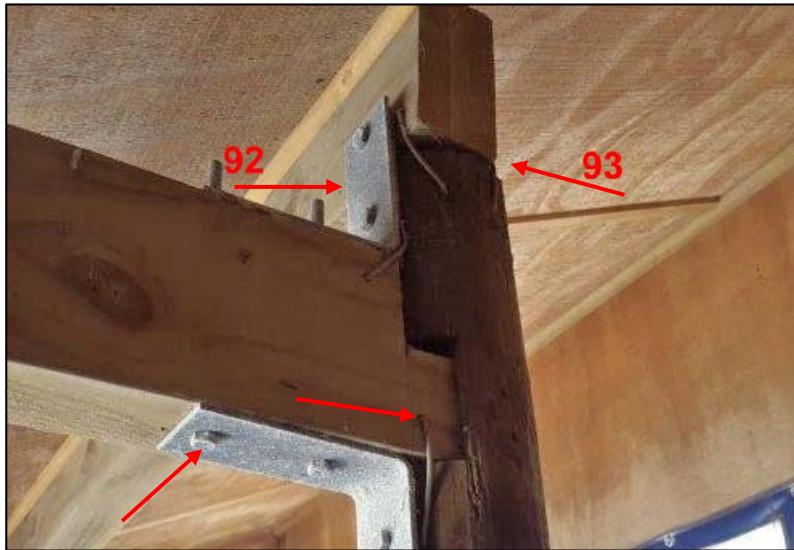
Photo 91: The beam on the left has been checked into and is well connected to the timber pole with top and bottom angle brackets, fixed with three bolts and four wire dogs. The top beam has been somewhat crudely fixed, with structural connections in the lower third of the beam only, allowing the beam to twist. Refer indicated closeups of top beam junction in following photos

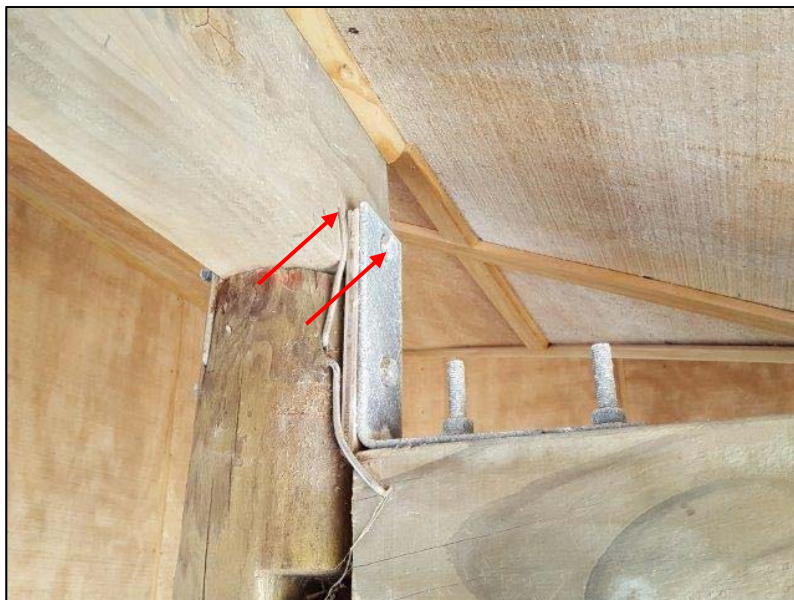
Photo 92: Top beam connection to timber pole is reliant on a single bolted connection and four wire dogs, all in the end and lower third of the beam. The connection could be improved significantly by installing a longer bracket with double bolted connection to the top beam. Refer next photo at other end of the single bolted connection
