433 PUKEHINA PARADE EASTERN

Land Information Memorandum

Repair No. 1 – Laundry bulkhead

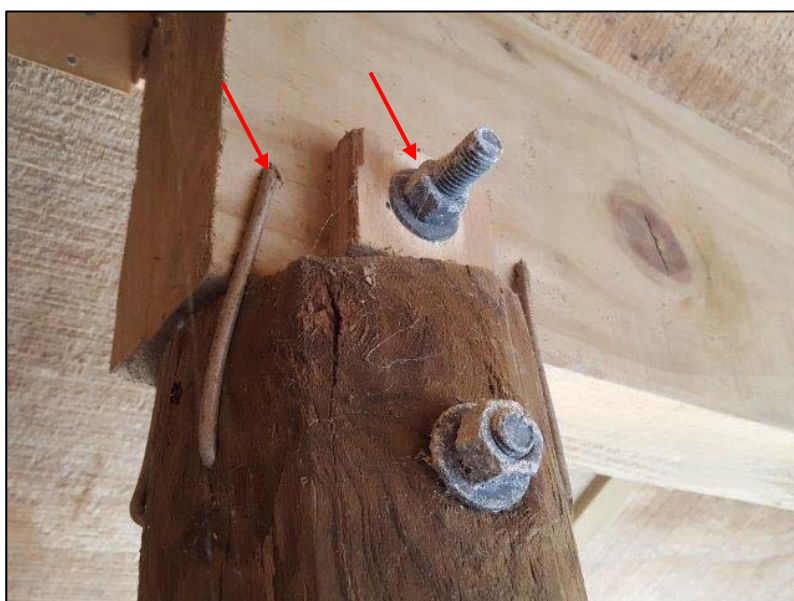
Photo 93: Top beam connection to timber pole is reliant on a single bolted connection and four wire dogs, all in the lower third and close to the end of the beam. The connection is required to perform for the life of the building (i.e. minimum 50 years). The adequacy of the connection is questionable in a major seismic or storm event
