# Roof Maintenance Report & Management Plan

*Thompson Bros  
Limited*

*50 Gracefield Road,  
Lower Hutt*

08.09.2021

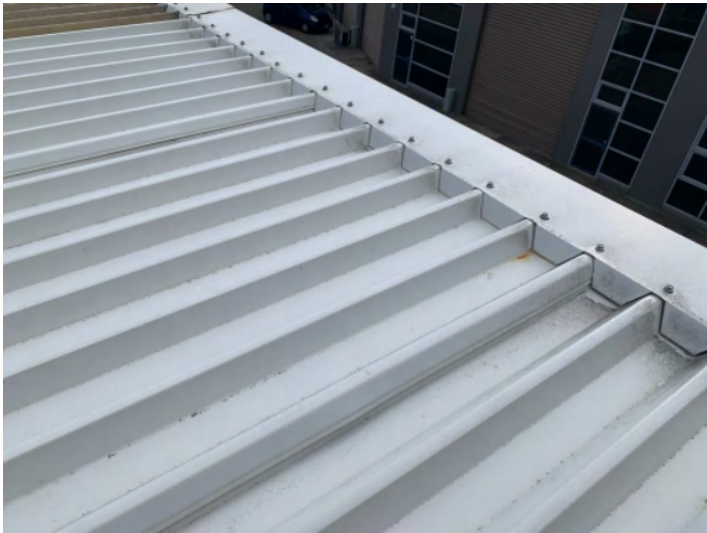
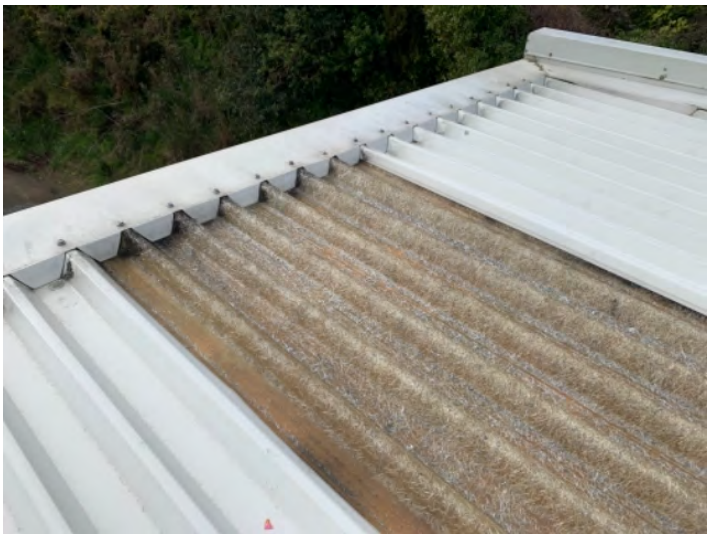
UV damaged and brittle skylights

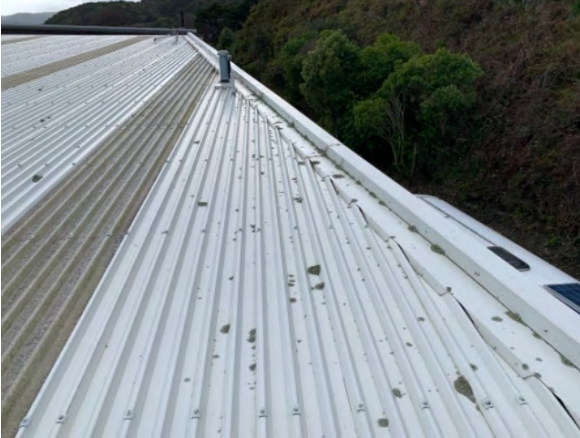
Moss on roof

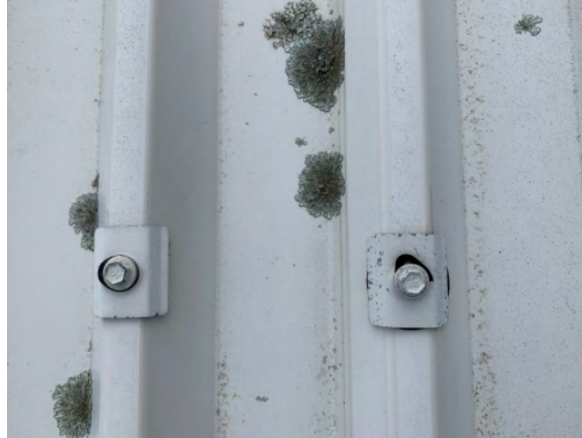
Split neo washers

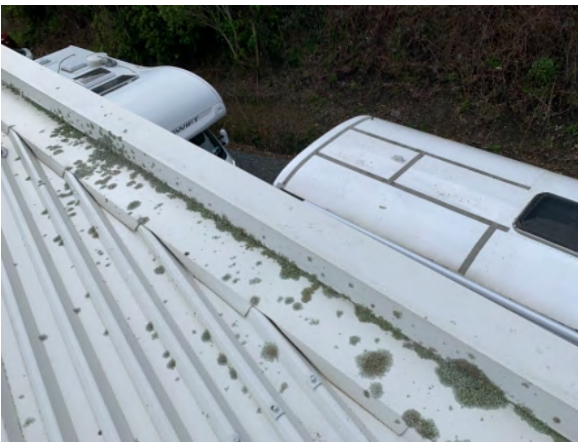
Moss build up on flashings

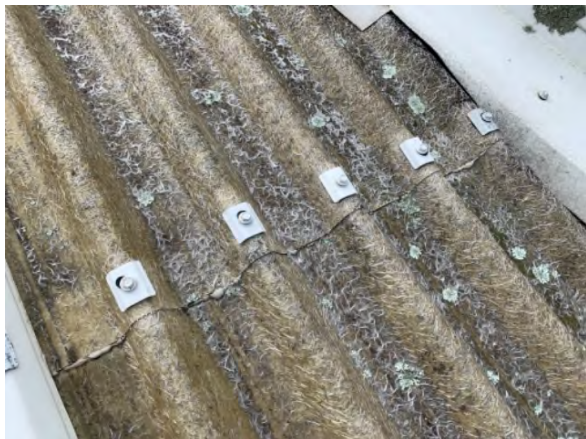
Skylight lap  
area where two skylight sheets lap

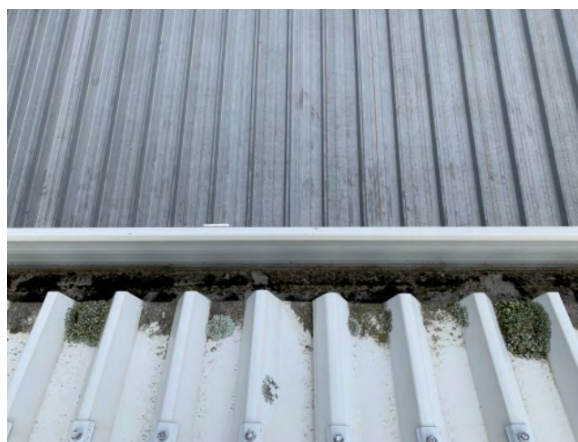
Moss and dirt build up at end of sheets  
There is a lot of moss and mold building up at the ends of the sheets going into the metal box gutter.

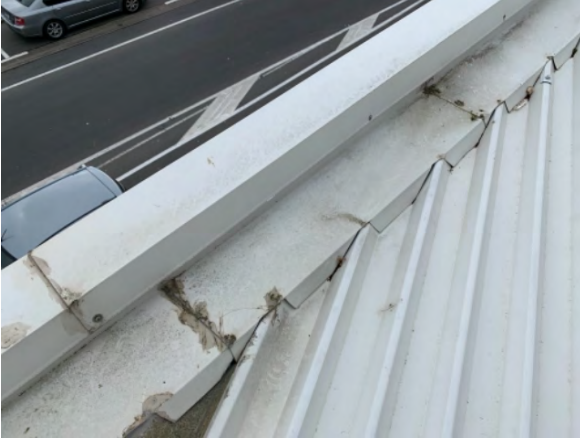
Faded sealant on flashings

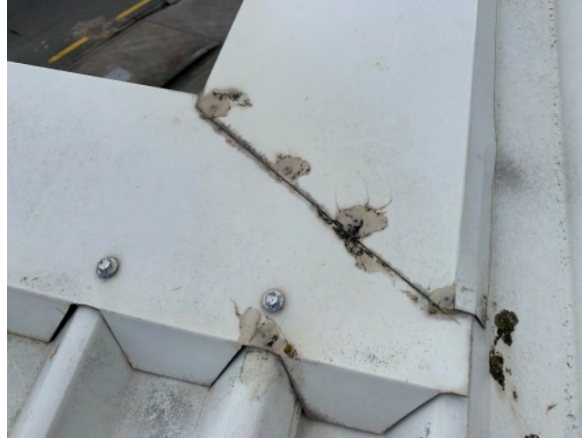
Faded sealant on flashings

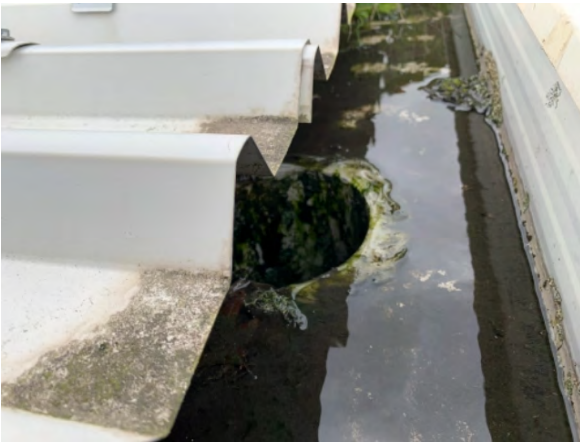
Outlet

Ponding water present around the outlet for the box gutter. There is also moss and mold present which can lead to blockages in the system.

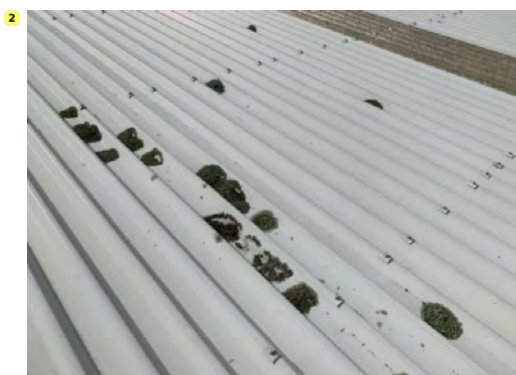
**Metal Roof - Moss and Mold (Remedial)**

Moss and mold along the roof. This can degrade and damage the metal coating by eating into the paint coating and causing corrosion on the metal.

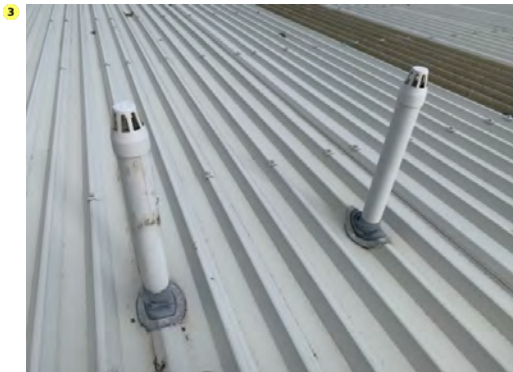
**Metal Roof - Failing Penetration (Remedial)**

Due to the penetration's age, improper installation, weathering or lack of maintenance, it has failed and is allowing water ingress.

The penetration should be repaired/flashed per industry standards to ensure a water tight seal. Remove the existing and install new dektite flexible flashing as required, to be installed with ring clip and sealant to ensure water tight seal.

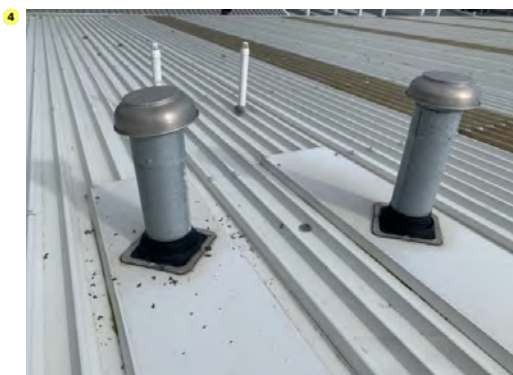
**Metal Roof - Failing Penetration (Remedial)**

Due to the penetration's age, improper installation, weathering or lack of maintenance, it has failed and is allowing water ingress.

The penetration should be repaired/flashed per industry standards to ensure a water tight seal. We will replace the failing dektite flashing and install ring clip and sealant.

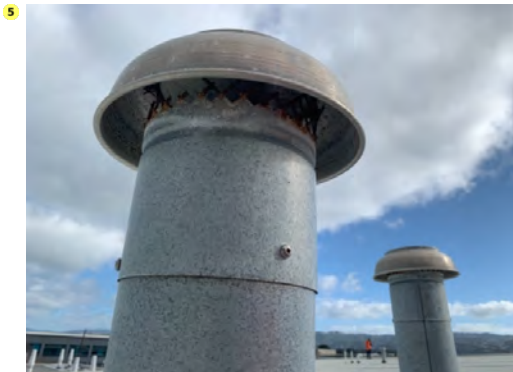
**Metal Roof - Damaged Roof Cowls (Remedial)**

There is corrosion and other damages on the roof cowls. The risk of rust extending to the metal roof can could allow water into the roof.

We will replace the damaged Roof Cowls. On the new ones we will apply a zinc coat which will kill any remaining rust and prevent it building up later on.

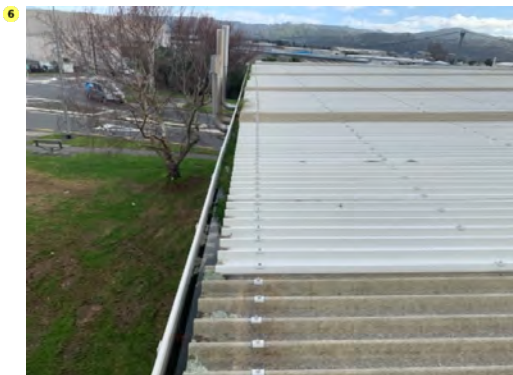
**Metal Gutter - Clogged Scupper/Drain/Gutter (Remedial)**

The existing scupper, drain, or gutter has become clogged due to the blockage of debris or organic material. It is no longer functioning correctly, thus potentially creating significant and/or long term issues. Moss and mold along the gutter. This can degrade and damage the metal coating by eating into the paint coating and causing corrosion on the metal.

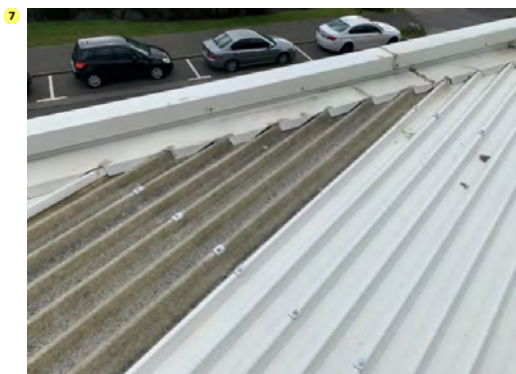
**Metal Roof - Broken and/or faded sealant (Remedial)**

Damaged or missing sealant can cause possible water ingress and leaks to the roof.

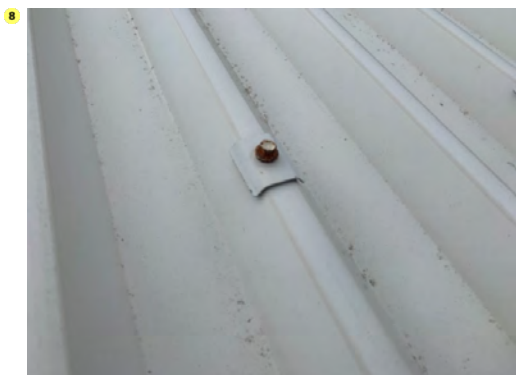
**Metal Roof - Corrosion in screws & washers (Remedial)**

Rust has been found in many screws and washers, If not replaced rust will begin to spread to the roofing iron. This requires urgent repairs in order to avoid future damage to the system.

All of the damaged screws and washers need to be replaced. We will also check for rust associated damages to the roofing iron. Circa 1500 need replacing.

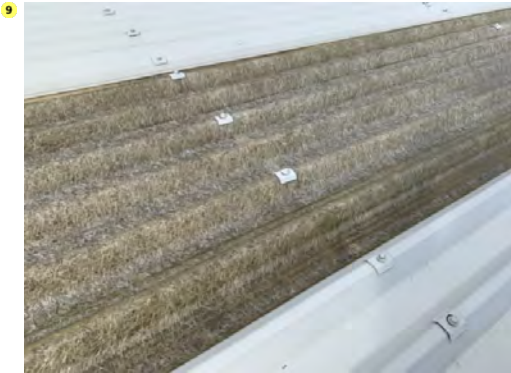
**Skylights - Replacement of skylights (Opt#1) (Emergency)**

The skylights are showing extensive damage, due to age, traffic, organic growing, lack of maintenance, weather or fatigue of materials.

Replacement of skylights with new trafficable skylights

As a permanent and durable solution, we propose to replace the existing skylights with new trafficable skylights to the entire roof. Below is a general budget number for the replacement of these skylights,

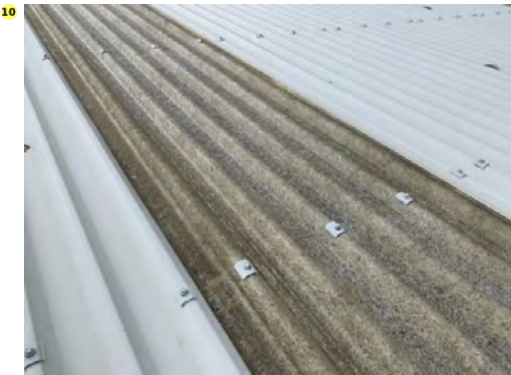
**Skylights - Replacement of skylights (Opt#2) (Emergency)**

The skylights are showing extensive damage, due to age, traffic, organic growing, lack of maintenance, weather or fatigue of materials.

Replacement of skylights with new metal sheets

As a permanent and durable solution, we propose to replace the existing skylights with new metal sheets to the entire roof.

Below is a general budget number for the replacement of these skylights with metal sheets, which will reduce the natural light in each of the units at Gracefield Road.

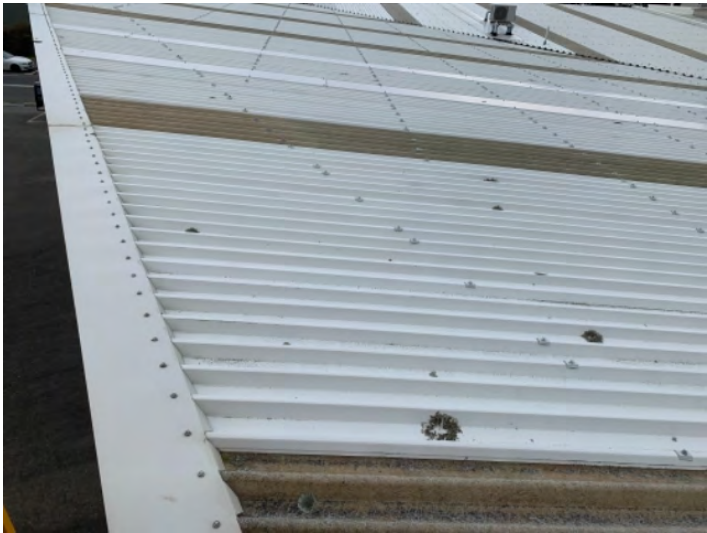
Trapezoidal metal roof

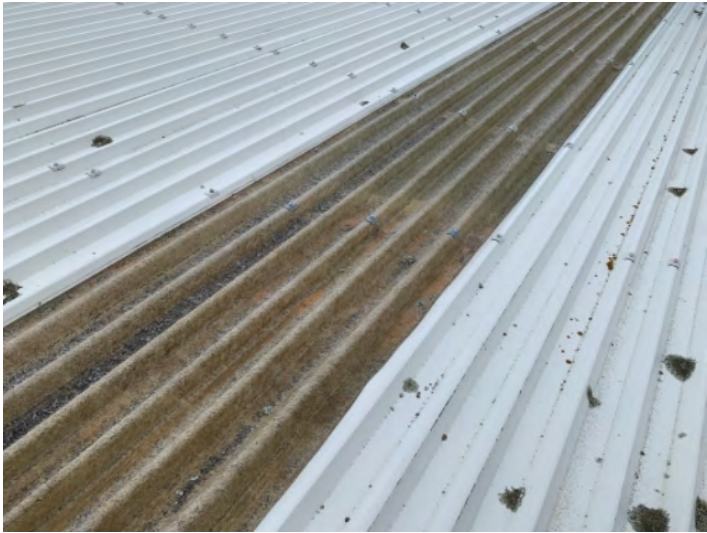
UV damaged and brittle skylights

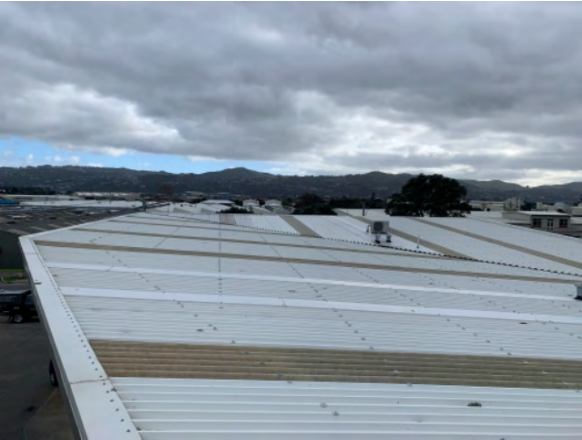
Roof overview

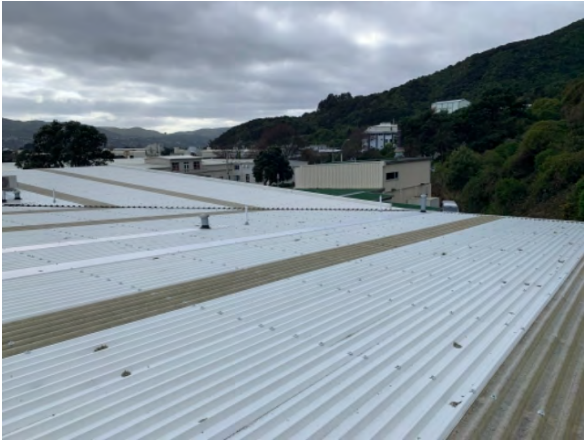
Roof over view

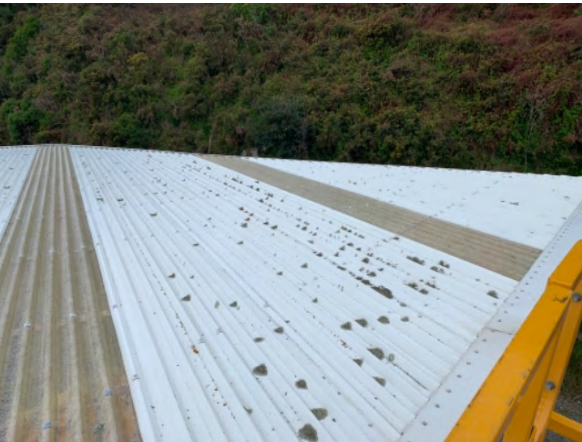
Roof overview

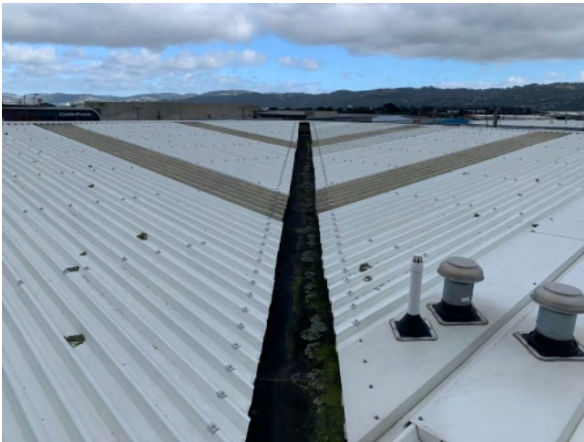
Butynol gutter overview

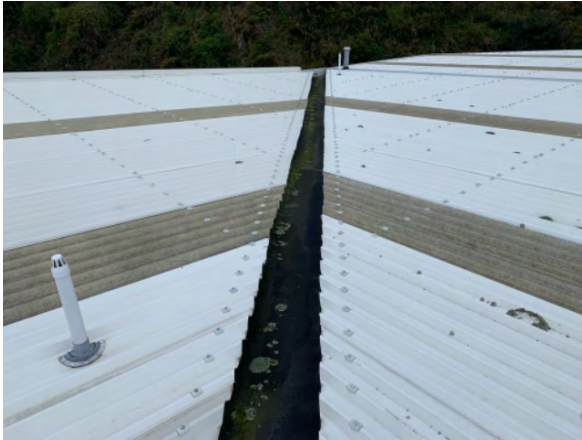
Butynol gutter overview

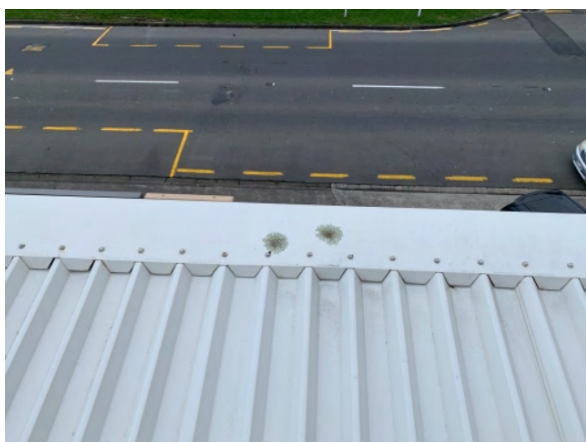
Moss on barge flashing

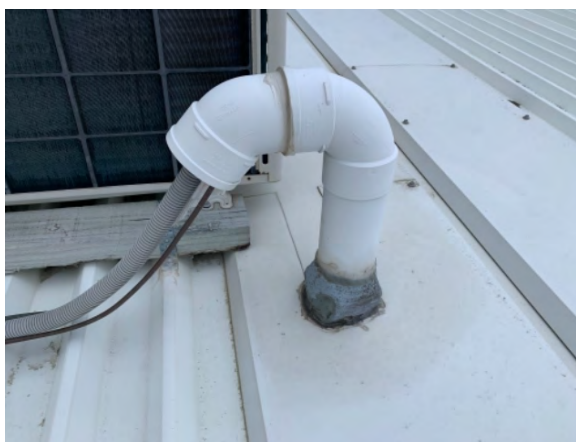
Penetration

Roof penetration for HVAC cables and hoses which is covered by tray flashing. A goose neck is installed, sealant around the penetration is fading which can lead to water ingress.

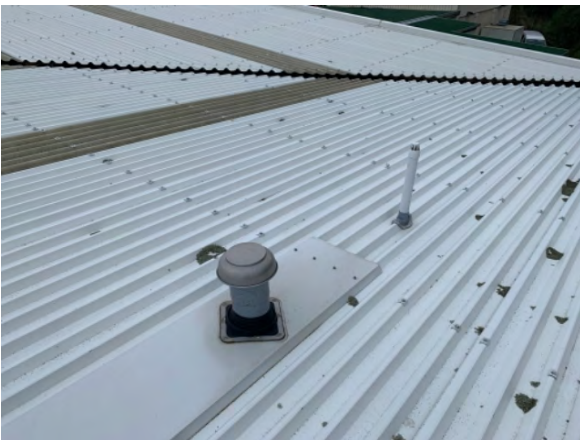
Penetrations covered by a tray flashing.

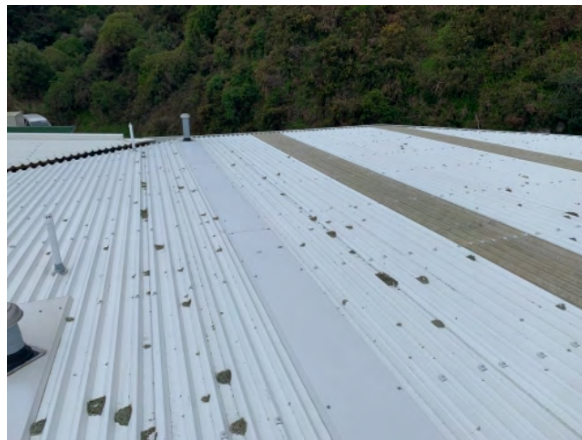
Moss on roof

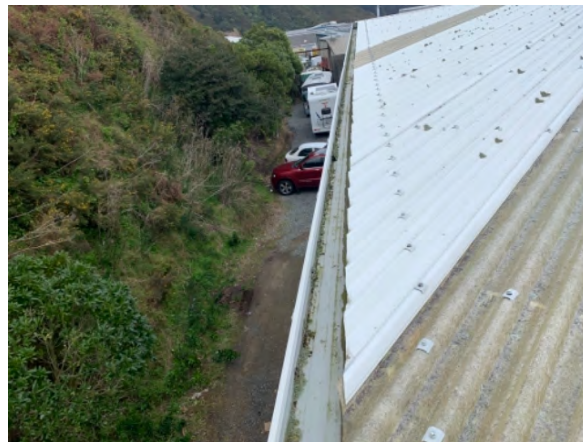
Box gutter with moss and mould

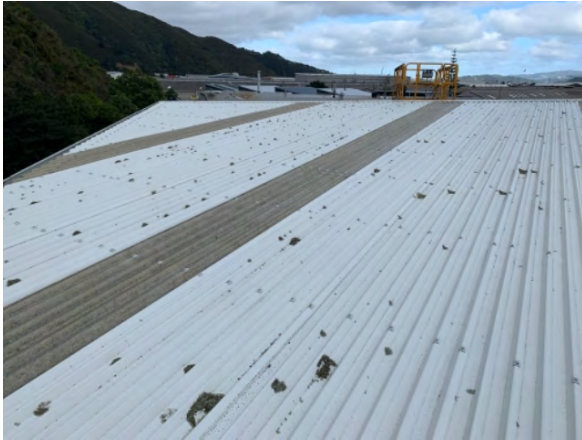
Moss on roof

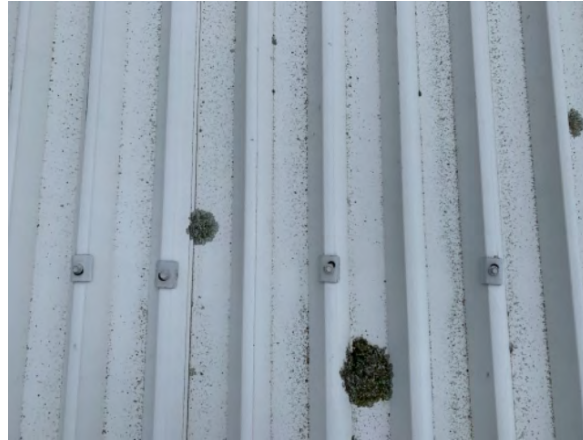
Screws with split neo washers

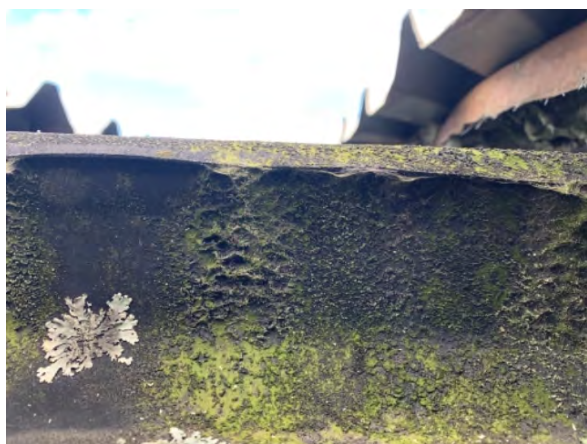
Lifting lap in gutter

Lifting Butynol lap in the gutter which can lead to water ingress into the building and under the Butynol membrane.

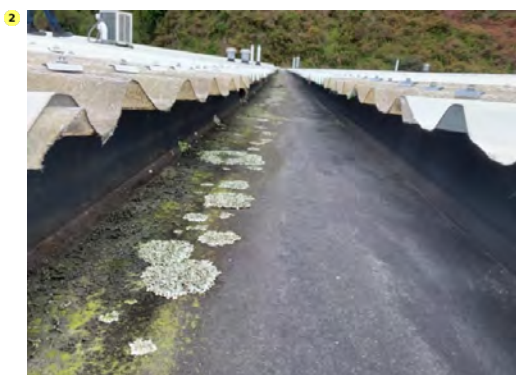
**Butynol Gutter - General Maintenance of Butynol Gutter (Remedial)**

The Butynol gutter requires an inspection at least once a year. Generally, the accumulation of organic material and debris can create blockages in the outlets, water ponding, open laps that can lead into potential leaks.

It is imperative to inspect the Butynol gutter, clean it and repair any open laps found in order to avoid costly repairs in the future.

We will carefully and methodologically inspect the Butynol gutter and assess its current condition.

Any debris or organic material found will be removed.

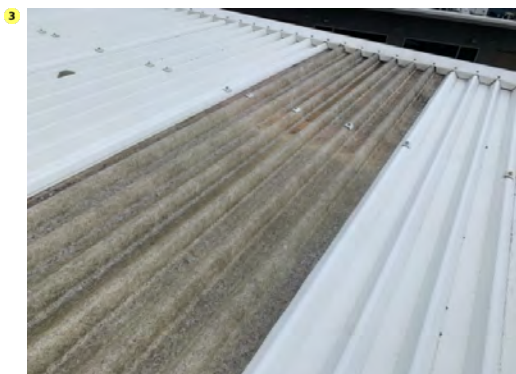
**Skylights - Cracks/holes/punctures in the skylight (Temporary Solution) (Remedial)**

There are cracks, holes or punctures in the skylight, this is likely to cause water ingress into the roof system. This requires urgent repairs in order to avoid future damage to the roof.

Temporary solution - We will thoroughly check all the skylights for damage and defects. We are able to offer a bandage patch solution of flashing tape over the worst affected areas. This solution will require frequent maintenance and is unwarranted.

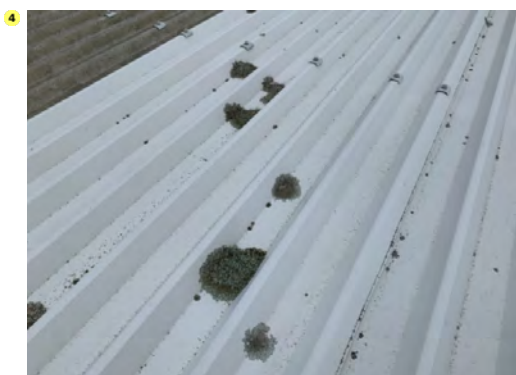
**Metal Roof - Moss and Mold (Remedial)**

Moss and mold along the roof. This can degrade and damage the metal coating by eating into the paint coating and causing corrosion on the metal.

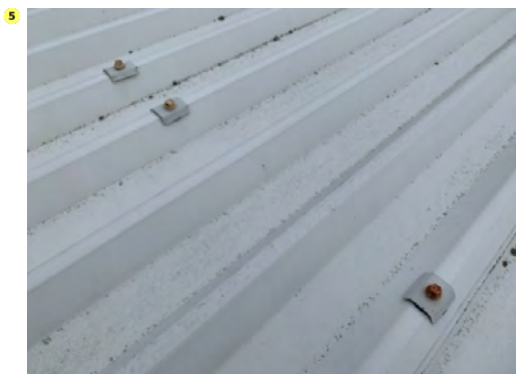
**Metal Roof - Corrosion in screws & washers (Remedial)**

Rust has been found in many screws and washers, If not replaced rust will begin to spread to the roofing iron. This requires urgent repairs in order to avoid future damage to the system. (Allow for 1500)

All of the damaged screws and washers need to be replaced. We will also check for rust associated damages to the roofing iron

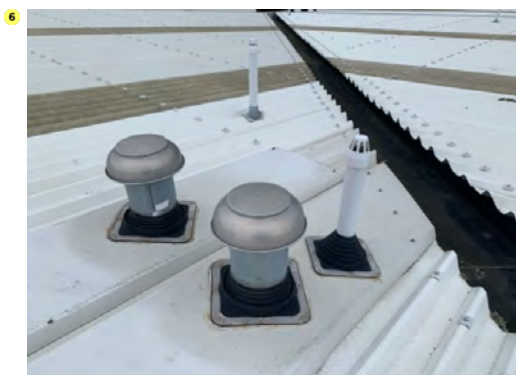
**Metal Roof - Failing Penetration (Remedial)**

Due to the penetration's age, improper installation, weathering or lack of maintenance, it has failed and is allowing water ingress.

The penetration should be repaired/flashed per industry standards to ensure a water tight seal. Replace damaged dektite flashings, install sealant and jubilee ring clip to ensure watertight seal.

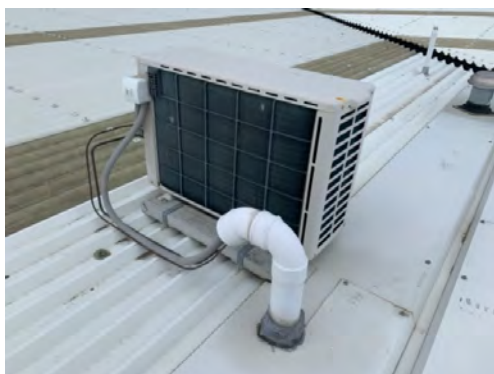
**Metal Roof - Failing Penetration (Remedial)**

Due to the penetration's age, improper installation, weathering or lack of maintenance, it has failed and is allowing water ingress. HVAC installation

The penetration should be repaired/flushed per industry standards to ensure a water tight seal. We will install a dektite flashing, jubilee ring clip and sealant to ensure watertight seal.

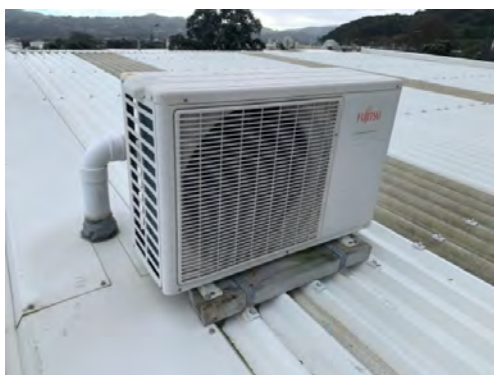
**Metal Roof - HVAC plinth damage (Remedial)**

HVAC unit has been mounted on timber directly onto the roof without a separation barrier which can lead to corrosion occurring on the sheets.

Work by others: Contact HVAC installer to replace existing timber plinths for new monkeytoe style HVAC mount.

We will carry out all the necessary repairs to the metal sheets by cleaning and sanding off the rust, apply Zinc anti-rust treatment and if necessary, apply a polyurethane membrane coat to waterproof the area. Please note this is only a temporary solution in order to try to stop the corrosion process and it will require regular maintenance.

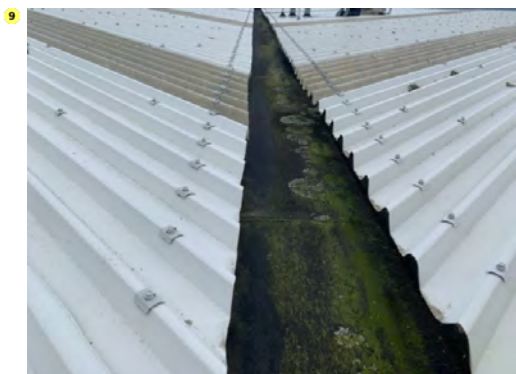
### Butynol Gutter - Moss and mold on gutter (Remedial)

Moss and mold along the gutter. This can degrade and damage the membrane by eating into the membrane causing it to deteriorate.

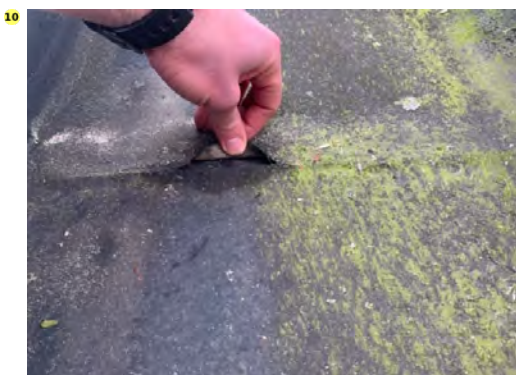
### Butynol Gutter - Open/loose Membrane Laps (Remedial)

Open membrane laps and splits have been found, they can allow water into the system. These require urgent repairs in order to avoid future leaks.

Seal all the open or loose laps by cleaning the area, re-welding the lap and/or installing a bandage over the affected area to ensure water tightness.

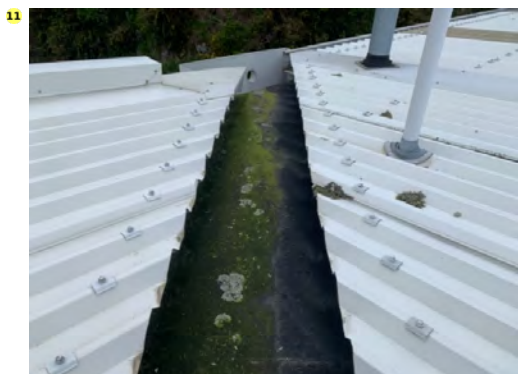
**Butynol Gutter - General damage of Membrane (Remedial)**

There are general damages on the membrane, the protective layer is compromised and can allow leaks to the roof. This can be due to aging, foot traffic, organic growth or lack of maintenance.

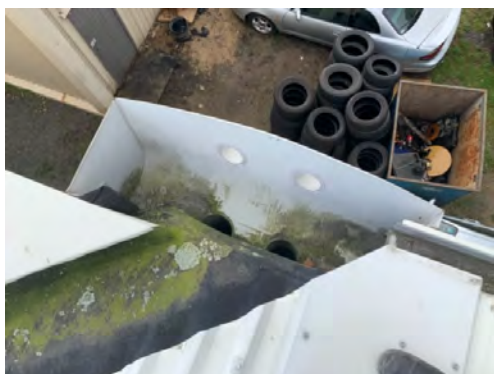
13

**Butynol Gutter - Open/loose membrane laps (Drain/scupper) (Remedial)**

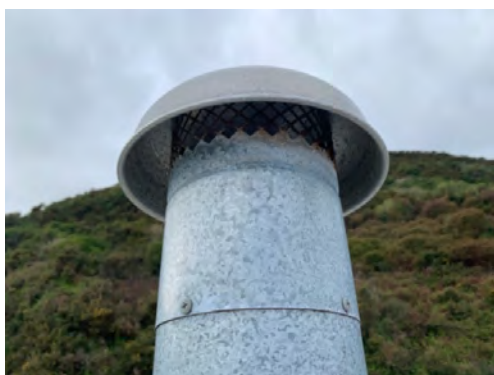
14

**Metal Roof - Damaged Roof Cowls (Remedial)**

There is corrosion and other damages on the roof cowls. The risk of rust extending to the metal roof can could allow water into the roof.

We will replace the damaged Roof Cowls. On the new ones we will apply a zinc coat which will kill any remaining rust and prevent it building up later on.

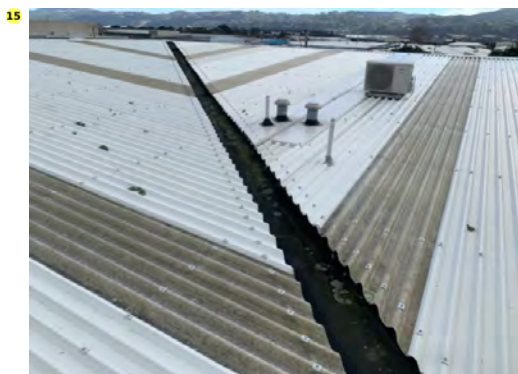
**Butynol Gutter - General Gutter Damage/Gutter-overlay Solution (Remedial)**

The gutter is showing signs of damages this can be due to age, foot traffic, organic materials growing, lack of maintenance or weathering. The gutter is at the end of its serviceable life and if no action is taken then major and long term issues will begin to show.

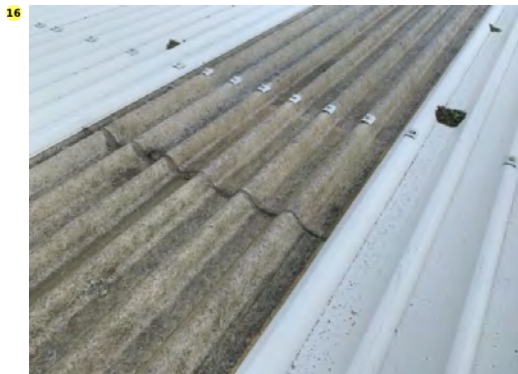
**Skylights - Replacement of skylights (Opt#1) (Emergency)**

The skylights are showing extensive damage, due to age, traffic, organic growing, lack of maintenance, weather or fatigue of materials.

Replacement of skylights with new trafficable skylights

As a permanent and durable solution, we propose to replace the existing skylights with new trafficable skylights to the entire roof. Below is a general budget number for the replacement of these skylights,

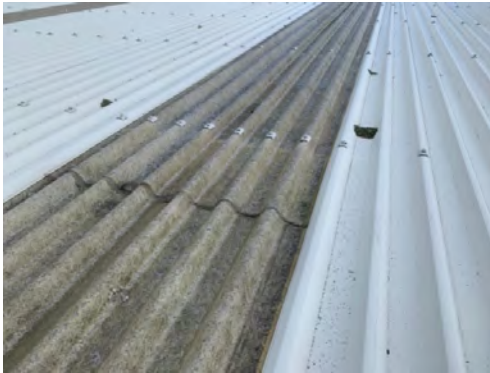
17

**Skylights - Replacement of skylights (Opt#2) (Emergency)**

The skylights are showing extensive damage, due to age, traffic, organic growing, lack of maintenance, weather or fatigue of materials.

Replacement of skylights with new metal sheets

As a permanent and durable solution, we propose to replace the existing skylights with new metal sheets to the entire roof.

Below is a general budget number for the replacement of these skylights with metal sheets, which will reduce the natural light in each of the units at Gracefield Road.

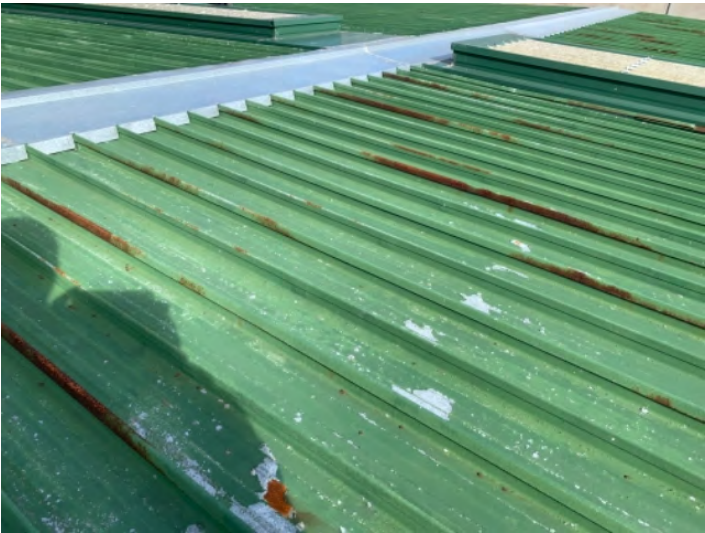
Metal roof

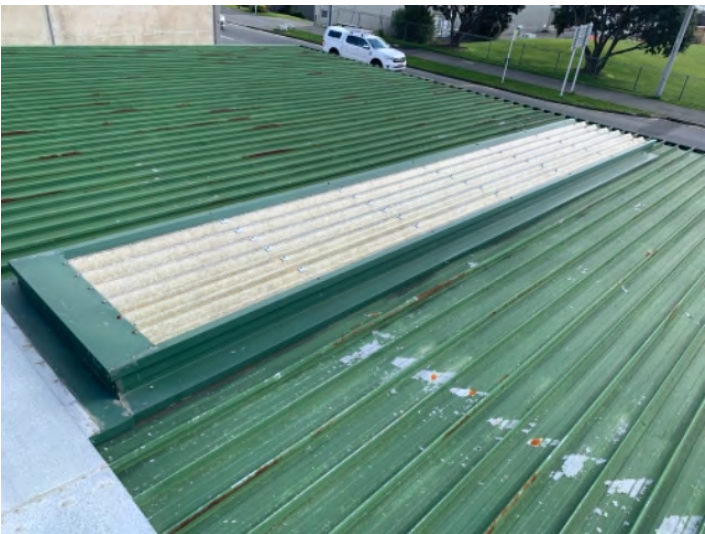
UV damaged and brittle skylights

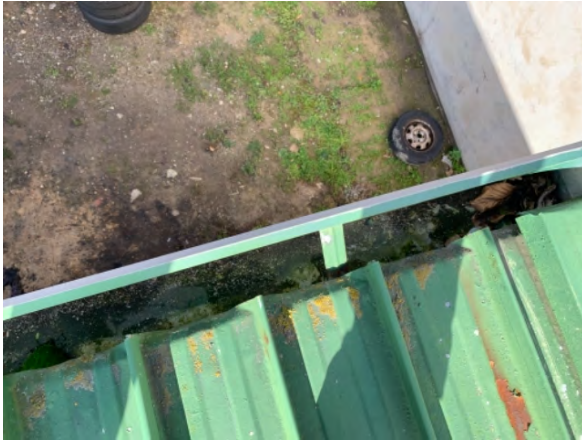
**Dirt, debris and organic material in gutter**  
The metal box gutter has a lot of dirt, debris and organic materials present which can lead to blockages in the system.

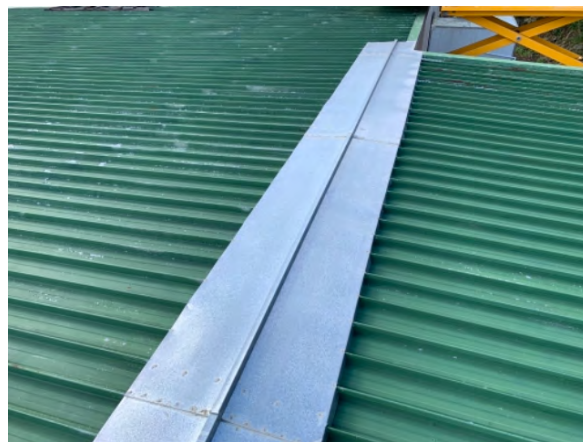
**Oversized ridge flashing**

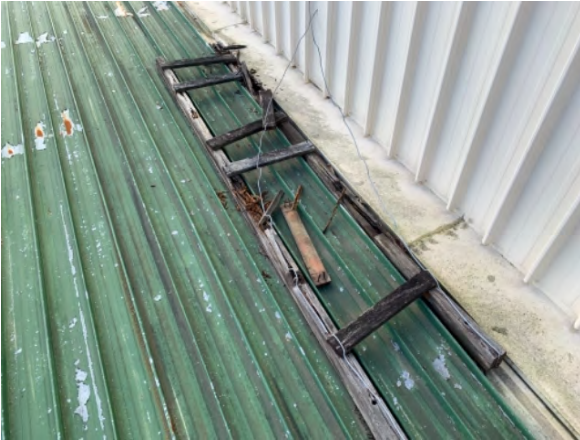
Old, rotten timber on roof

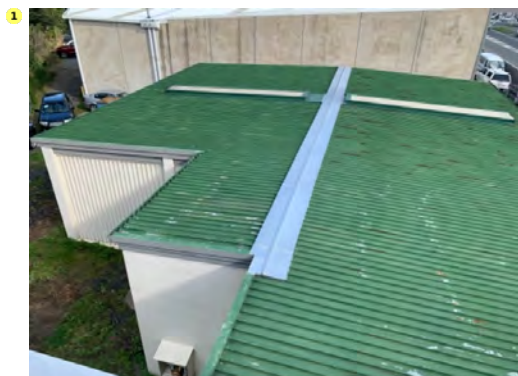
**Metal Roof - General Maintenance (Remedial)**

The metal roofing is required to be inspected at least once a year. Generally, the accumulation of organic material and debris can create blockage on the outlets, water ponding, openings that can lead into potential leaks. It is imperative to inspect the metal roof, clean it and repair any openings found in order to avoid costly repairs in the future.

We will carefully and methodologically inspect the metal roof and assess its current condition. Any debris or organic material found will be removed.

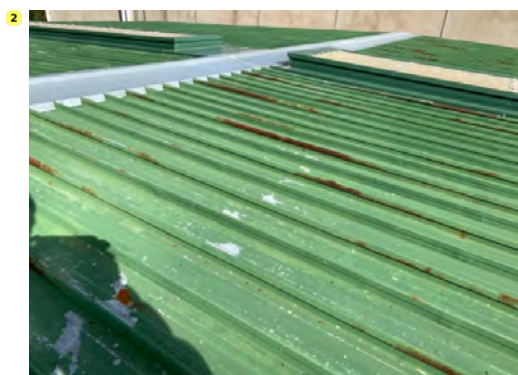
**Metal Roof - Corrosion on metal roof sheets (Temporary solution) (Remedial)**

Corrosion found on metal sheets, some areas show an advanced corrosion state, the rust is eating through the metal, potentially creating holes on the system.

We will carry out all the necessary repairs to metal sheets by cleaning and sanding off the rust and apply Zinc anti-rust treatment to the worst areas.

It is recommended that a full repaint solution could be carried out to prolong the servicable life of this roof. We can give recommendations for this if you choose.

(Please note that this is only a temporary solution in order to try to stop the corrosion processes and it will require regular maintenance.)

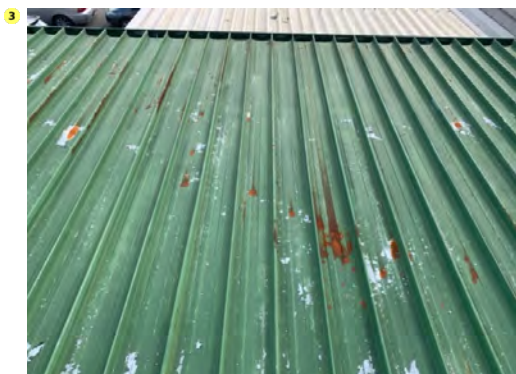
**Metal Roof - General damage of Metal (Remedial)**

There are general damages on the metal, the protective layer is compromised and can allow advanced corrosion and leaks to the roof. This can be due to aging, exposed bare metal, foot traffic, organic growth or lack of maintenance.

We will clean and apply patches to areas where the metal has severe damage and then apply polyurethane protective topcoat to the worst effected areas of the roof.

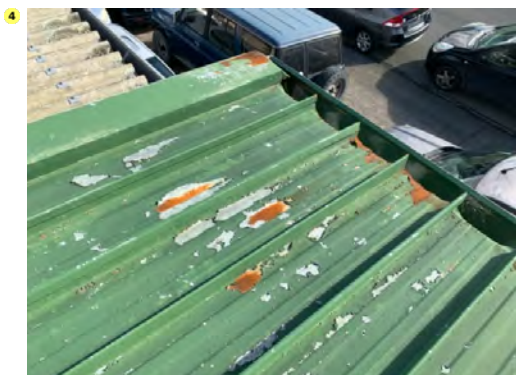
**Metal Roof - Damaged Flashing (Corrosion) (Remedial)**

There is corrosion found on metal flashings, some areas show an advanced corrosion state. Rust can eat through the metal, potentially creating holes on the system.

Carry out all the necessary repairs to flashings by cleaning and sanding off the rust, apply Zinc anti-rust treatment, and if necessary apply a polyurethane membrane coat to waterproof the area.

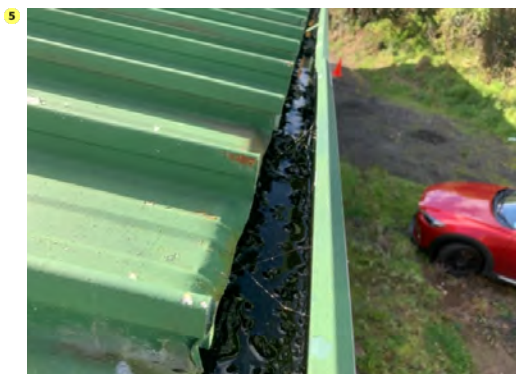
**Metal Gutter - Clogged Scupper/Drain/Gutter (Remedial)**

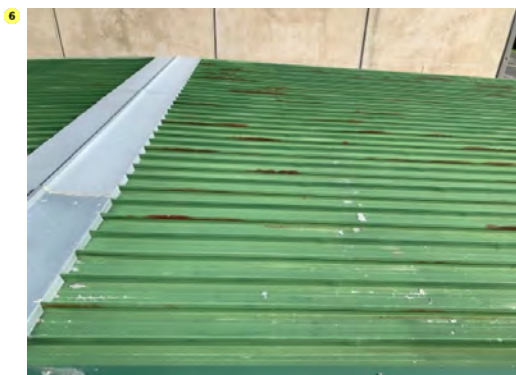
**Metal Roof - Roof overlay solution/General roof damages (Emergency)**

The roof is showing signs of damage this can be due to age, foot traffic, organic materials growing, lack of maintenance or weathering. The roof is at the end of its serviceable life and if no action is taken then major and long term issues will begin to show. The low pitch of the metal roof also causes issues with standing water on the roof causing advanced corrosion. These low pitched roof are no longer warrantied.

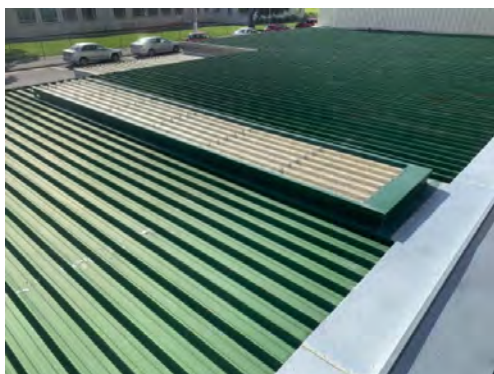
7

**Skylights - UV Damaged brittle skylights (Permanent Solution) (Remedial)**

The skylights are damaged and the end of their serviceable life. These damages can be due to overall age, weathering, UV rays or lack of maintenance. This is likely to cause water ingress into the roof system. This requires urgent repairs in order to avoid future damage to the roof.

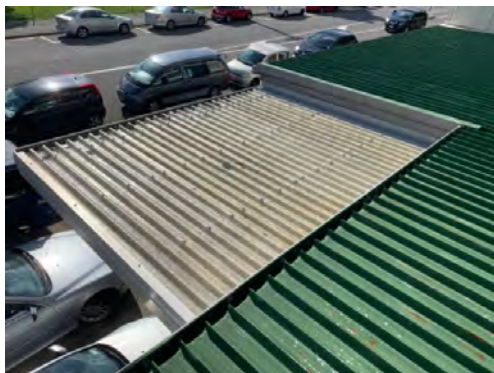
8

**Skylights - UV Damaged brittle skylights (Permanent Solution) (Remedial)**

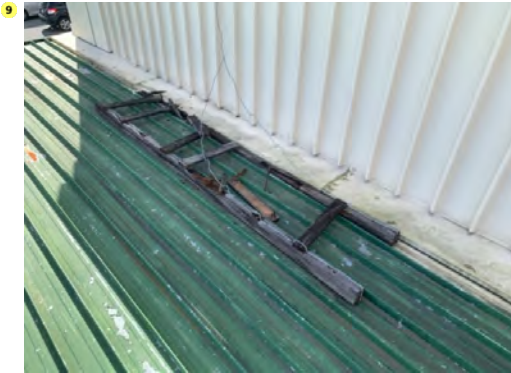
**Metal Roof - Loose Debris (Remedial)**

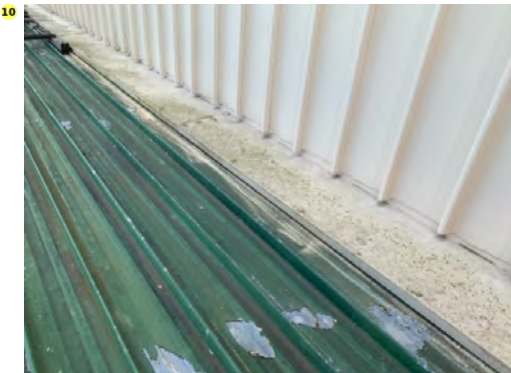
**Metal Roof - Moss and Mold (Remedial)**

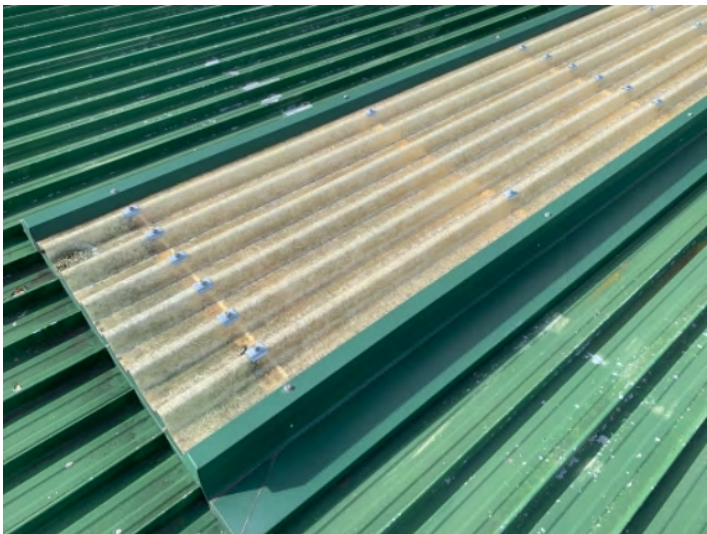
UV damaged and brittle skylights

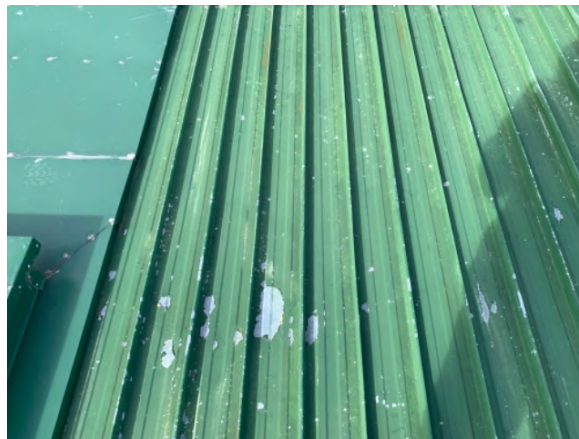
Paint flaking example

The roof has been repainted and the paint is now flaking off in many areas.

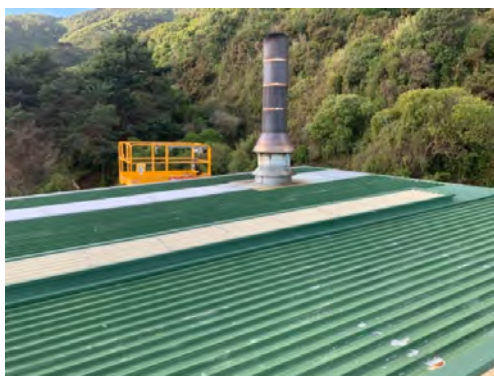
1

**Metal Roof - General Maintenance (Remedial)**

The metal roofing is required to be inspected at least once a year. Generally, the accumulation of organic material and debris can create blockage on the outlets, water ponding, openings that can lead into potential leaks. It is imperative to inspect the metal roof, clean it and repair any openings found in order to avoid costly repairs in the future.

We will carefully and methodologically inspect the metal roof and assess its current condition. Any debris or organic material found will be removed.

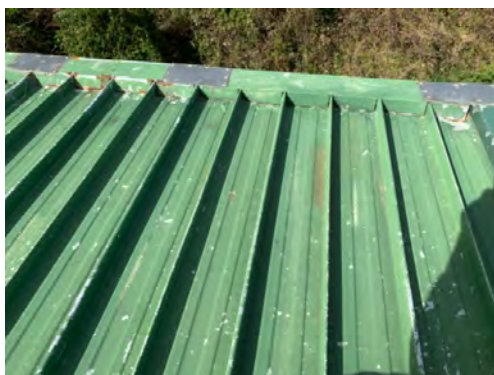
2

**Metal Roof - General damage of Metal (Remedial)**

There are general damages on the metal, the protective layer is compromised and can allow advanced corrosion and leaks to the roof. This can be due to aging, exposed bare metal, foot traffic, organic growth or lack of maintenance.

We will clean and apply patches to areas where the metal has severe damage and then apply polyurethane protective topcoat to the worst effected areas of the roof.

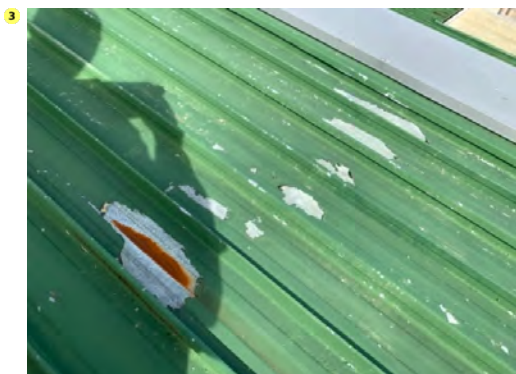
**Metal Roof - Corrosion on metal roof sheets (Temporary solution) (Remedial)**

Corrosion found on metal sheets, some areas show an advanced corrosion state, the rust is eating through the metal, potentially creating holes on the system.

We will carry out all the necessary repairs to metal sheets by cleaning and sanding off the rust and apply Zinc anti-rust treatment to the worst areas.

It is recommended that a full repaint solution could be carried out to prolong the servicable life of this roof. We can give recommendations for this if you choose.

(Please note that this is only a temporary solution in order to try to stop the corrosion processes and it will require regular maintenance.)

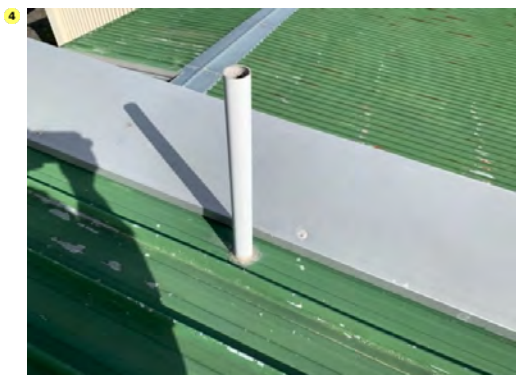
**Metal Roof - Failing Penetration (Remedial)**

Due to the penetration's age, improper installation, weathering or lack of maintenance, it has failed and is allowing water ingress.

Missing dektite flashing required to be installed.

The penetration should be repaired/flashed per industry standards to ensure a water tight seal. We will install a new dektite flashing, seal and jubilee clip to ensure a watertight seal.

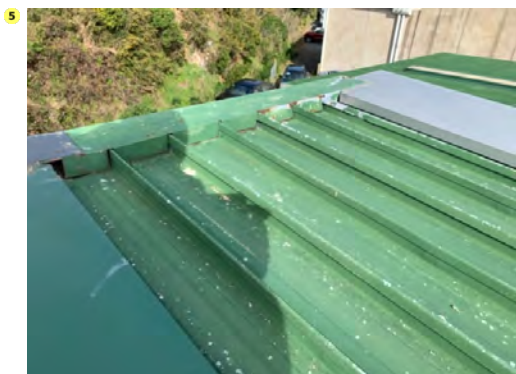
**Metal Roof - Corner Flashing Open (Remedial)**

The corner detail flashing is open and has gaps that needs to be sealed otherwise water related damages may occur.

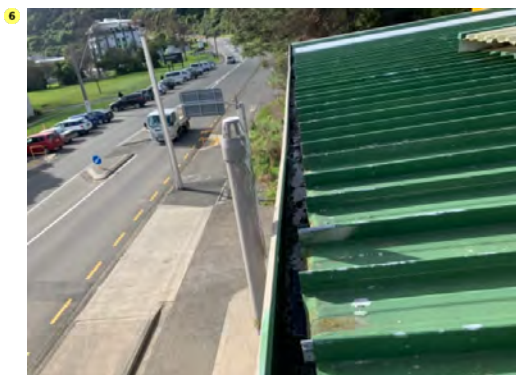
**Metal Gutter - Clogged Scupper/Drain/Gutter (Remedial)**

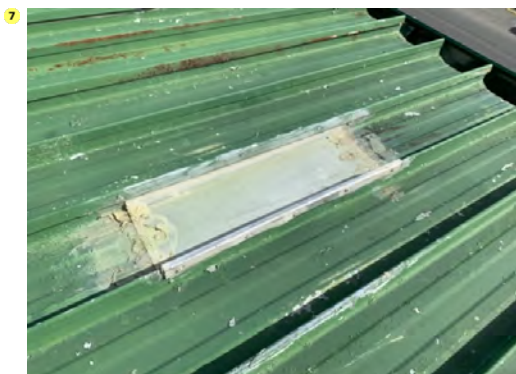
**Metal Roof - Holes in metal sheets (Remedial)**

Holes have been found in the metal sheets from a previous repair failure, this requires urgent repairs in order to avoid future damage to the roof.

We will clean and apply patches to areas where the metal has severe damage and then apply polyurethane protective topcoat to the worst effected areas of the roof.

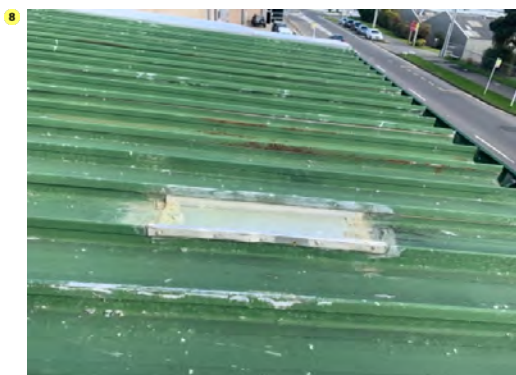
**Metal Roof - Roof overlay solution/General roof damages (Emergency)**

The roof is showing signs of damage this can be due to age, foot traffic, organic materials growing, lack of maintenance or weathering. The roof is at the end of its serviceable life and if no action is taken then major and long term issues will begin to show. The low pitch of the metal roof also causes issues with standing water on the roof causing advanced corrosion. These low pitched metal roofs are no longer warrantied.

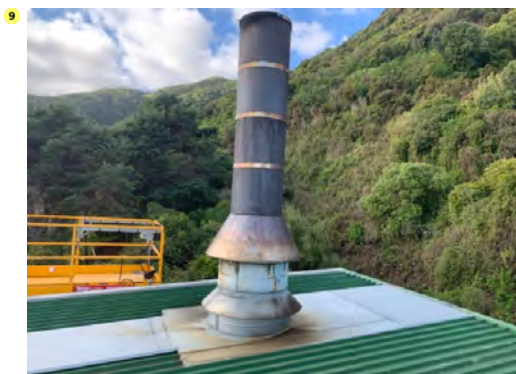
**Metal Roof - Chimney extract damage (Remedial)**

The flashings around the chimney extract are damaged this can cause possible water ingress. The sealant is faded and can lead to water ingress. The metal is getting damaged from the flue and early signs of corrosion process are visible.

Carry out any isolated repairs to the affected areas by repairing the existing flashings to the lower section of the chimney. We will carry out all the necessary repairs to metal sheets by cleaning and sanding off the rust and apply Zinc anti-rust treatment to the worst areas. We will remove the faded sealant and replace it with new.

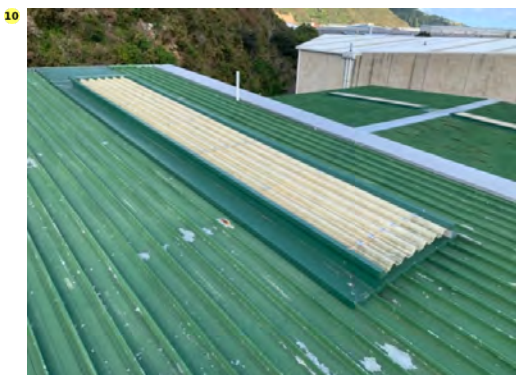
**Skylights - UV Damaged brittle skylights (Permanent Solution) (Remedial)**

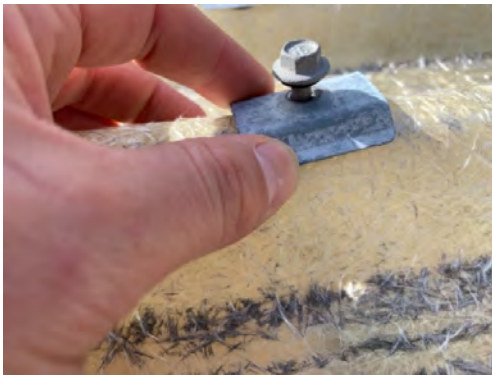
11

Skylights - Loose or missing screws and rivets. (Remedial)
