Christchurch Property Inspections Report

419 Kainga Road,
Brooklands

30/05/2025

Pre-Sale Visual Non-Invasive Property Inspection

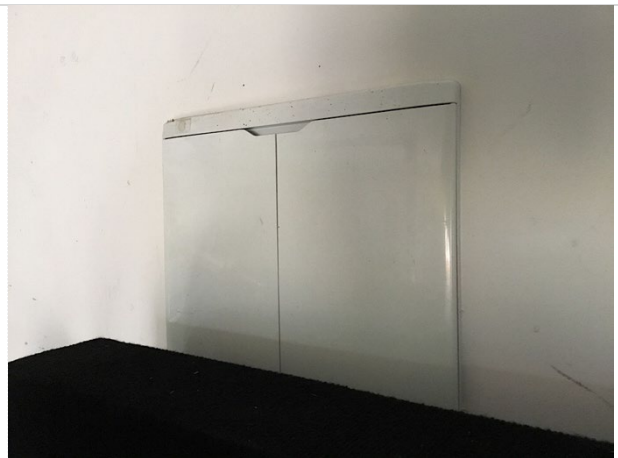
10. Switchboard

Hot Water	250L mains pressure electric hot water cylinder manufactured 2009 and located in the hallway storage. Generally sound, typical for age. Untested. Seismic strapping is installed.	Photo 9
Electrical Services	Mini circuit breaker switchboard. (See switchboard photo) Power was on at time of inspection. Untested.	10
Plumbing Services	Some polybutylene pipework visible. No Dux Quest plumbing observed.	
Ventilation System	N/A.	
Smoke Alarms	NOT installed within 3m of all bedrooms. Untested.	
Intruder Alarms	N/A.

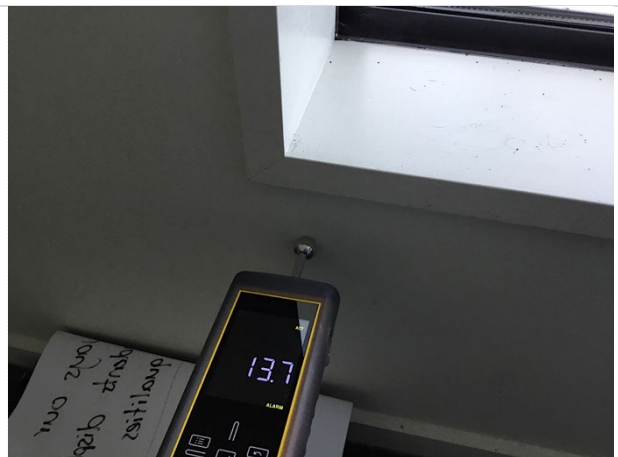
Moisture Tests See note below	Multiple moisture readings were taken in each room and on window sills. The readings give an overall indication of the moisture levels in the house but do not mean that there may not be areas with high moisture levels. Whilst every effort is made to detect moisture problems it is not possible to check every square metre of the interior wall space during inspection.	12-19

12. Typical low moisture reading under windows

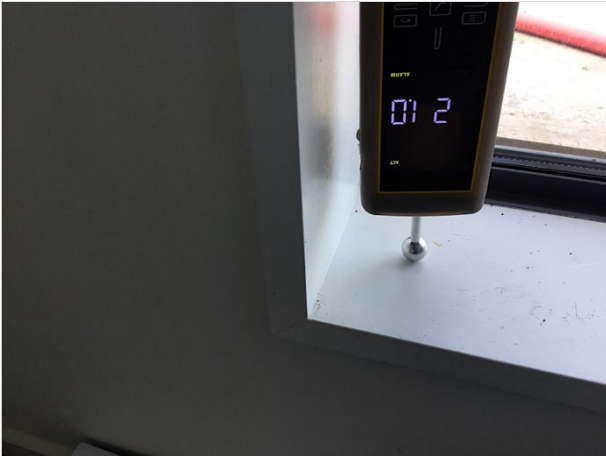
13. Typical window reveal reading
