## PRODUCER STATEMENT – PS4 – CONSTRUCTION REVIEW

IN RESPECT OF: Seismic Strengthening  
(Description of Building Work)

AT: 34 Upland Road, Kelburn  
(Address)

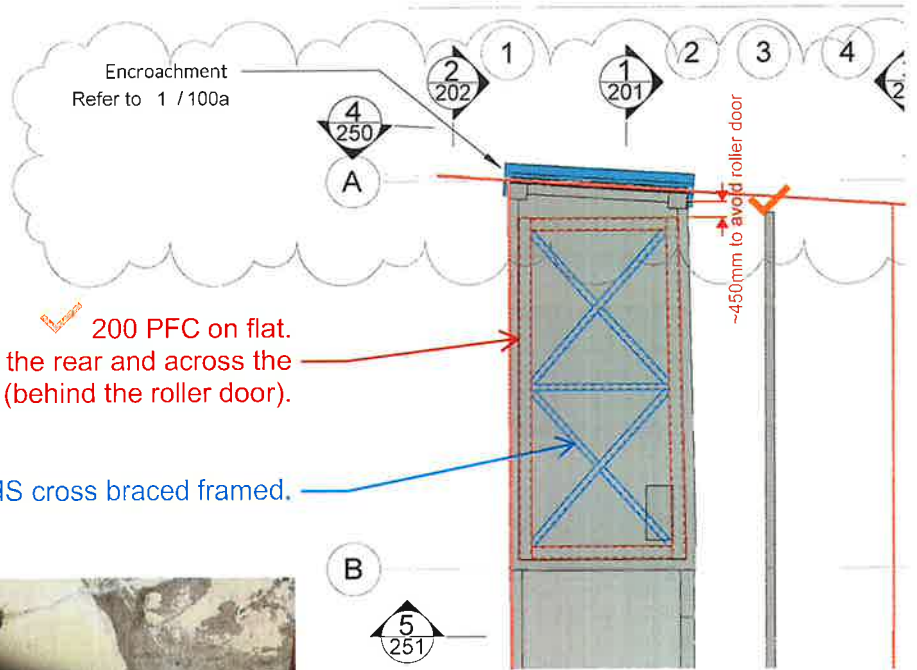
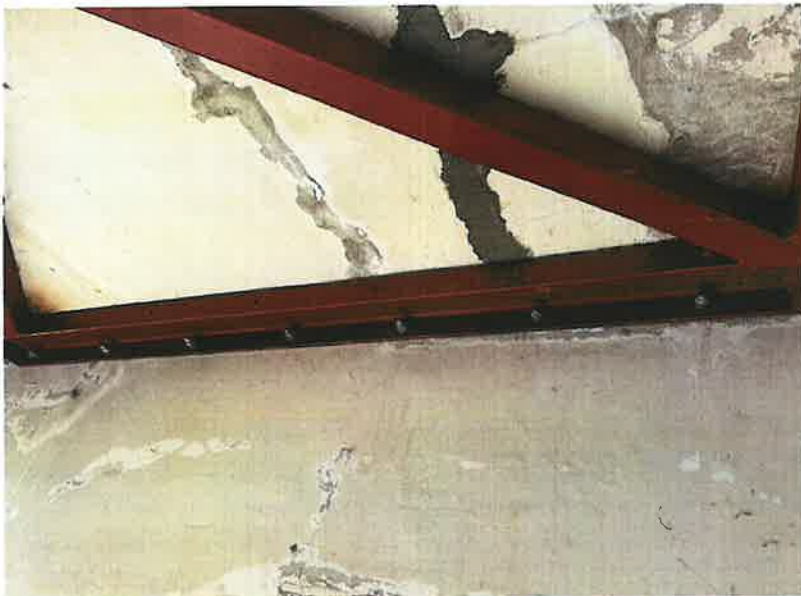
Photos of installed steel frame received and approved on 6/11/2025.  
Garage strengthening now complete.

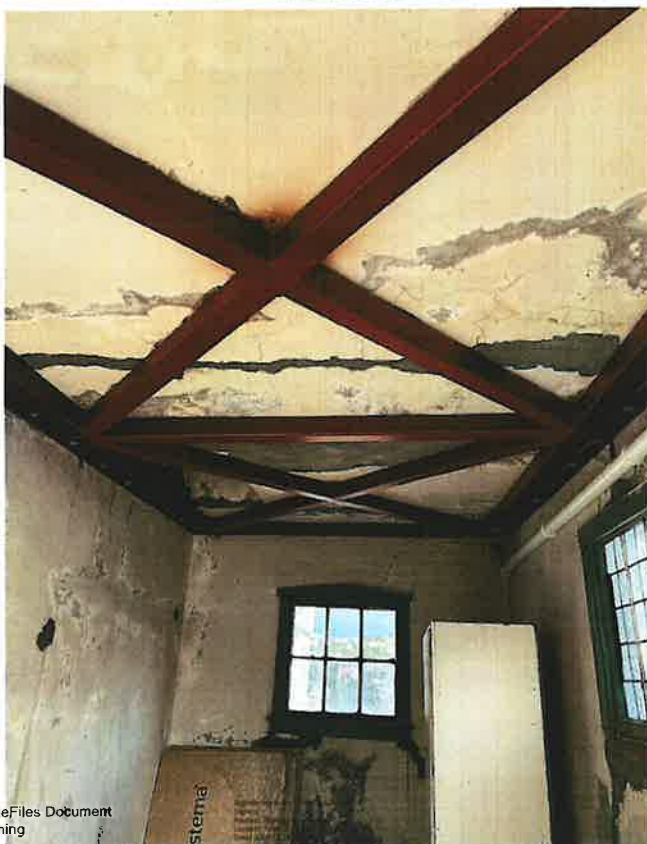
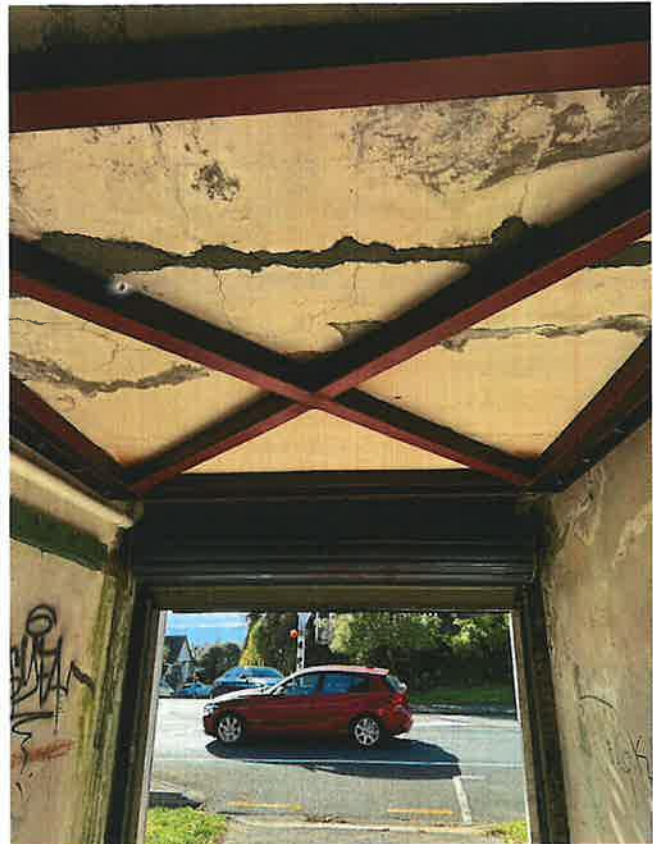
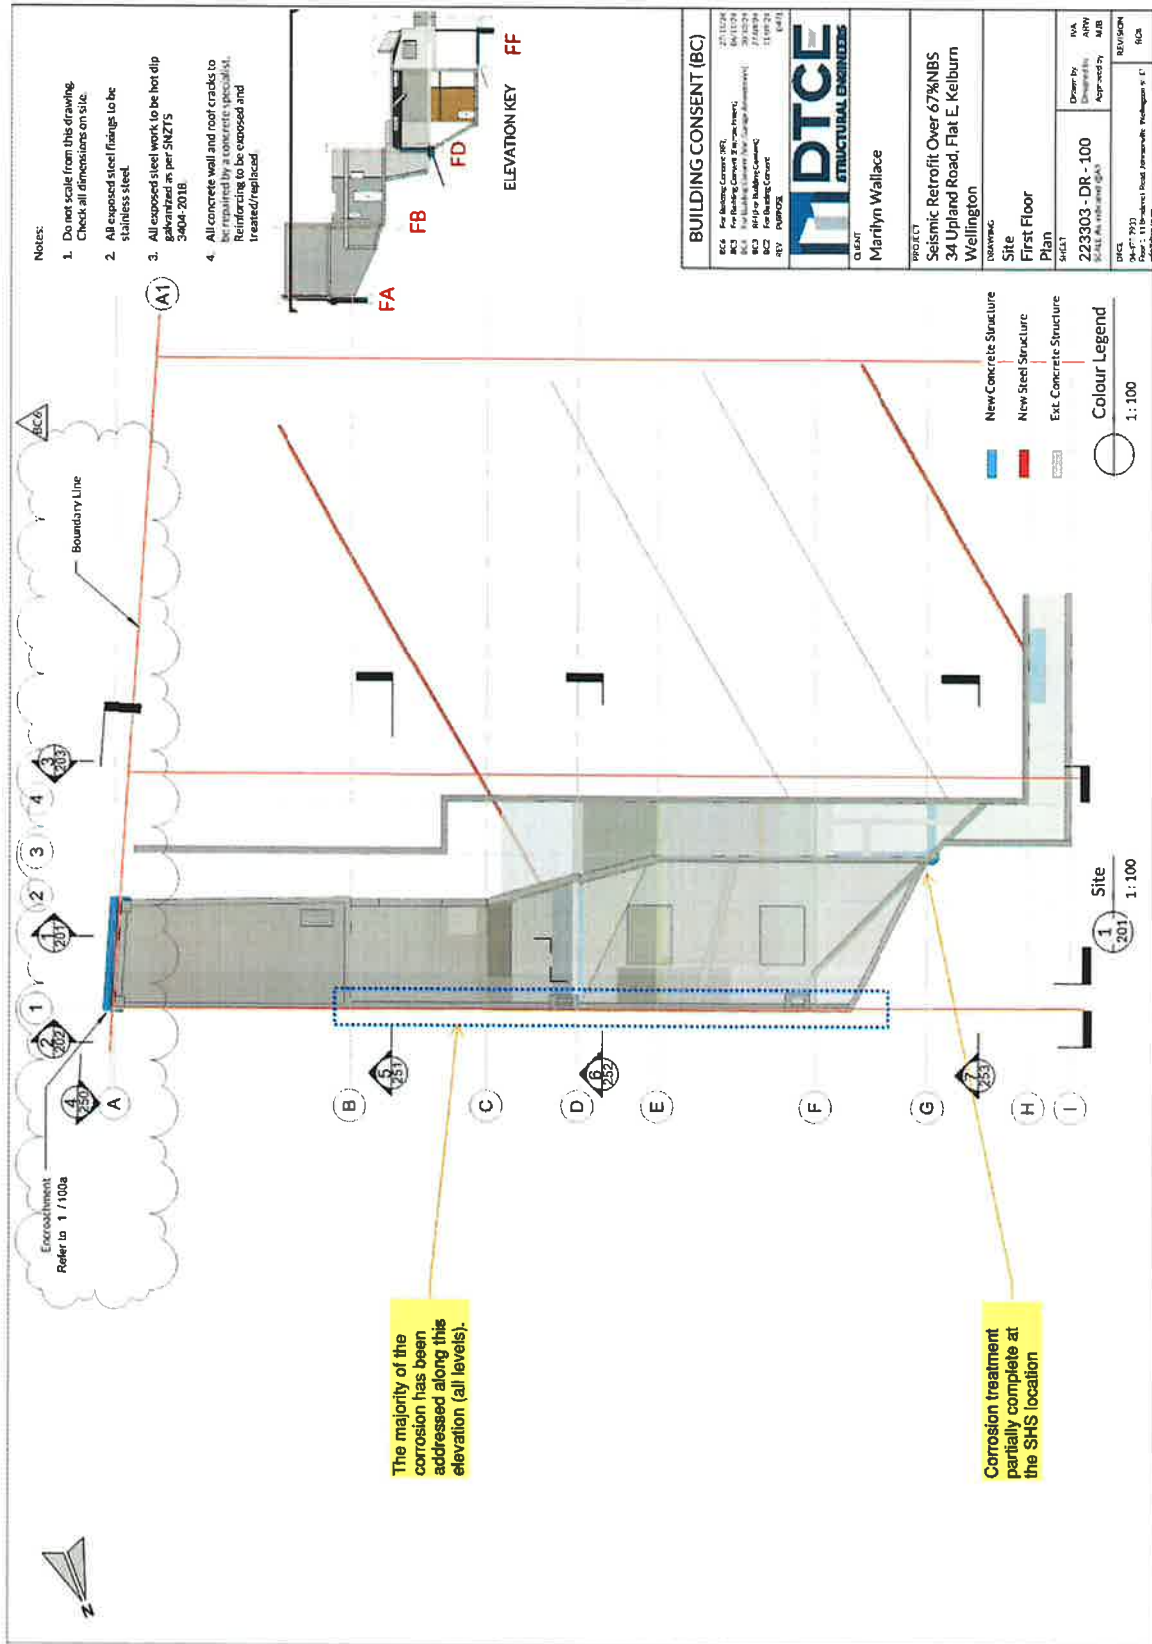
**Figure 5.**

Corrosion has been wire brushed and treated (darker colour).

Towards the left-hand side, there was no corrosion.
