**Re: Body Corporate 582203  
Property at Lyall Bay Junction, 68-72 Kingsford Smith Street, Rongotai, Wellington  
Annual General Meeting**

## BODY CORPORATE NO 582203 (BODY CORPORATE)

### Property at Lyall Bay Junction, 68-72 Kingsford Smith Street, Rongotai, Wellington

Ref: 68 – 72 Kingsford Smith Street Lyall Bay Wellington / Defects Report

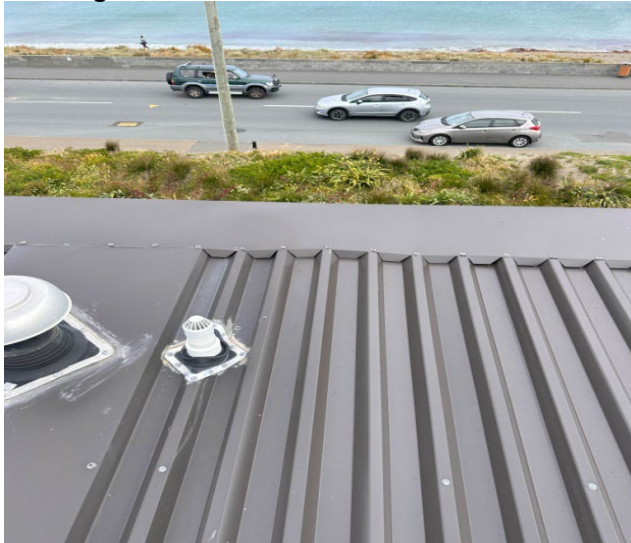
Barge flashing laid over obstruction in roofing substrate

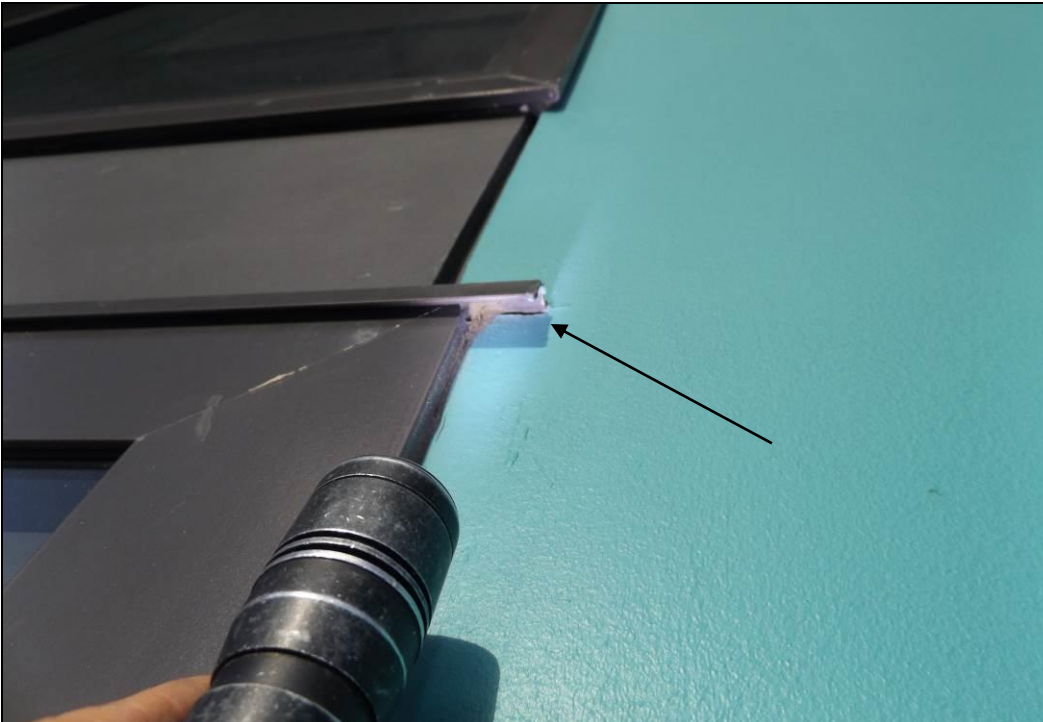
Showing a lower level joinery unit set against fibre-cement – showing the window set 5mm beyond the cladding with easy access behind the cladding if it were not for the reliance on the foam strip which is barely secure due to lack of joinery pressure – unit 53- 54

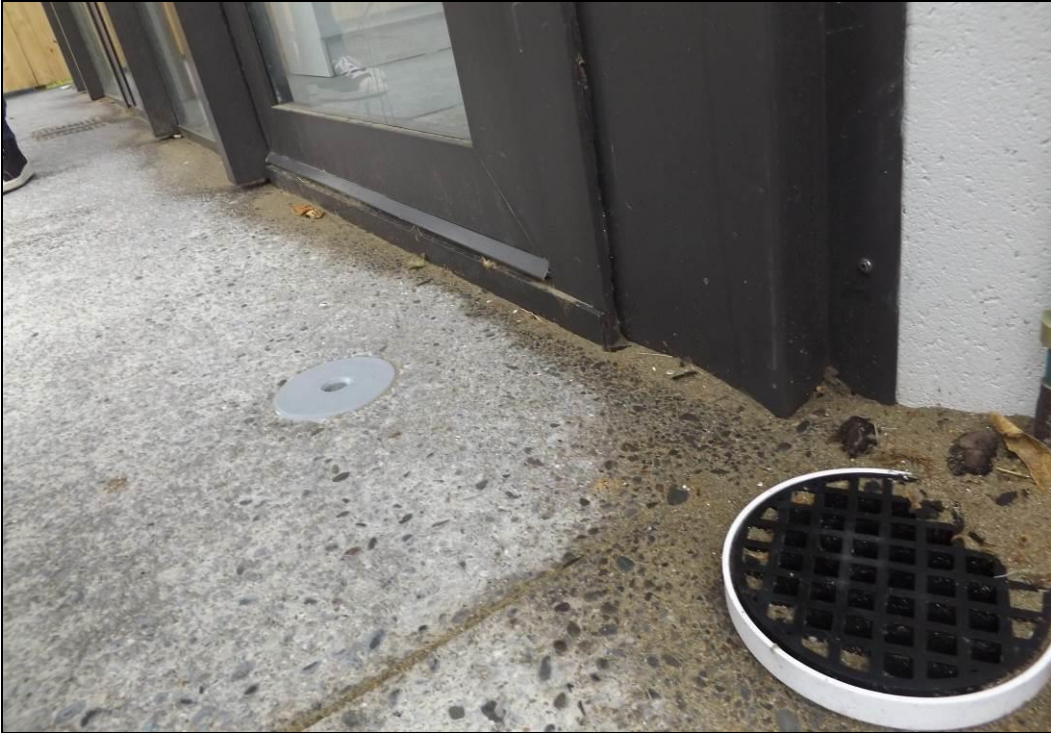
An example of sand deposits filling the gap and general accumulation – its realistically very difficult for a Body Corporate or Individual owners to manage / maintain this sort of repeat occurrence – an alternative raised threshold design would have been a great site specific improvement

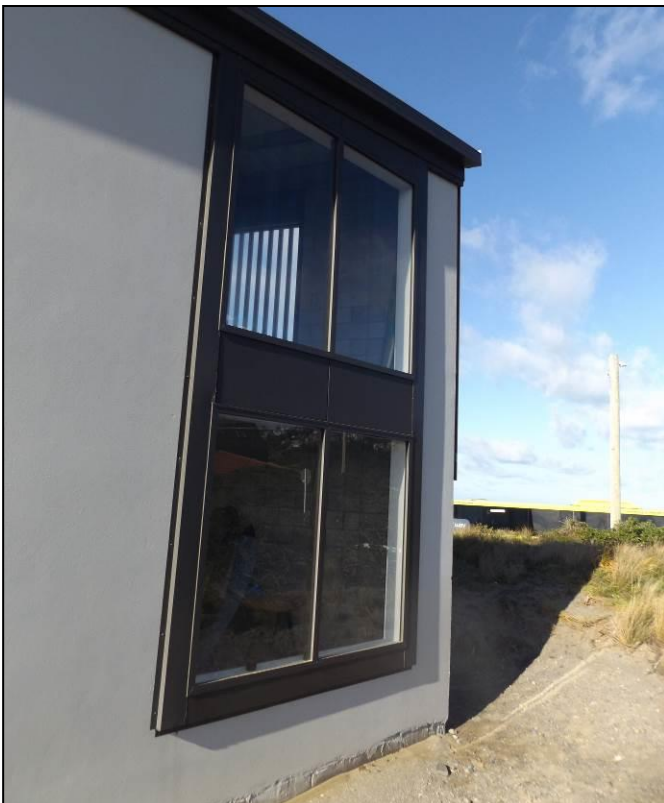
The western large western corner window assembly – Unit 35

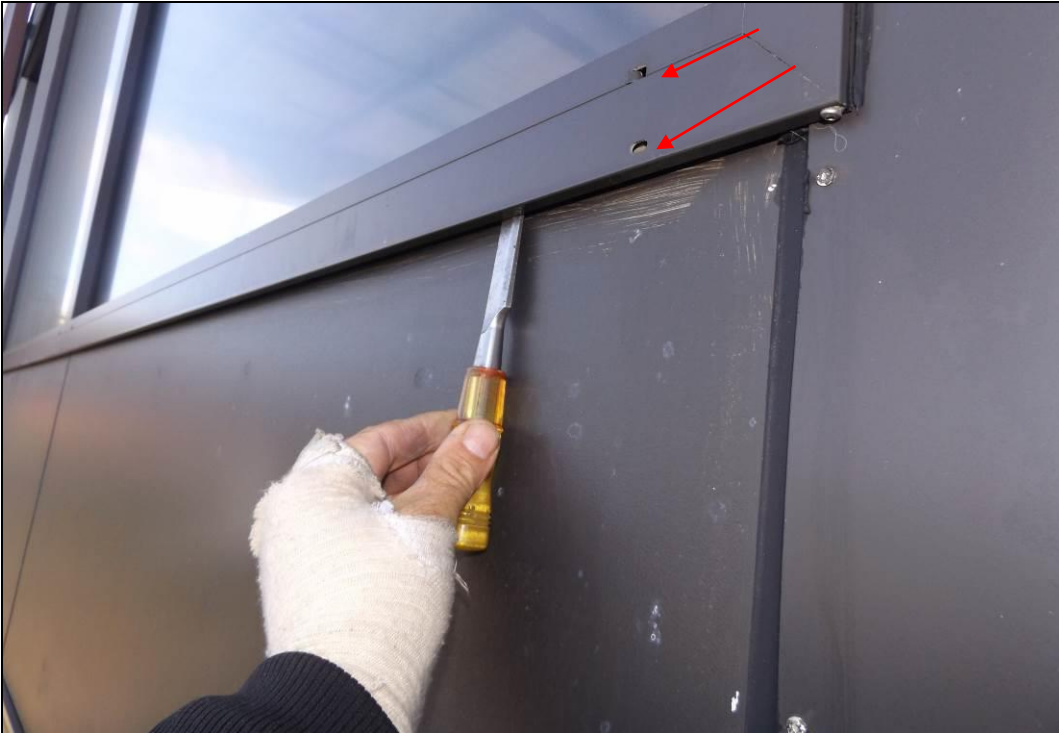
Showing poor painting but also gaps beneath the window sill – in this environment its not ideal  
Note the drainage gaps – again not ideal in a sand blown marine environment – eventually the joinery frame tends to fill with sand and also enters the interior

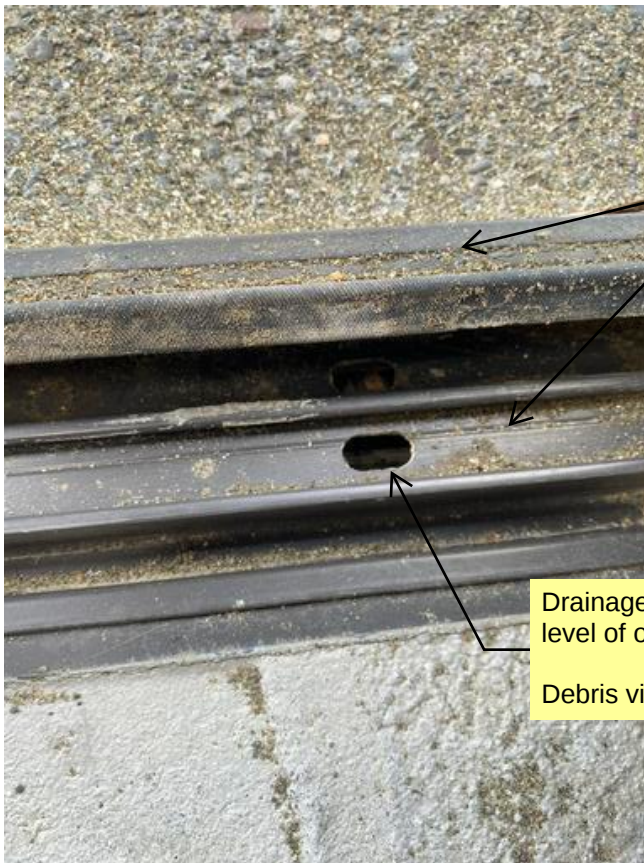
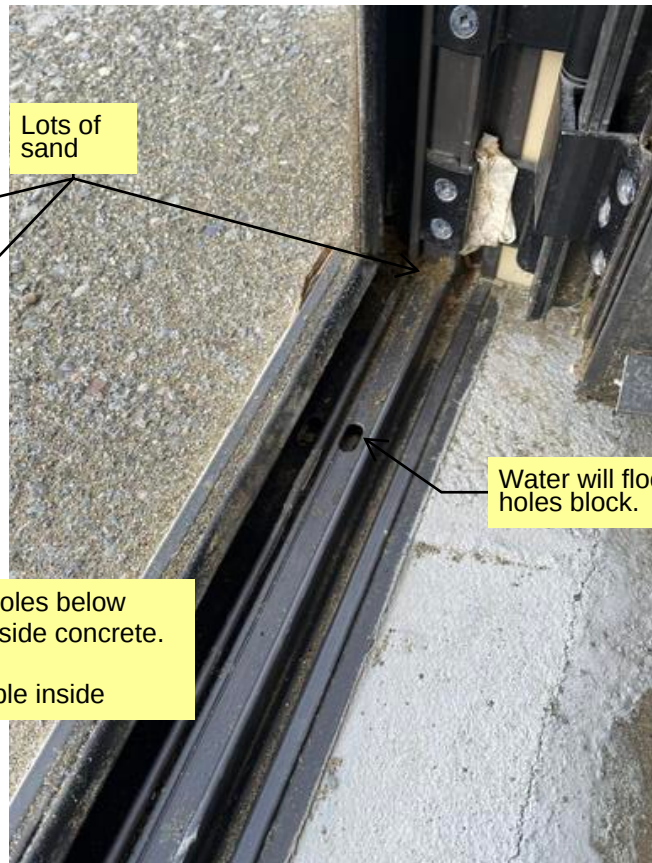
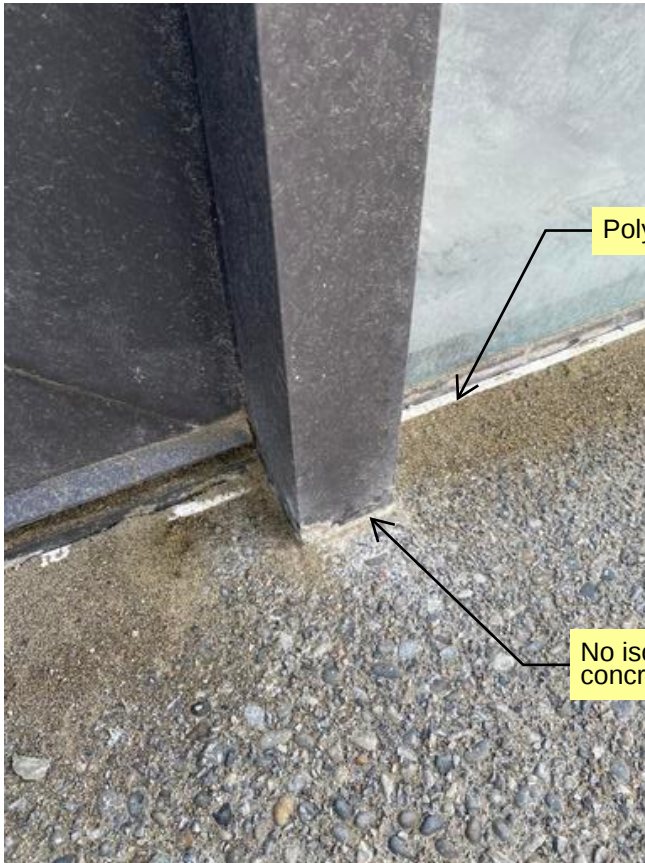
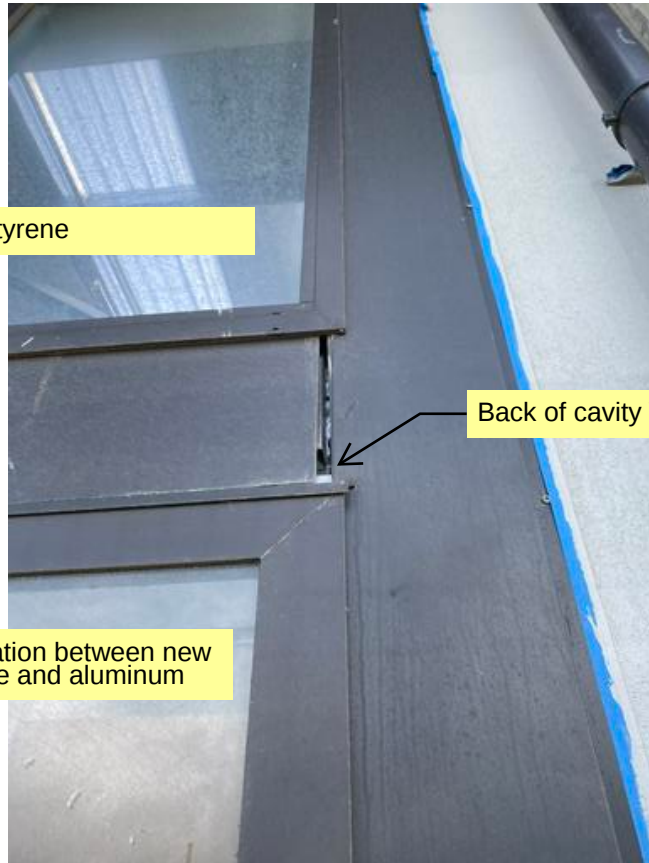
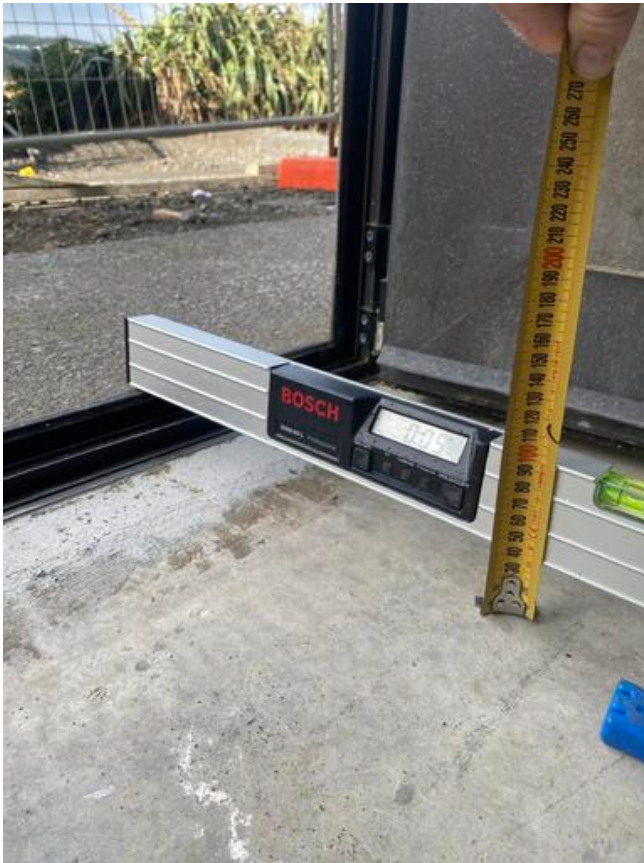
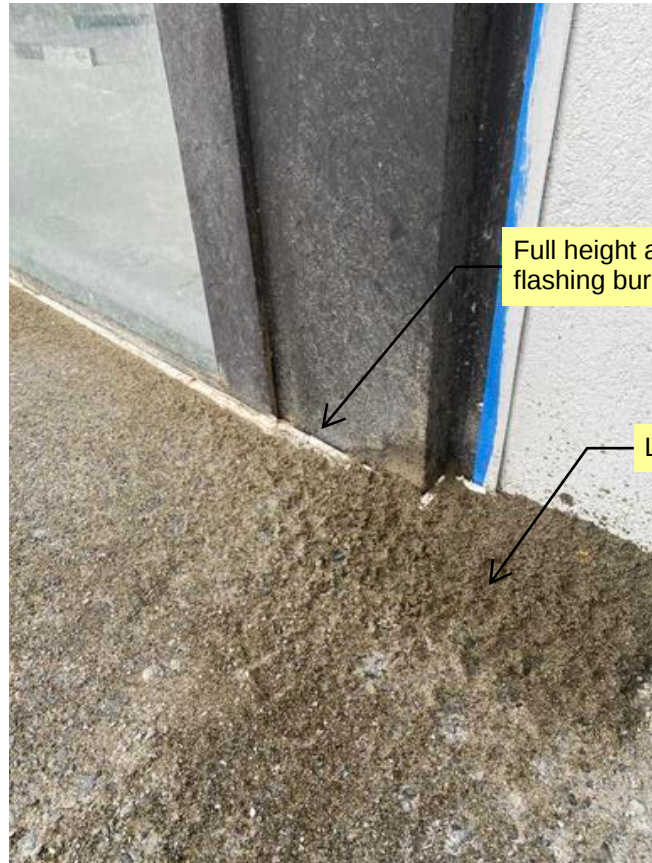
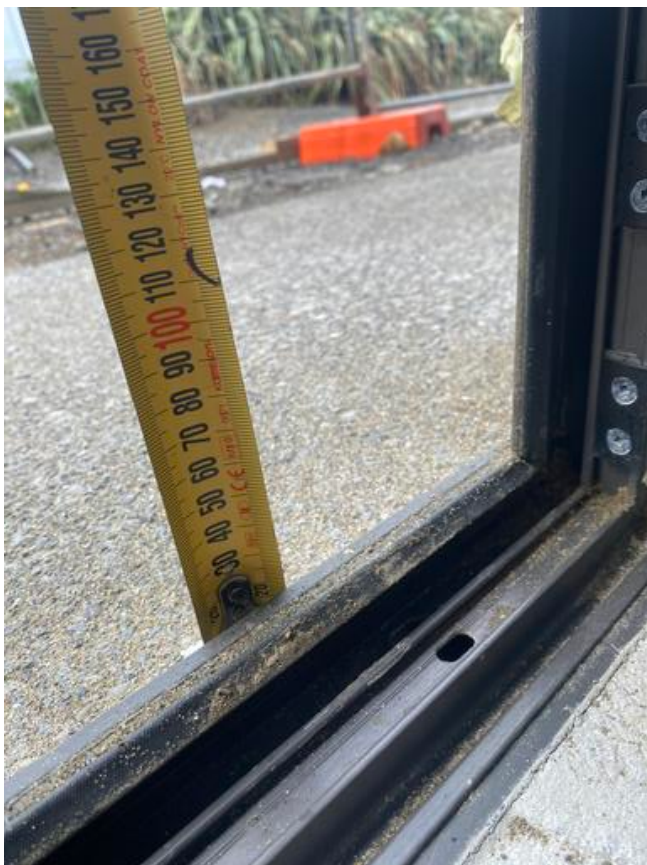
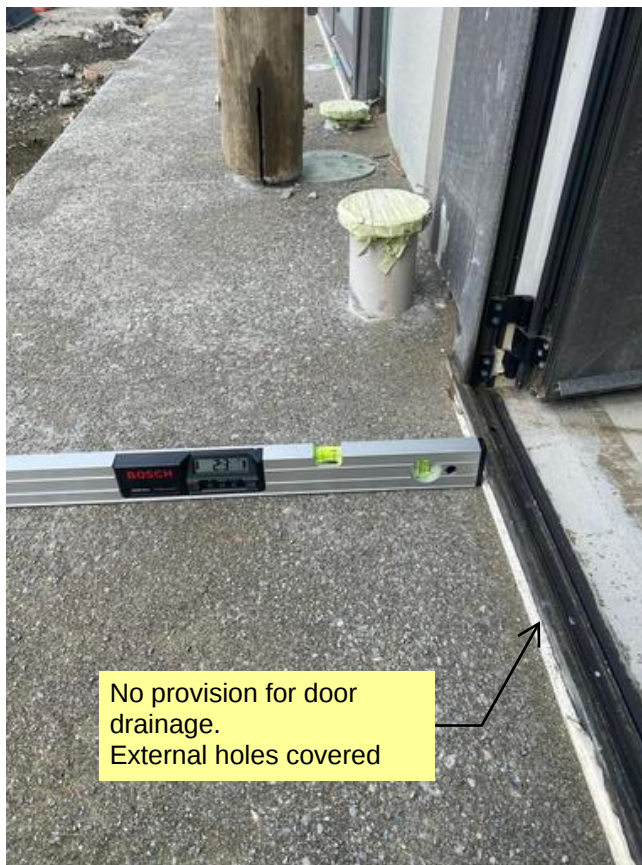
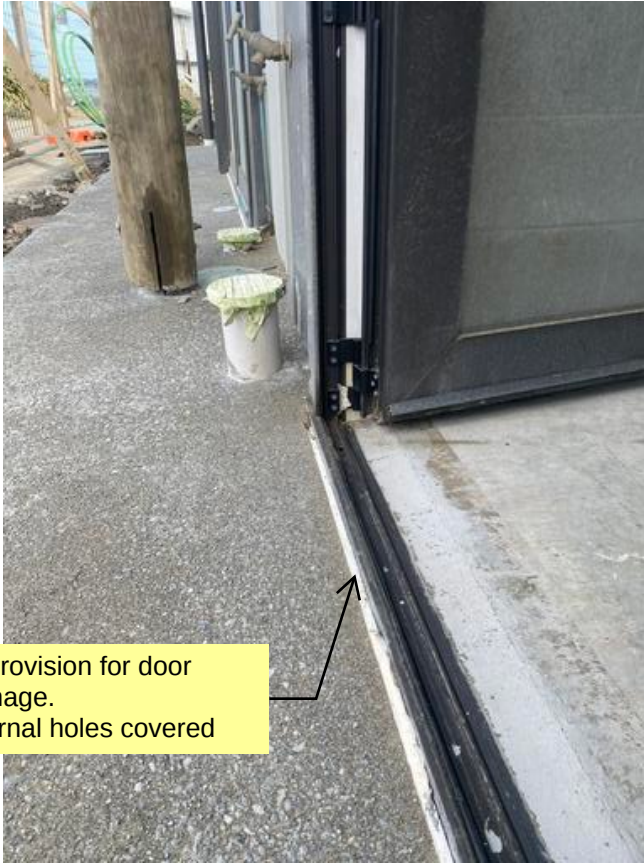
Door installation Concerns
