REPORT

This report covers the structural damage sustained by the Sheer Adventure Workshop building at 78 Byron St, as a result of the series of earthquakes including the Darfield Earthquake that struck at 4:36am on 4<sup>th</sup> September, 2010 and the Lyttelton Earthquake that struck at 12.51 pm on the 22<sup>nd</sup> of February, 2011. The Sheer Adventure Workshop building consists of the original western warehouse structure and the eastern lean-to addition.

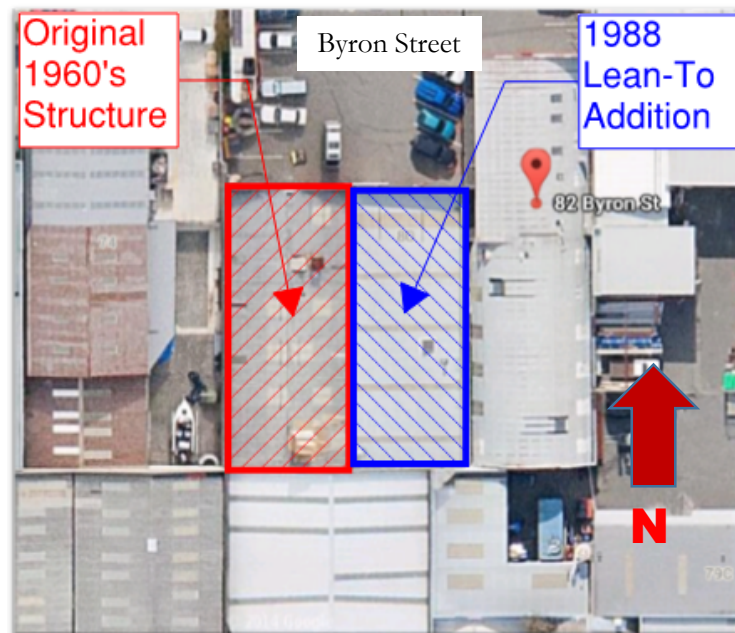
Figure 3-2: Sheer Adventure Workshop – Original Structure and Eastern Addition

direct observation of the gap. There was originally a link (door opening) between the eastern addition and the building to the south. This has since been filled in with a fire rated concrete block wall. The block wall appears to be attached to the southern building and separated from this building. The overall building footprint is illustrated in Figure 3-2.

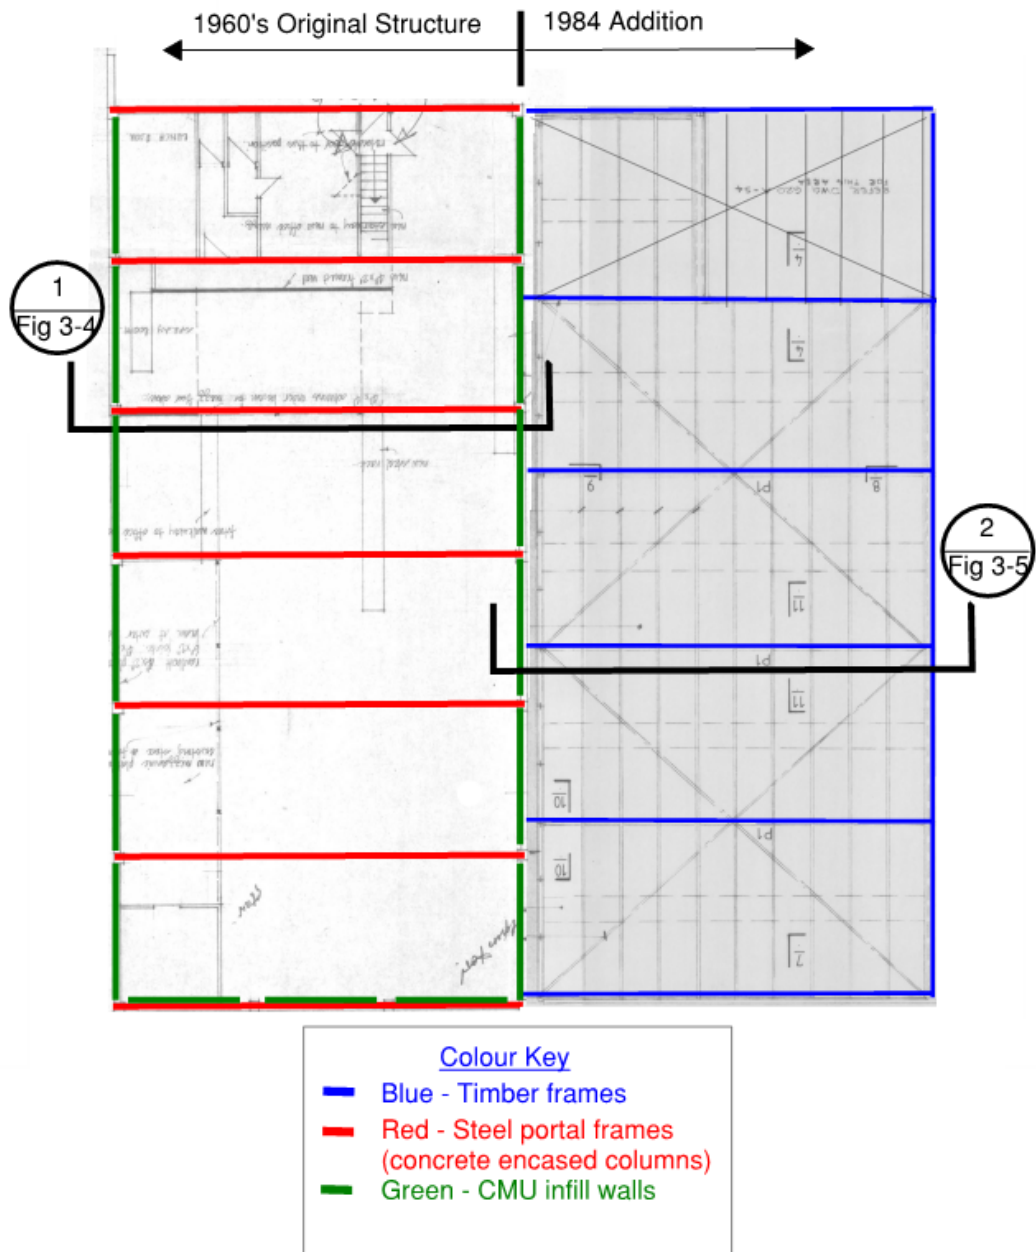
Figure 3-3: Sheer Adventure Workshop – Plan View of Building

The original structure, the western section, was designed and constructed in the 1960's (Figures 3-3 and 3-4). The building was likely designed to predecessor standards of the current NZ Building Code, comprising principally NZS1900:1965. The building is a single story structure, with an internal timber framed mezzanine at the north end of the building. The structure is an open warehouse with steel portal frames running across the building in the east-west direction. The portal frames are composed of I-sections with the columns encased in concrete. Infill walls around the west, south, and original 1960's eastern perimeter of the building are constructed of ungrouted concrete blockwork. There is a solid bond beam along the top of these walls that appears to be reinforced concrete. The roof is composed of diagonal sarking on timber framing with numerous skylights. There is no foundation information available to review however given the type of building and damage observed, the likely construction is concrete slab on grade with shallow pads under portal legs and shallow strip foundations under the walls.

The lean-to addition, the eastern section, was designed and constructed in 1988 (Figures 3-3 and 3-5). This addition was likely designed to the NZS4203 (1984) loadings standard. The structure consists of glulam cantilevered L-shaped frames which span in the east-west direction and are pinned to the original structure's reinforced concrete bond beam. The roof is composed of light gage metal roofing and insulation supported by timber purlins. The south, north, and east walls are composed of light timber framing. A connection doorway to the building adjacent to the south wall has been in-filled with a grout filled concrete block wall. The wall appears to be tied into the structural concrete blockwork walls of the adjacent structure, and are therefore not a part of this building. There is a short height timber framed mezzanine at the north end.

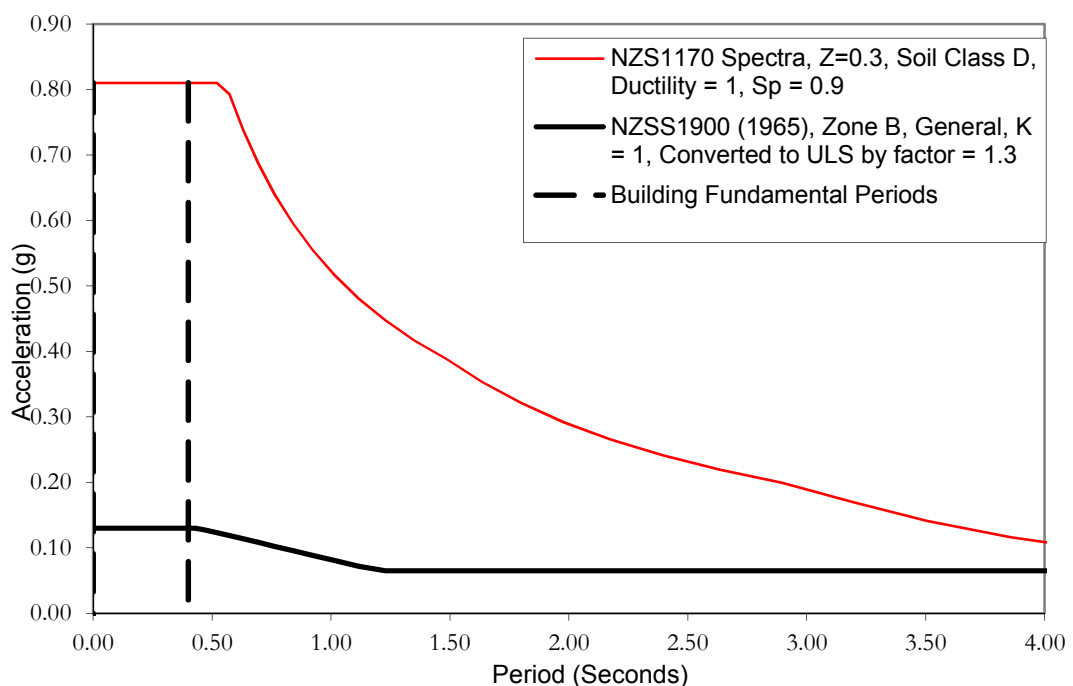
Figure 3-6: Comparison of Design Codes (NZSS1900 to NZS1170)

Comparisons of the load levels represented by the original loading standards to the current loading standard are plotted below for a building fundamental period of 0.4s. The seismic design loads from NZS1900:1965 are approximately 15% of current design loads. Seismic loads from NZS4203(1984) are approximately 35% of current design loads.

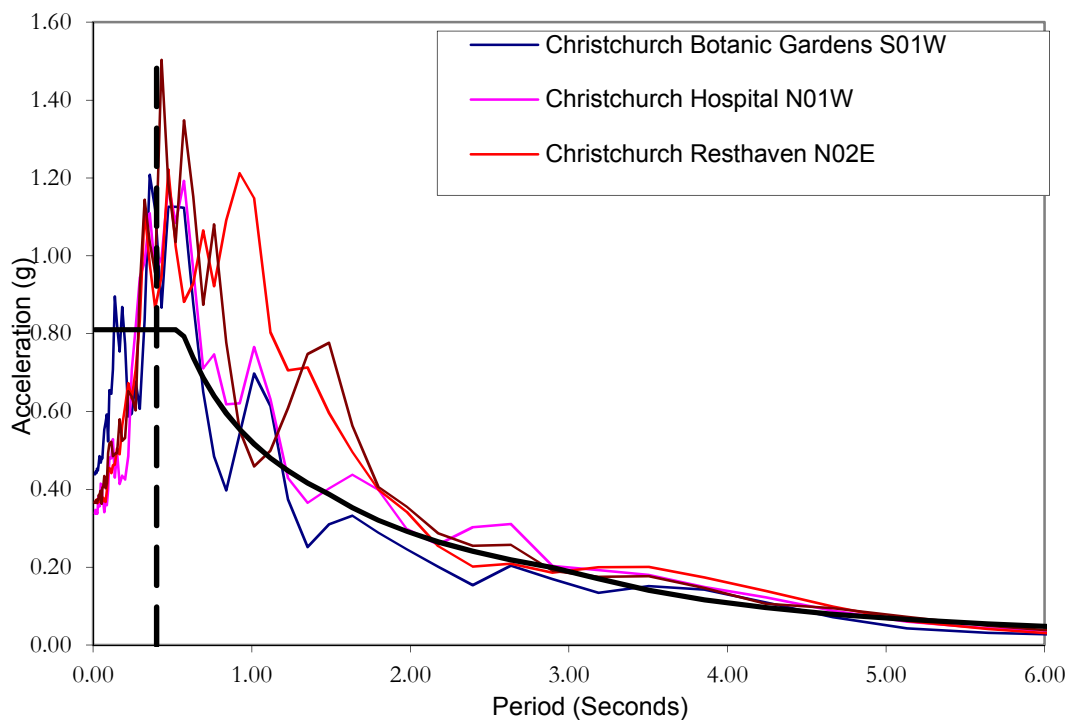
Figure 4-2: 5% Damped Spectra – North-South

It is apparent that in both directions there is significant variation in the shaking experienced at the different monitoring sites. This is due to the highly variable ground conditions around Christchurch.

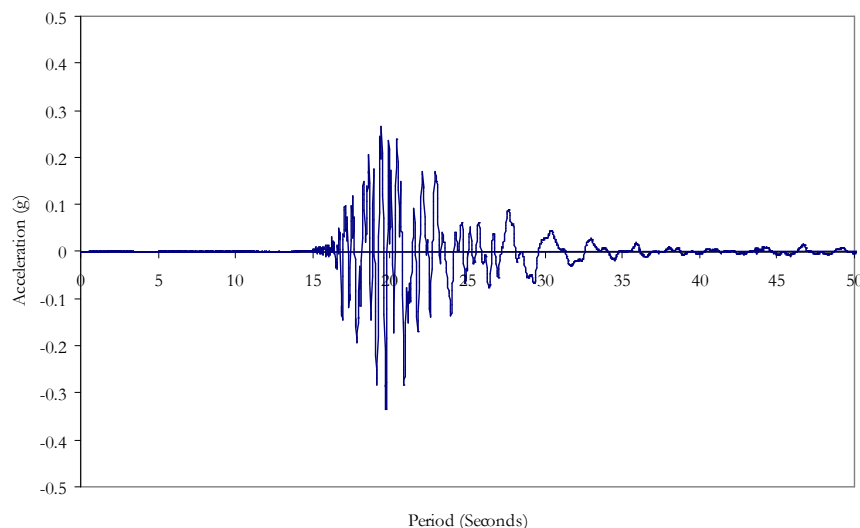
Figure 4-4: Earthquake Record from Christchurch Hospital Site

However it should also be noted that this earthquake was relatively short in terms of the strong shaking produced. The following plot of the earthquake record from the Christchurch Hospital monitoring station at 12:51 pm on the 22<sup>nd</sup> of February shows that the strong motion only lasted for a duration of approximately 5-10 seconds.

Because of this the building has only gone through a limited number of inelastic cycles. A full design earthquake for Christchurch (eg rupture of the Alpine Fault) is expected to have a significantly longer record of shaking, although the accelerations are not expected to be as strong. As an indication, rupture of the Alpine Fault is expected to contain in excess of 60 seconds of strong motion.
