# STEVEN YOUNG & ASSOCIATES LTD

## 69 WAIONE STREET, PETONE – 6 BUILDING COMPLEX

We have been engaged by Eddie Hawkins to review and summarise a Detailed Seismic Assessment report prepared by Spencer Holmes for the complex at the above address.

## Detailed Seismic Assessment

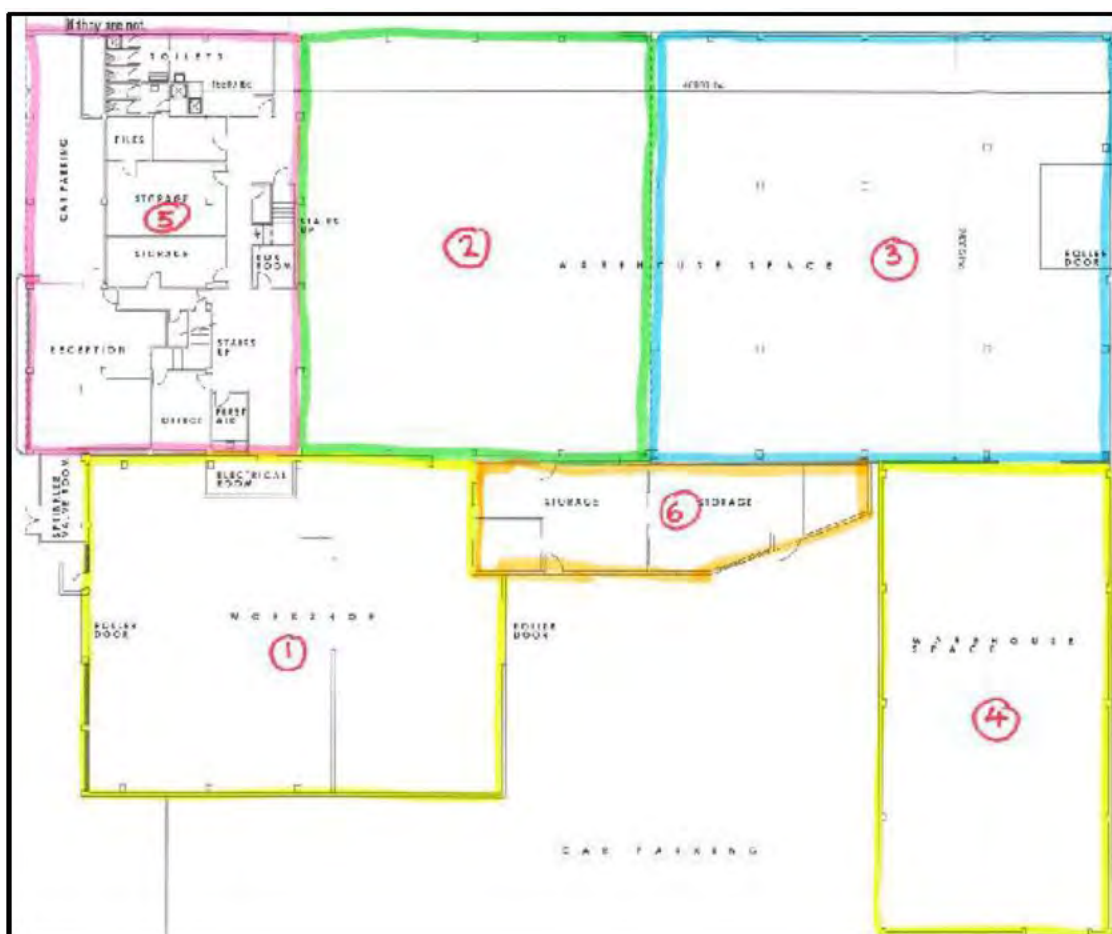
69 Waione Street is comprised of six parts comprising their own structural systems. For ease of assessment, these have been labelled

Building 1-4 and 6: Single-Storey  
Building 5: Two-Storey
