# Land Information Memorandum

Property address:  
46B Belfast Road

LIM number: H00765010  
Page 1

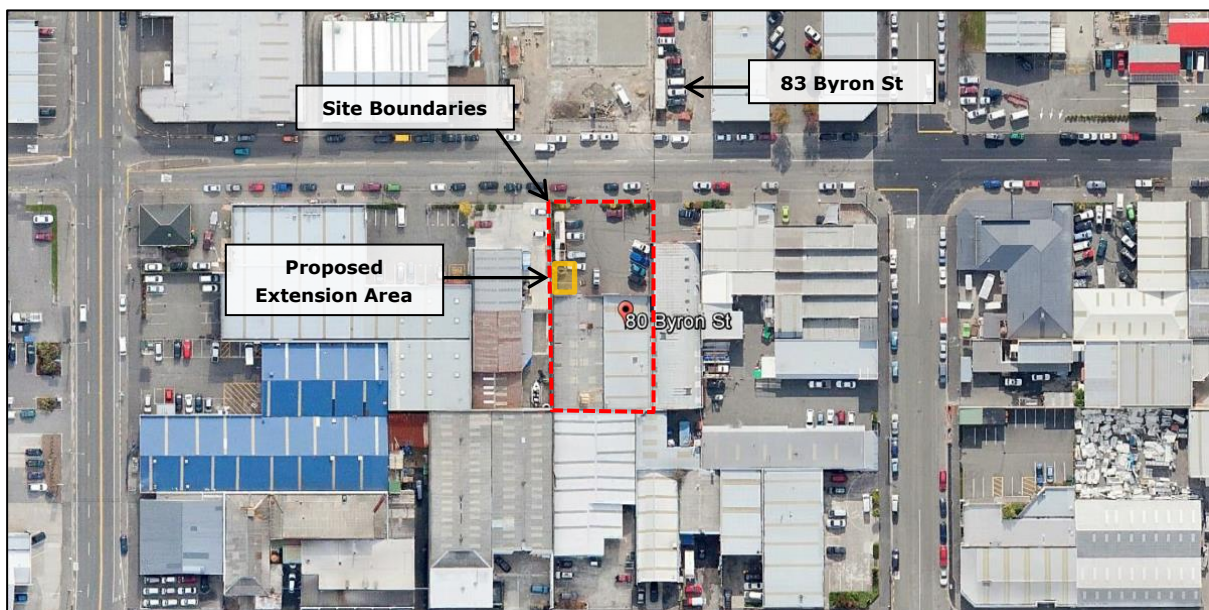
**Figure 1: Site Location**

The site's legal description is Lot 1 DP 449853. The property is rectangular, covers an area of 1280m<sup>2</sup> and is located on the south side of Byron Street in Sydenham, as shown below on Figure 1:

These drawings indicate that the proposed extension is to be situated near the northwest corner of the existing west building, as shown on Figure 1 above. The drawings also indicate that the extension is approximately 13m long (north-south), 7.8m wide (east-west) and one-storey. The foundation is proposed to be a concrete slab and is to be tied into the existing buildings concrete slab.

The site owner has supplied a geotechnical report completed for the property at 83 Byron Street (approx. 40m northeast of extension; see Figure 1) by Engco Consulting Engineers (Ref: 16363) in January 2017. The following is a summary of relevant information:

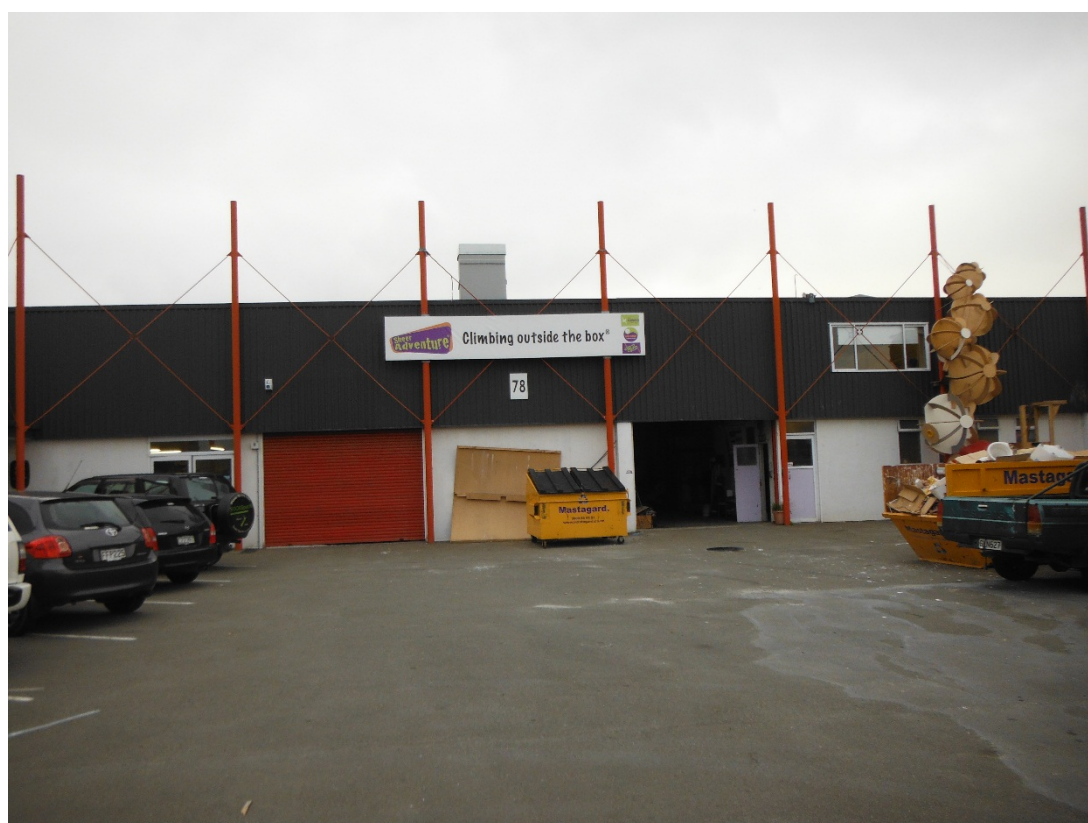
Figure 3-1: Sheer Adventure Workshop – 78 Byron St

This section discusses the form and capacity of the building prior to the Canterbury Earthquakes. The Sheer Adventures Workshop building at 78 Byron Street was constructed in two different time periods. The main structure was constructed in the 1960's with an addition along the eastern side of the building constructed in 1988. The original structural design for the 1988 addition was completed by Buchanan and Fletcher Ltd. Designers of the 1960's section are unknown. The street facing side of the structure is shown in Figure 3-1.

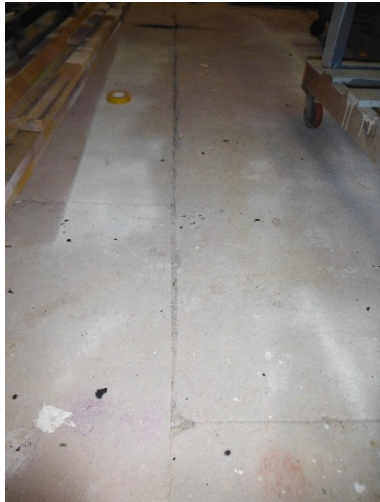
| Damaged Item | Location | Example | Recommended Repair |
|---|---|---|---|
| 1.2. Differential settlement of slab | <p>South section of eastern structure</p> <p>See damage map photo 2.</p> | | Remove section of slab that has lifted. Re-level ground. Install new slab with epoxy dowels into adjacent slab sections. |

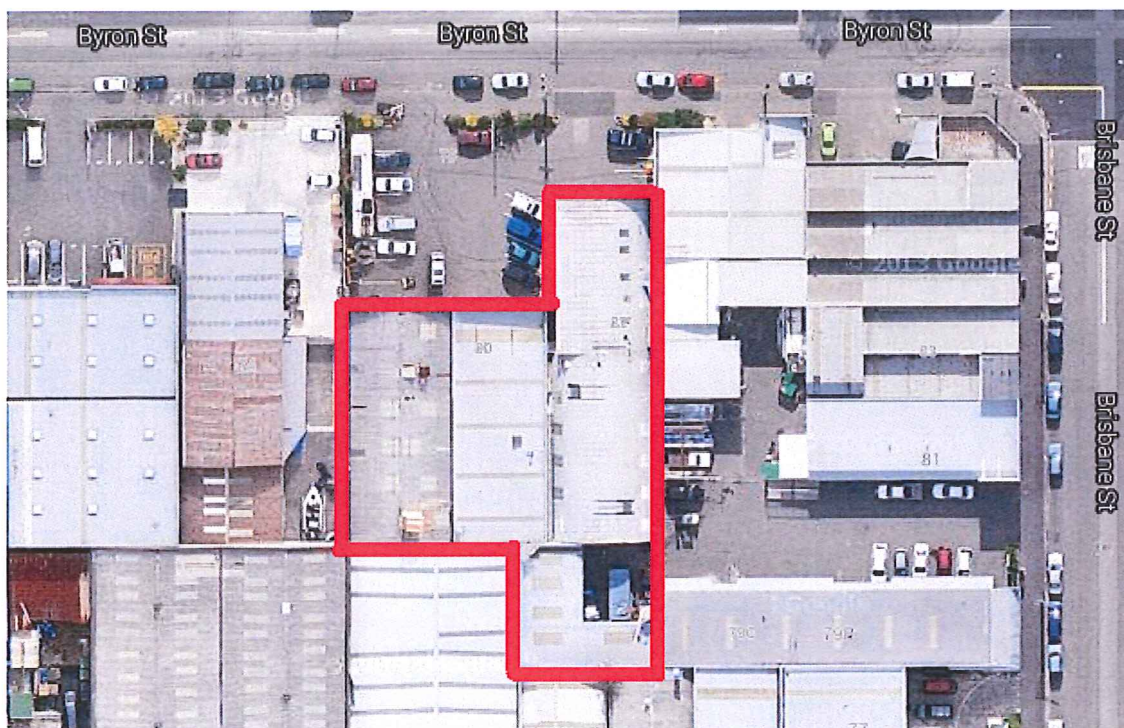
*Diagram of the buildings surveyed.*

Staic and Smith Ltd were engaged to carry out a survey of the buildings at 78 & 82 Byron St. The site comprises four individual buildings; the eastern and south-eastern buildings are tenanted by Socks Pacific and the two western buildings are tenanted by Sheer Adventure.
