# Land Information Memorandum

59 Newtown Street

**Project:** 59 Newtown Street  
Detailed Engineering Evaluation  
Quantitative Assessment

**Reference:** 228626  
**Prepared for:** TPA  
Godfreys Ltd  
**Revision:** 1  
**22 June 2012**

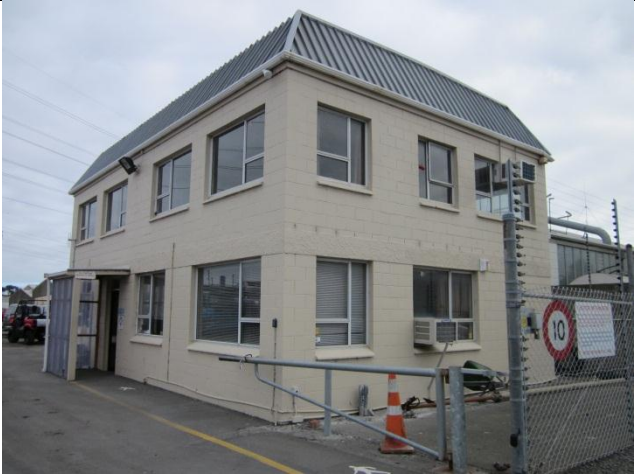
| Ref | Description | Photograph |
|---|---|---|
| 1 | General southeast view of the building. | A photograph showing the exterior of a two-story building with a grey tiled roof and light-colored walls. The building has several windows and a small entrance on the ground floor. A chain-link fence and a red and white striped pole are visible in the foreground. |

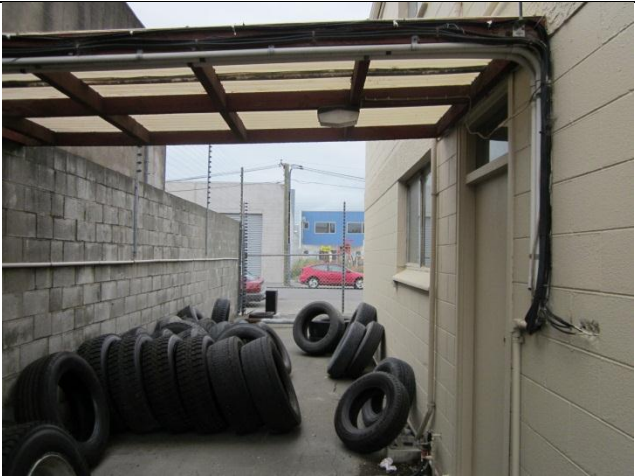
| Ref | Description | Photograph |
|---|---|---|
| 2 | General northeast view of the building. | A photograph showing the exterior of the building from a different angle. The building has a grey tiled roof and light-colored walls. A large pile of black tires is visible in the foreground, and a red car is parked in the background. |

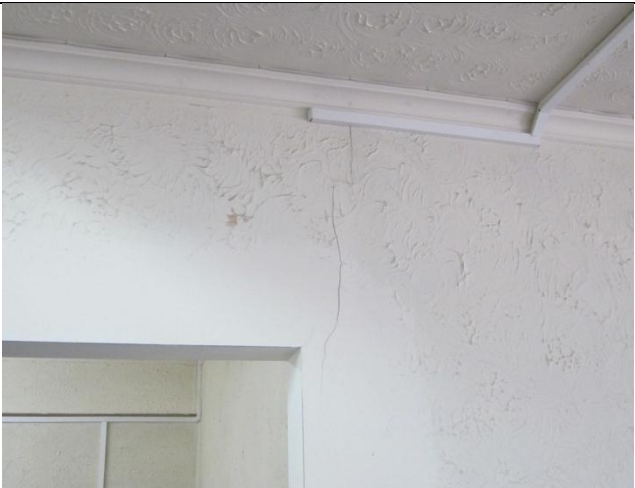
| Ref | Description | Photograph |
|---|---|---|
| 3 | Minor cracking to internal linings, typical. | A photograph showing the interior of the building. The walls are white and have some minor cracking. A white door frame is visible in the foreground. |

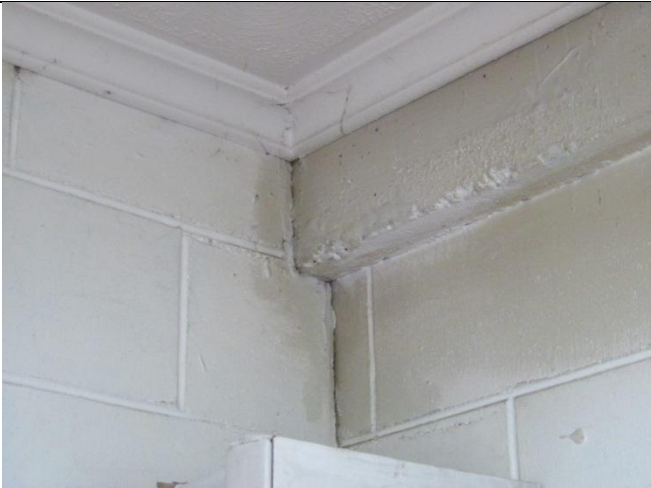
| 4 | Minor movement between internal and external block walls. | |

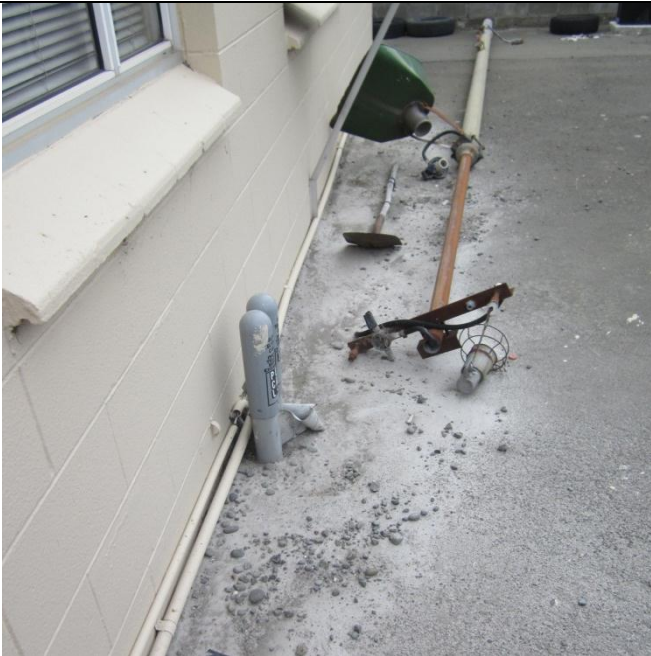
| 5 | Evidence of liquefaction on site. | |

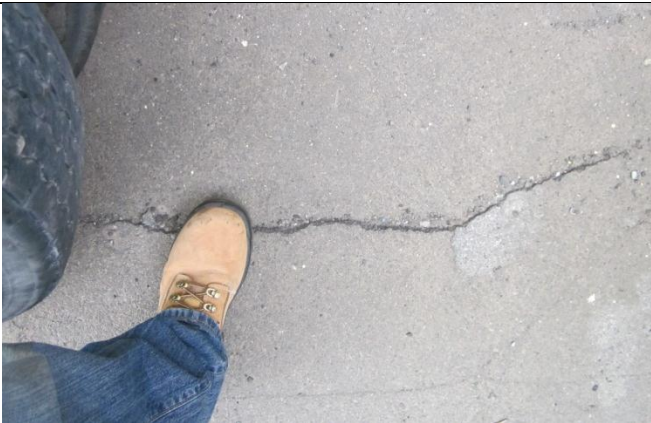
| 6 | Minor damage to asphalt. | |
