## Fire Sprinkler System Survey Report

8 Burnham Street  
Petone

Date: 28 September 2022  
Survey No: 23665  
Site Ref: A1928  
Issue: A

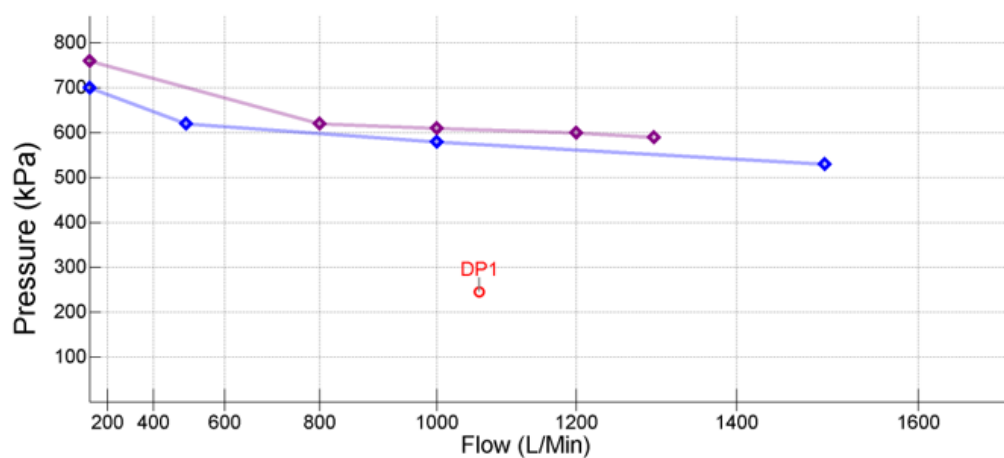
○ Design Points    ◆ Primary    ◆ Secondary
