# Your Building Inspection Report

CONFIDENTIAL REPORT FOR  
Wallcork Upland Ltd  
ID 165984  
Monday, April 13, 2026

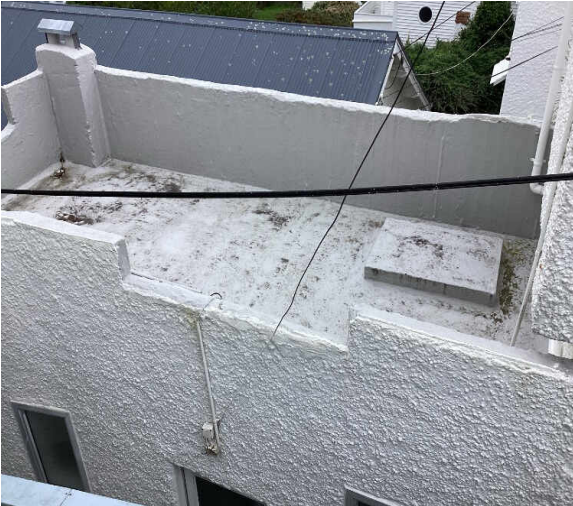
Membrane roof coatings such as the one on this dwelling have the potential to allow water entry through poor application and installation, lack of maintenance, poor detailing and complex junctions. This tends to occur particularly on buildings built between 1990 and 2006. We suggest that a thorough examination is completed bi-annually (ideally at the end of winter and end of summer), and any bubbling, water pooling, lifting of membrane or any signs of deterioration of the membrane should be investigated by a membrane roofing specialist. Our visual inspection confirms that the roof on this dwelling appears to be performing.

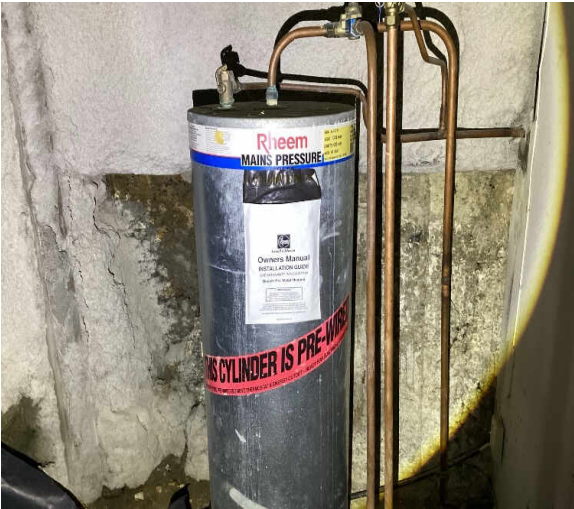
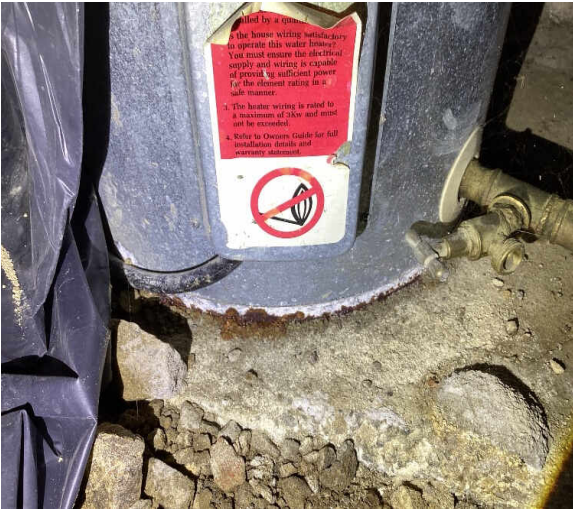
The average life span of this type of hotwater system is 10-12 years. This system is estimated to be older than this time frame. We suggest that a thorough examination is completed bi-annually (ideally at the end of winter and end of summer), and any pipe or cylinder breakdown, water pooling or any signs of deterioration should be investigated by a qualified plumber. On the balance of probability it is likely that this system will need replacing in the near future. We recommend this system be further investigated by a qualified plumber.

The hot water cylinder shows signs of corrosion. We recommend this is replaced.

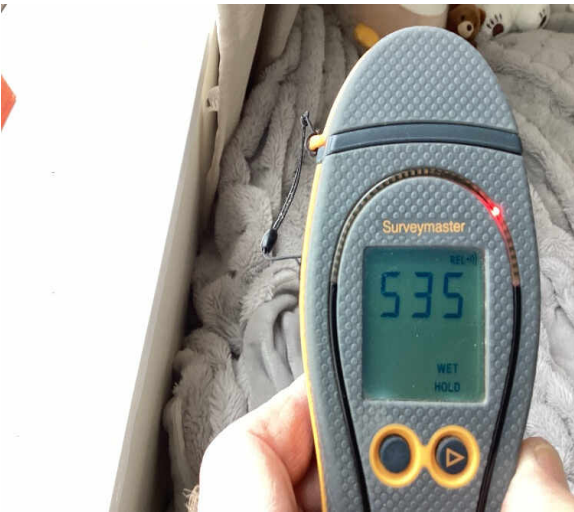
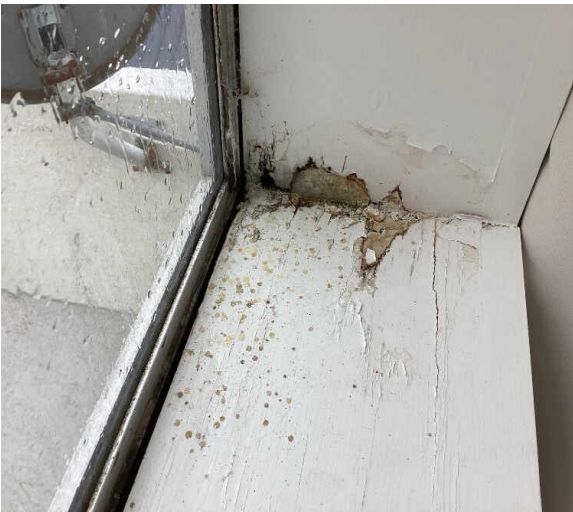
# MOISTURE READING #4

A higher than average moisture reading was noted. This is an indicator that there is potential water ingress. On the balance of probability it is likely that this high reading is caused by a weather tightness issue. The window frame is visibly water damaged, repair or window replacement is needed. This is located in the upper bedroom.

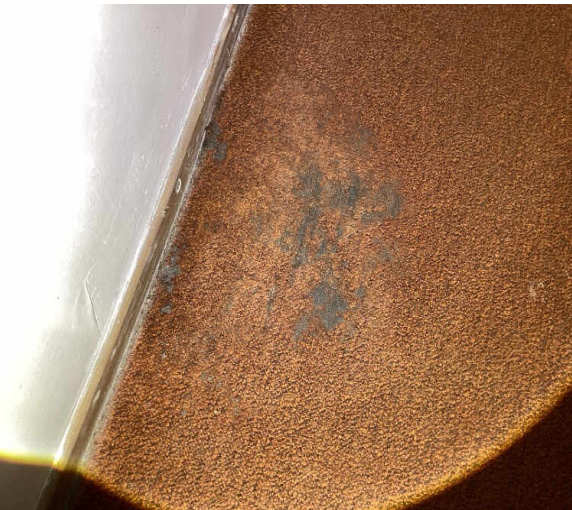
The floor covering is in poor condition. The floor covering requires replacement.

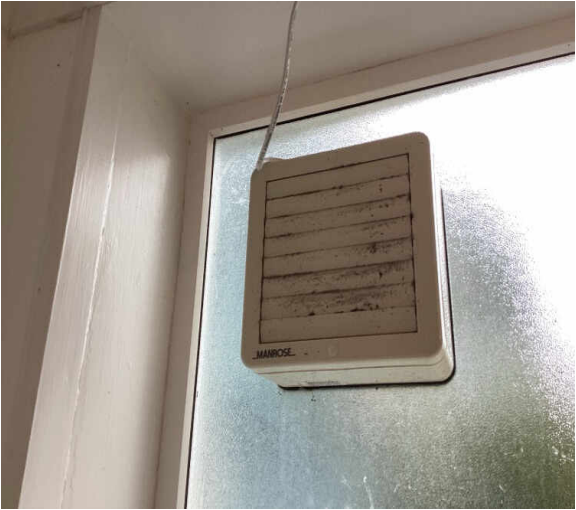
No visible issues noted during the inspection. The fan would benefit from cleaning.
